Annex B

Internal photos of the EUT

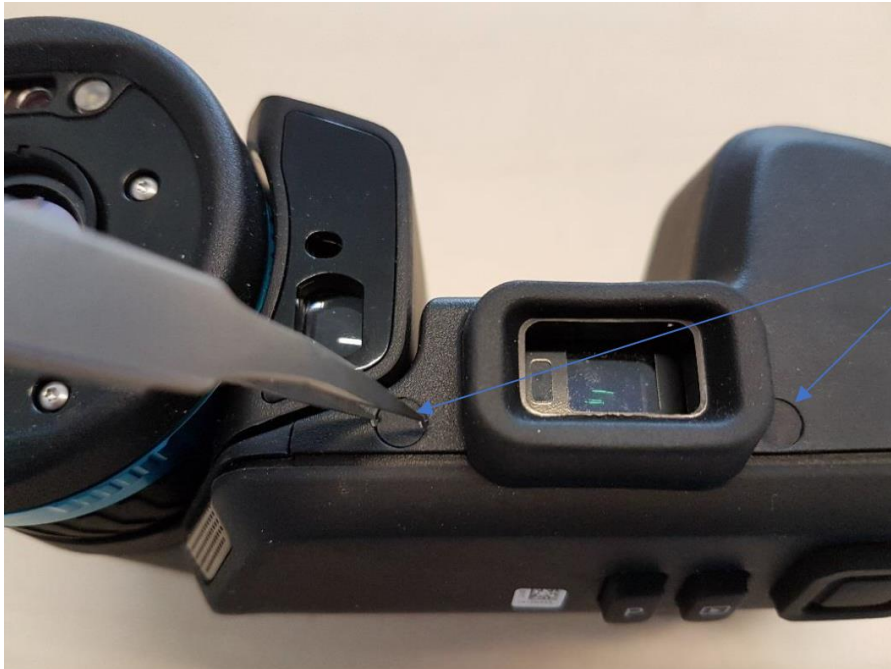
Photo 1:

Remove these covers

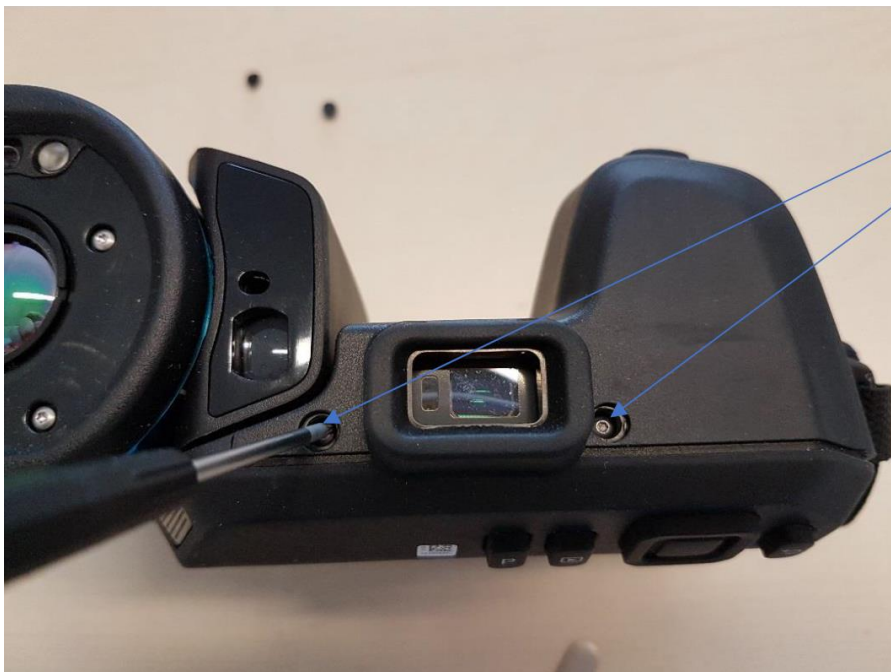
Photo 2:

Remove the two screws

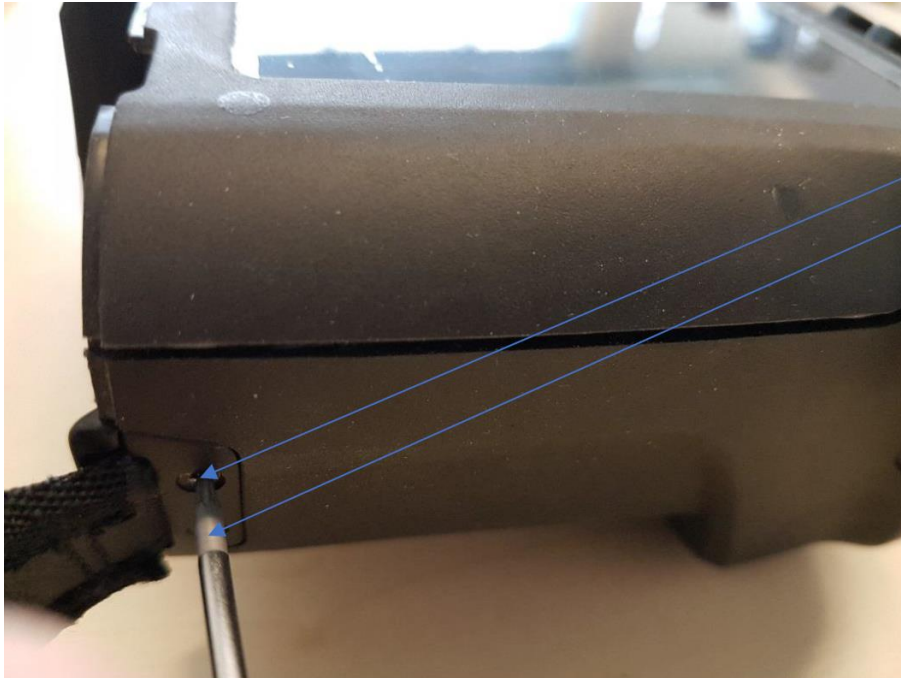
Photo 3:

Remove the hand strap.
Two screws.

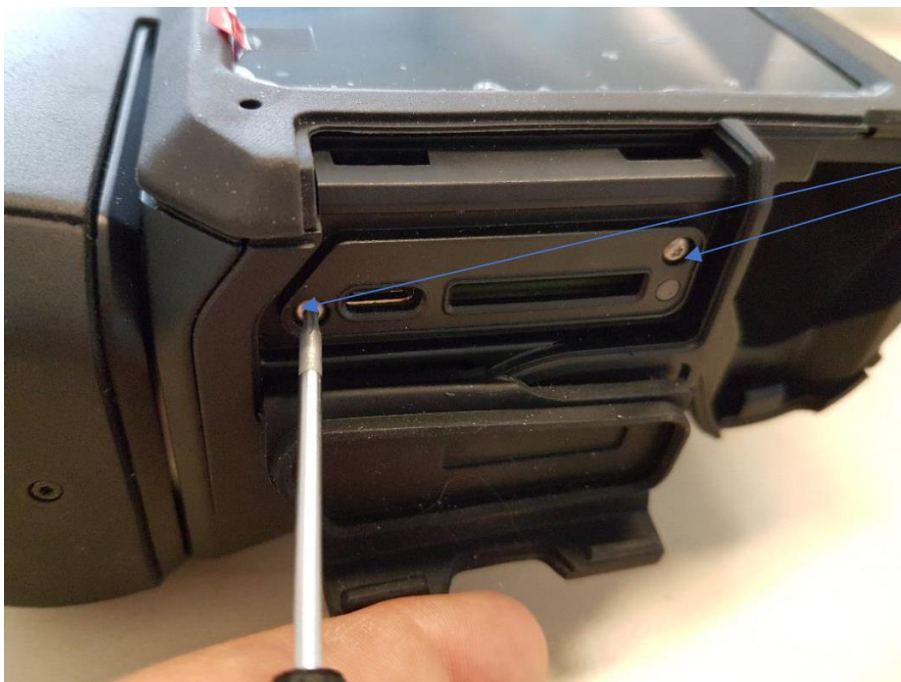
Photo 4:

Remove the USB cover.
Two screws.

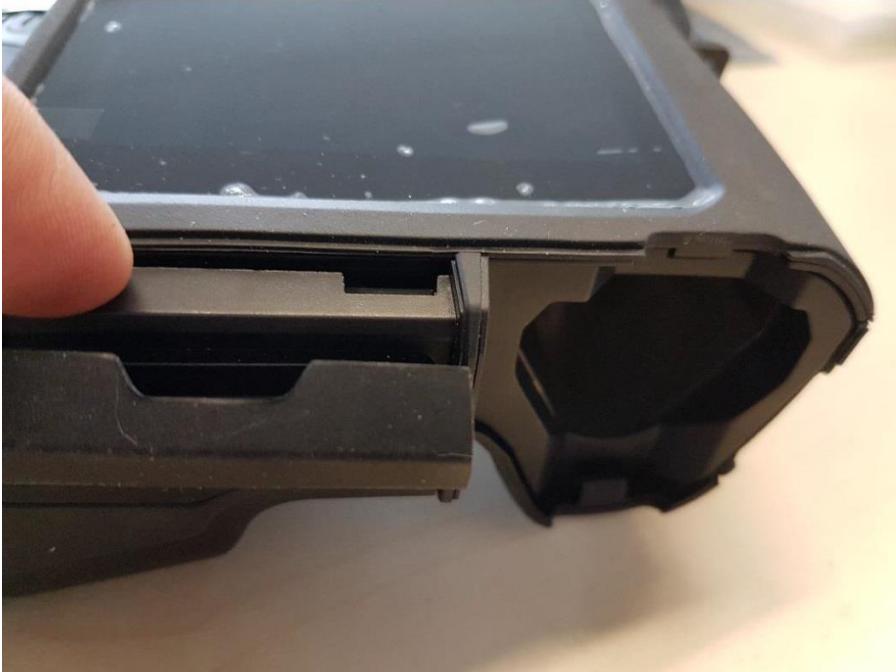
Photo 5:

Remove the USB cover.

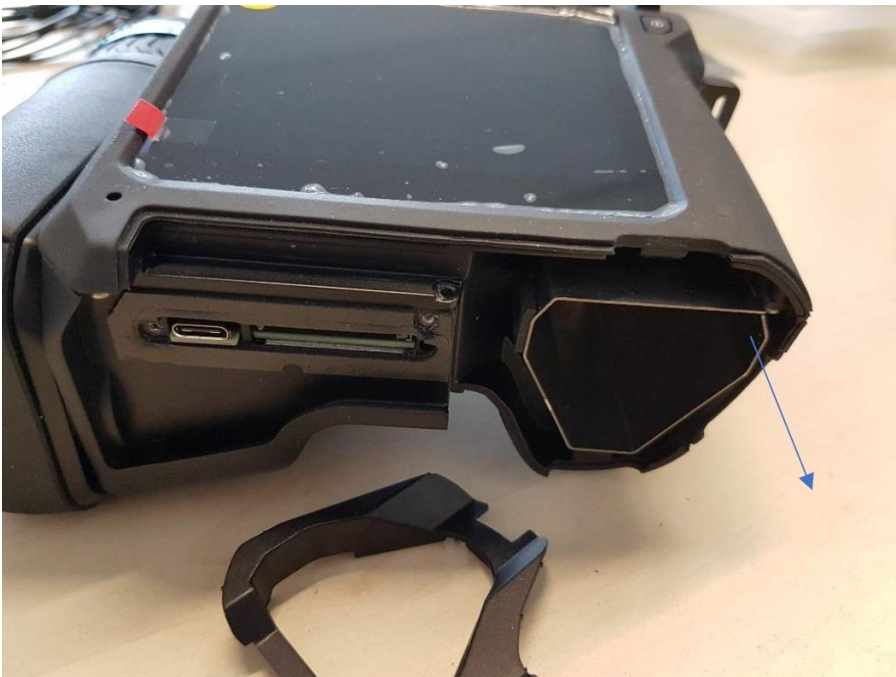
Photo 6:

Take out the battery holder.

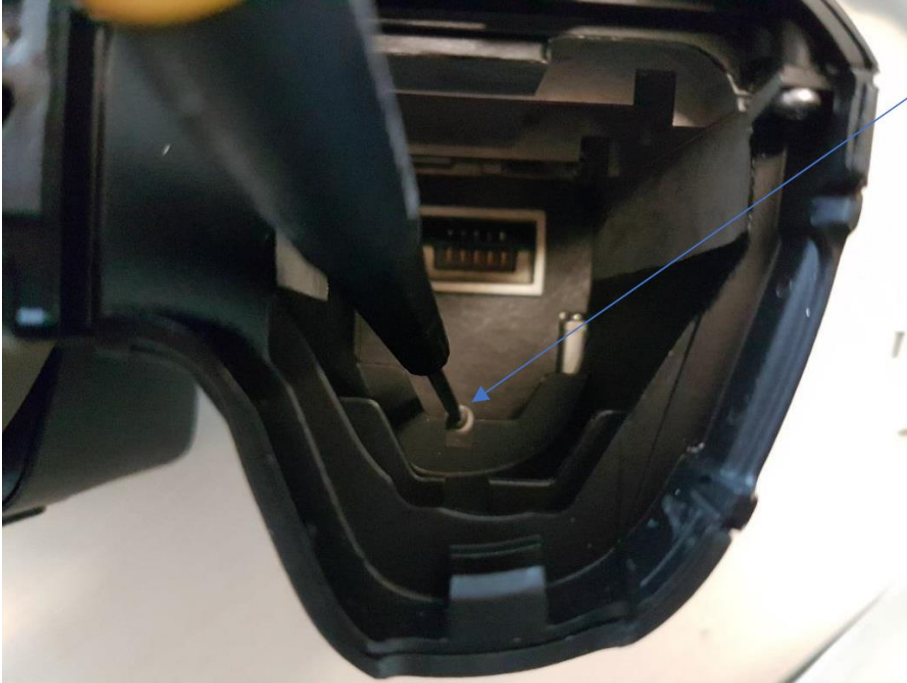
Photo 7:

Re move screw in battery
co mpart ment.

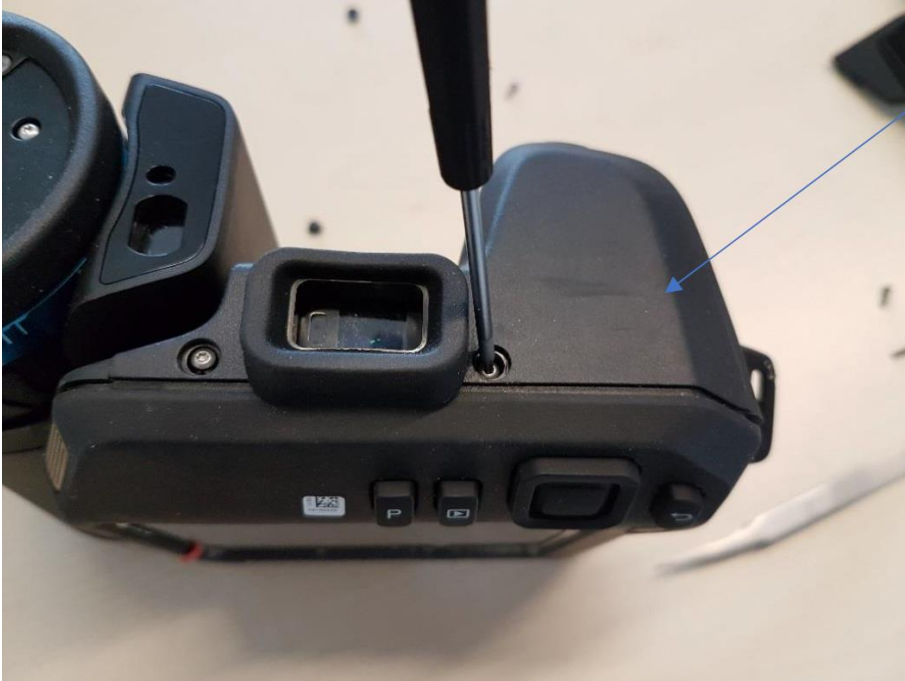
Photo 9:

Remove antenna cover.

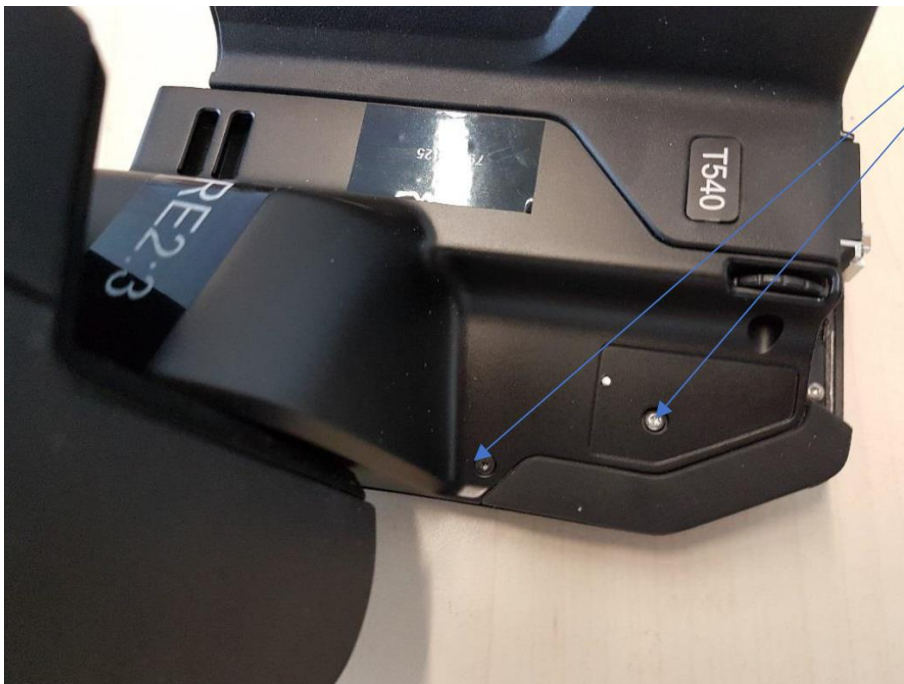
Photo 12:

Re move 2 screws.

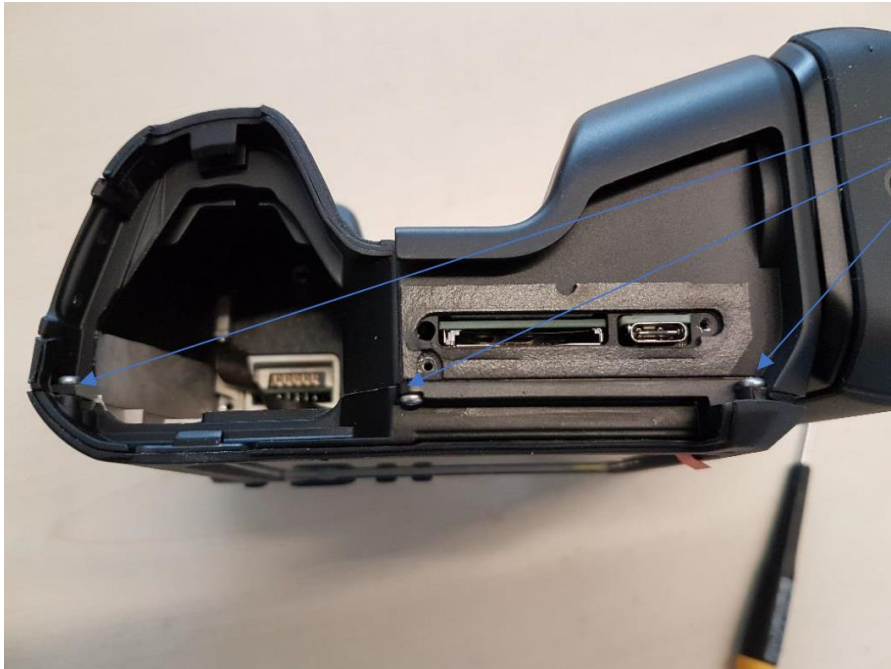
Photo 13:

Re move 3 screws.

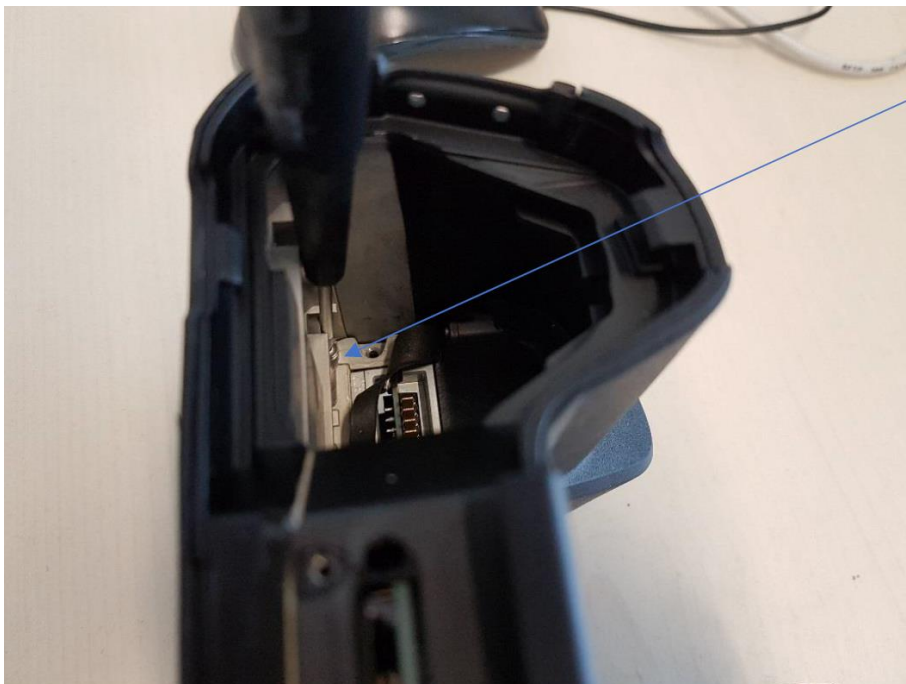
Photo 14:

Re move 1 screw in the
battery co mpart ment.

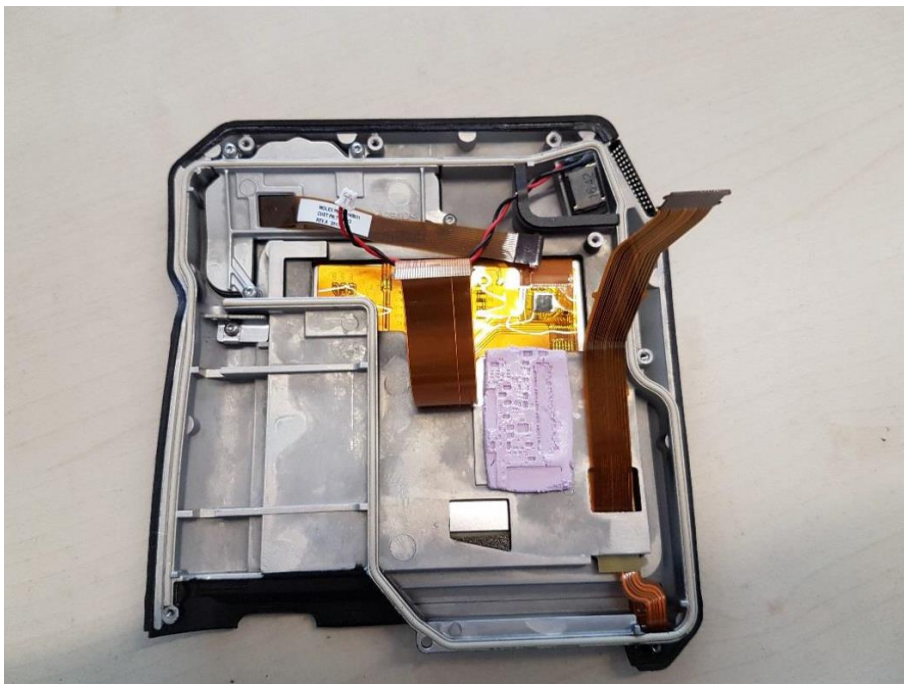
Photo 16:

Display unit now loose.

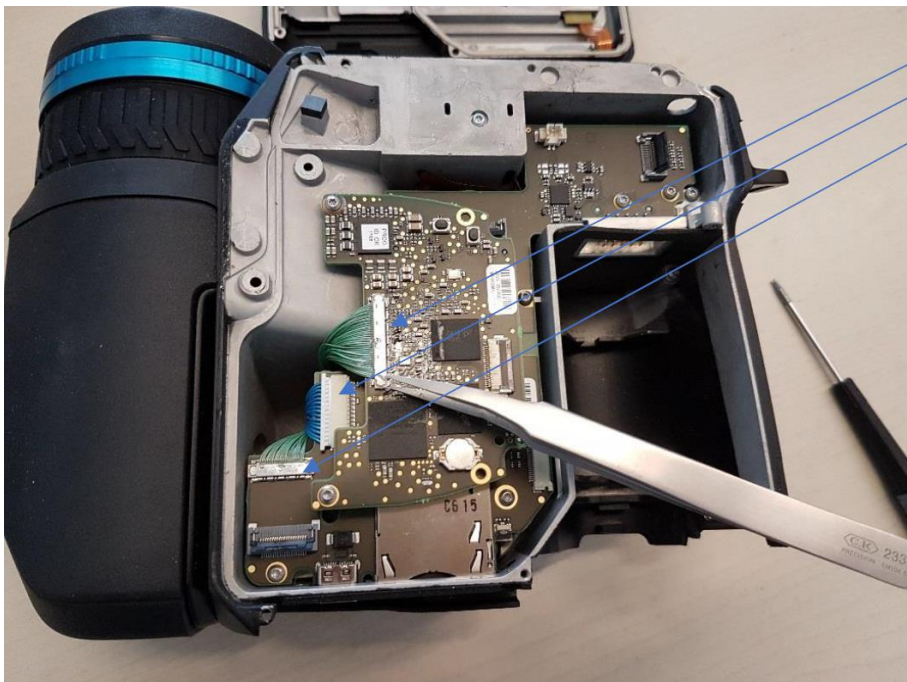
Photo 18:

Remove 3 cables.

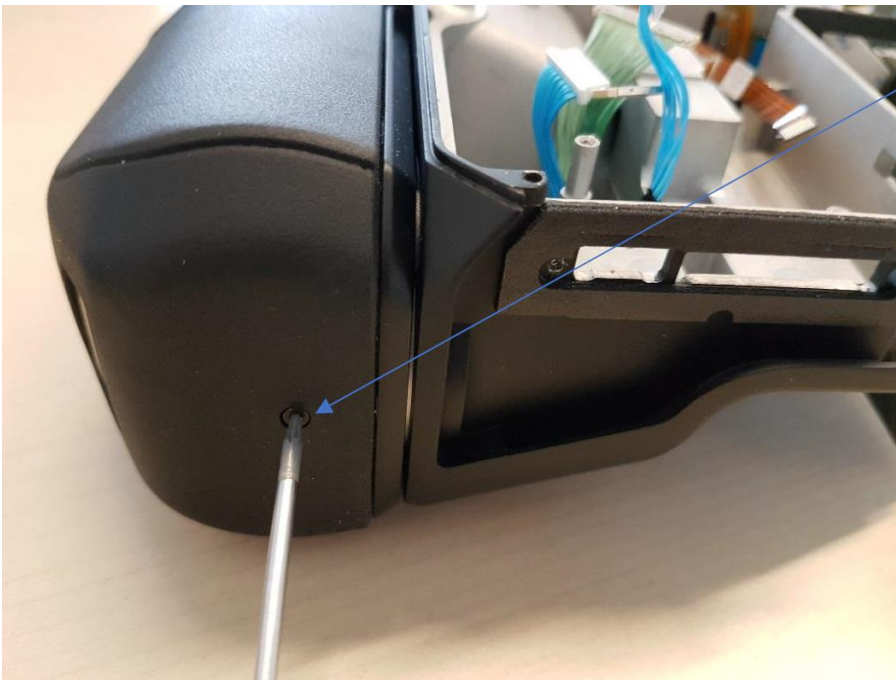
Photo 24:

Remove screw.

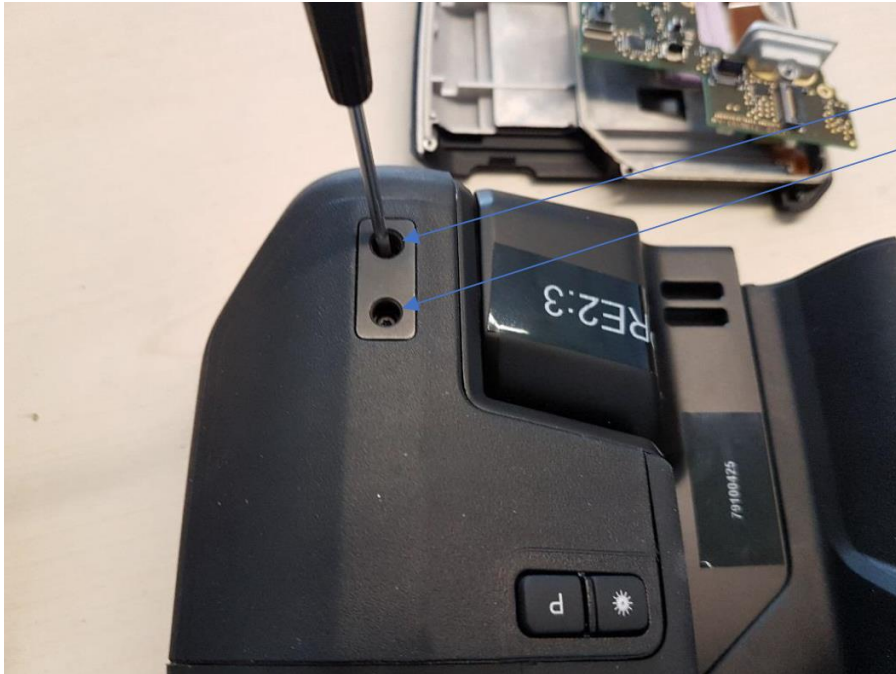
Photo 25:

Remove 2vscrews

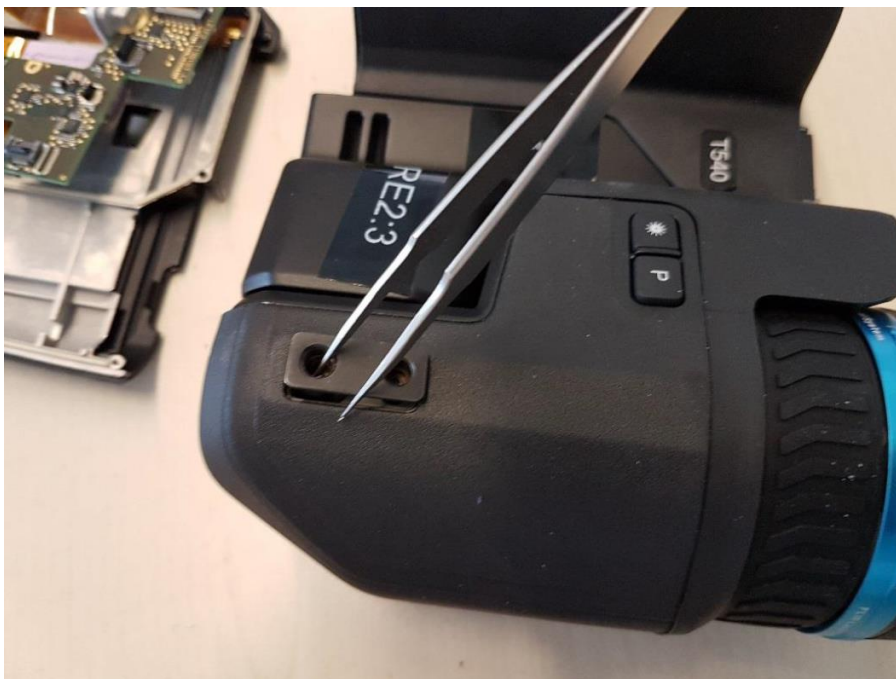
Photo 26:

Take out metallic part.

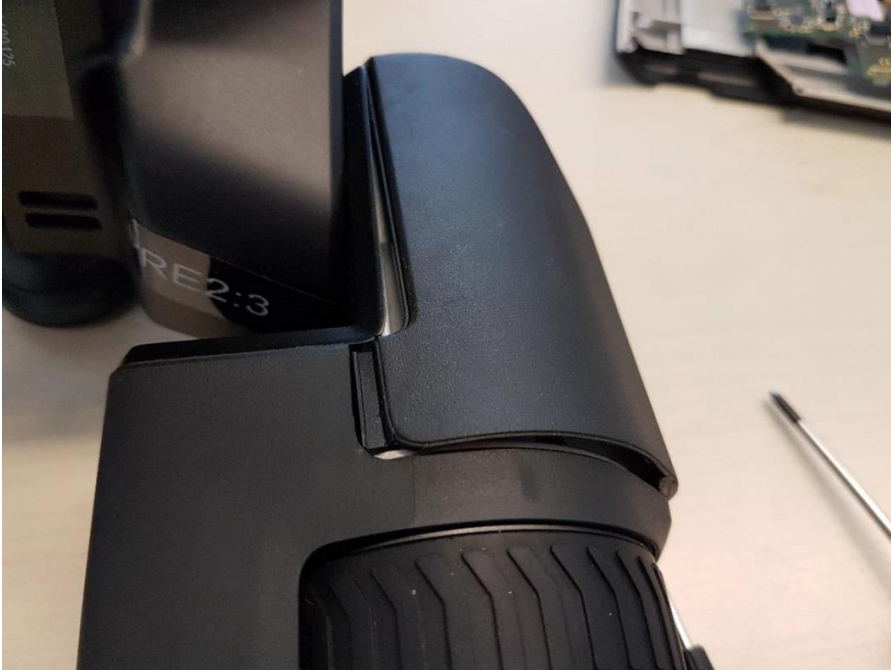
Photo 27:

Remove plastic cover.

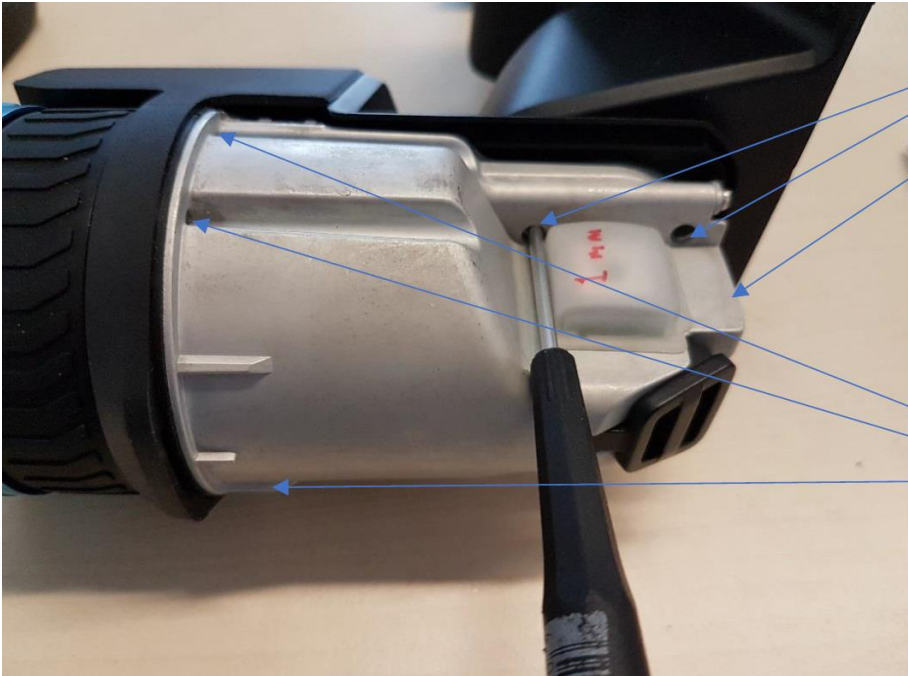
Photo 29:

To divide the two parts
Remove 4 screws

To take off cover.
Remove 4 screws
