### **APPENDIX 3: Photographs of test setup**

#### **Conducted Emission**

### Radiated Spurious Emission

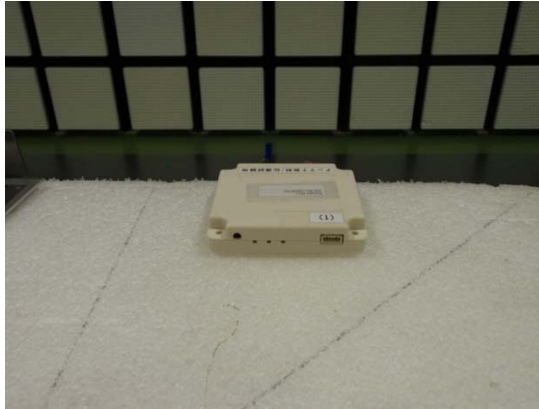
**X-axis**

**Worst Case Position**

**Below 1 GHz (Horizontal: X-axis/ Vertical:X-axis)**

**Above 1 GHz (Horizontal: X-axis/ Vertical:Z-axis)**

**Module**

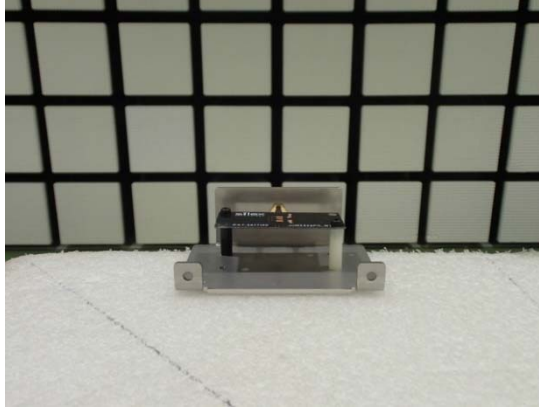
**X-axis**

**Worst Case Position**  
**Below 1 GHz (Horizontal: X-axis/ Vertical:X-axis)**  
**Above 1 GHz (Horizontal: Y-axis/ Vertical:Z-axis)**

**Antenna**
