## U-NII-3

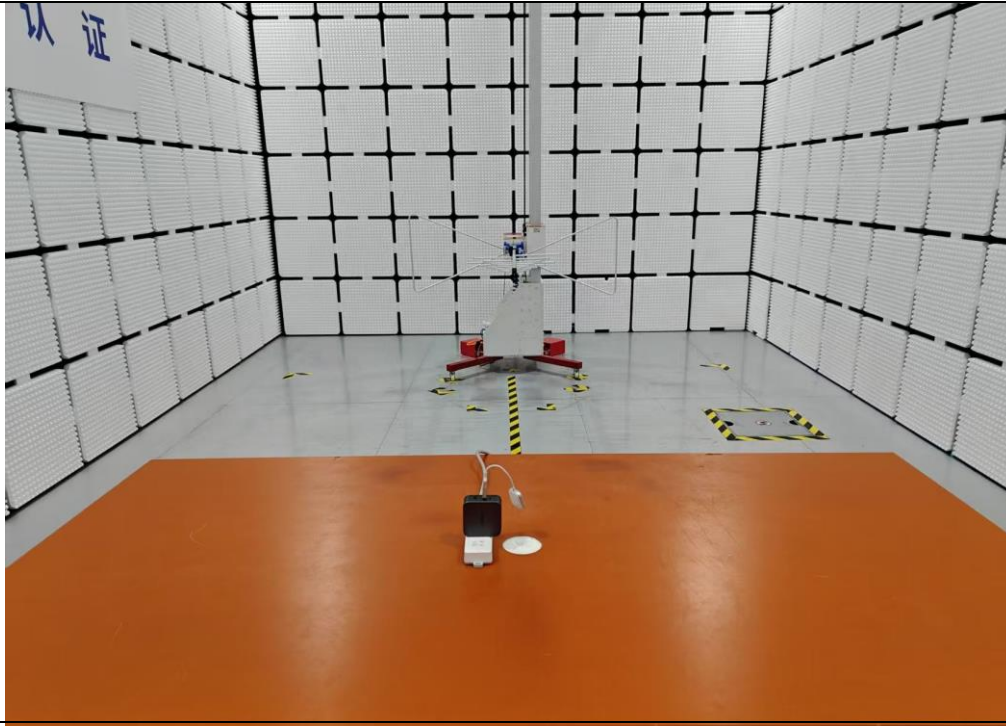
Radiated Emission Below 1GHz

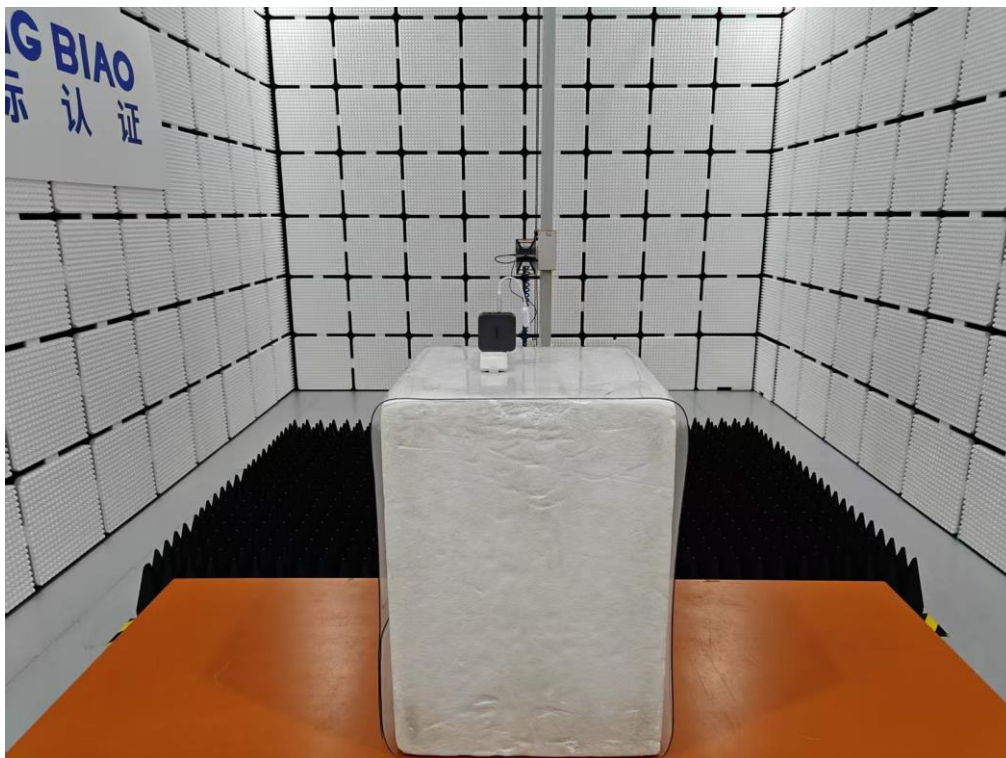
Radiated Emission Above 1GHz

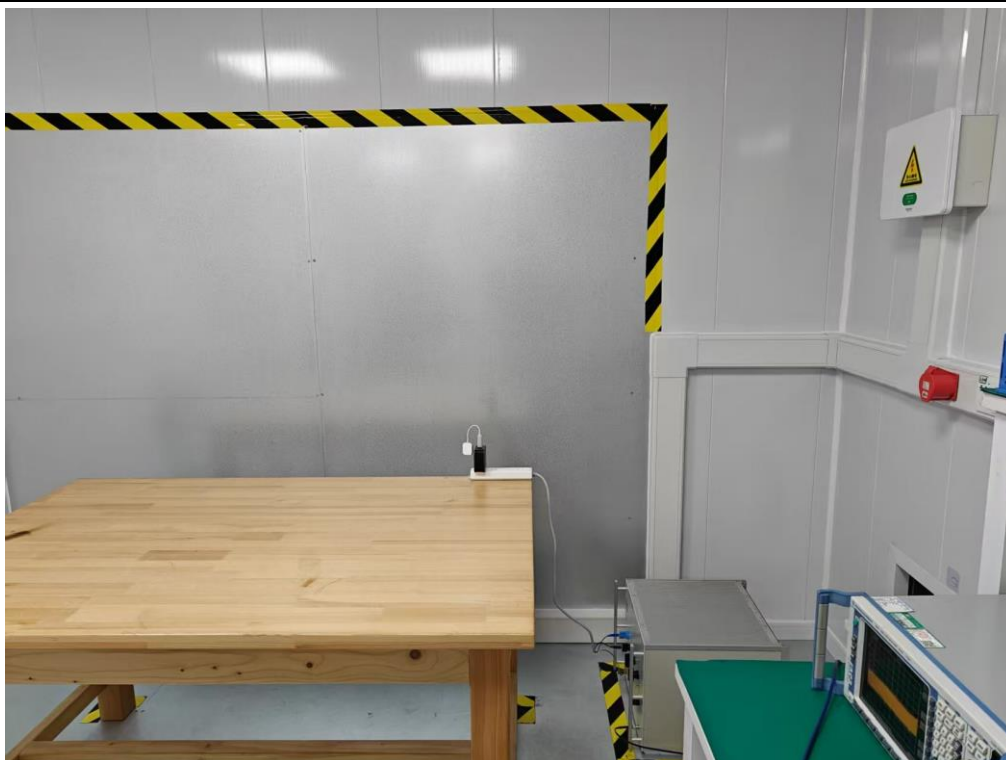
Conducted Emission
