### **APPENDIX 3: Photographs of test setup**

**UL Japan, Inc.**

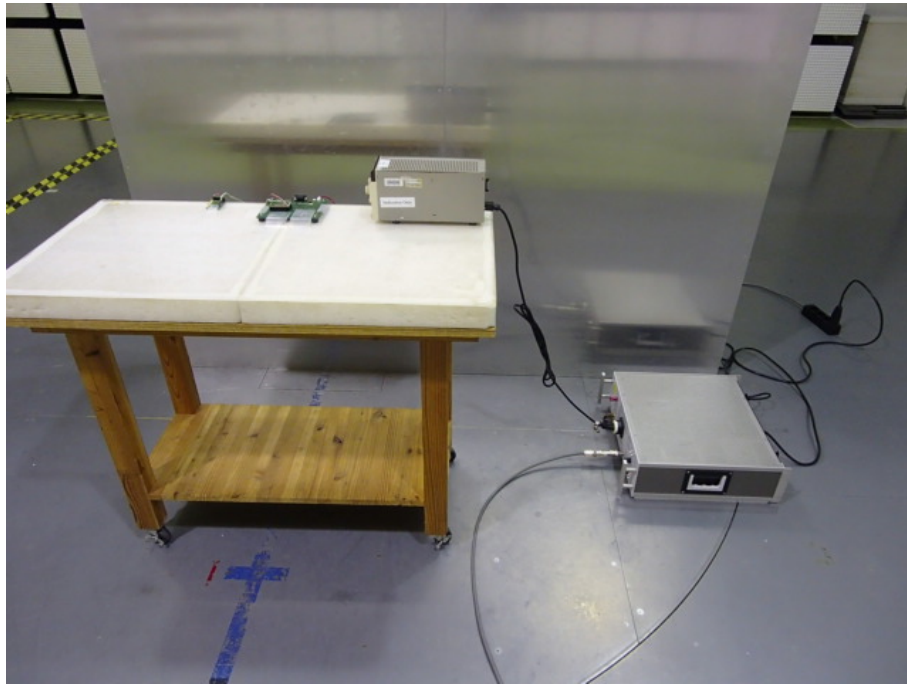
**Photo 1**

#### **Conducted Emission**

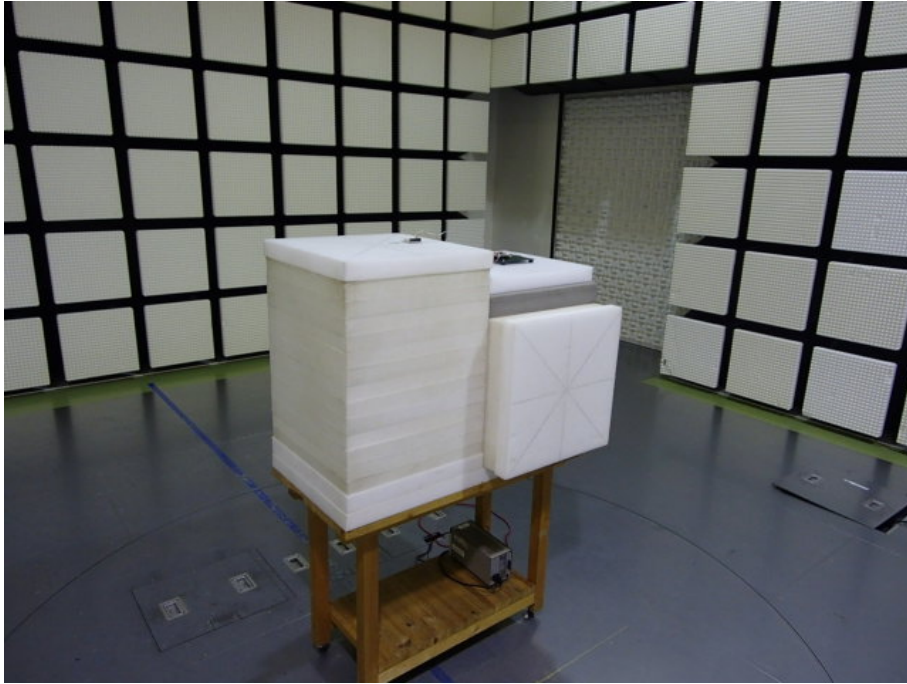
**Photo 1**

### Radiated Spurious Emission

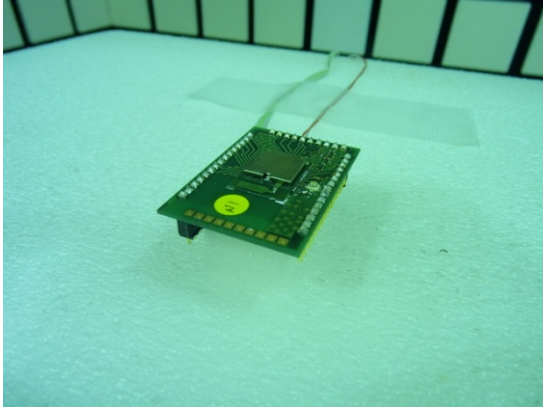
**X-axis**

**Worst Case Position**

Above 1GHz (Horizontal: X-axis/ Vertical: Y-axis)

Below 1GHz (Horizontal: X-axis/ Vertical: X-axis)
