## Appendix A: Test Configuration Test Photographs

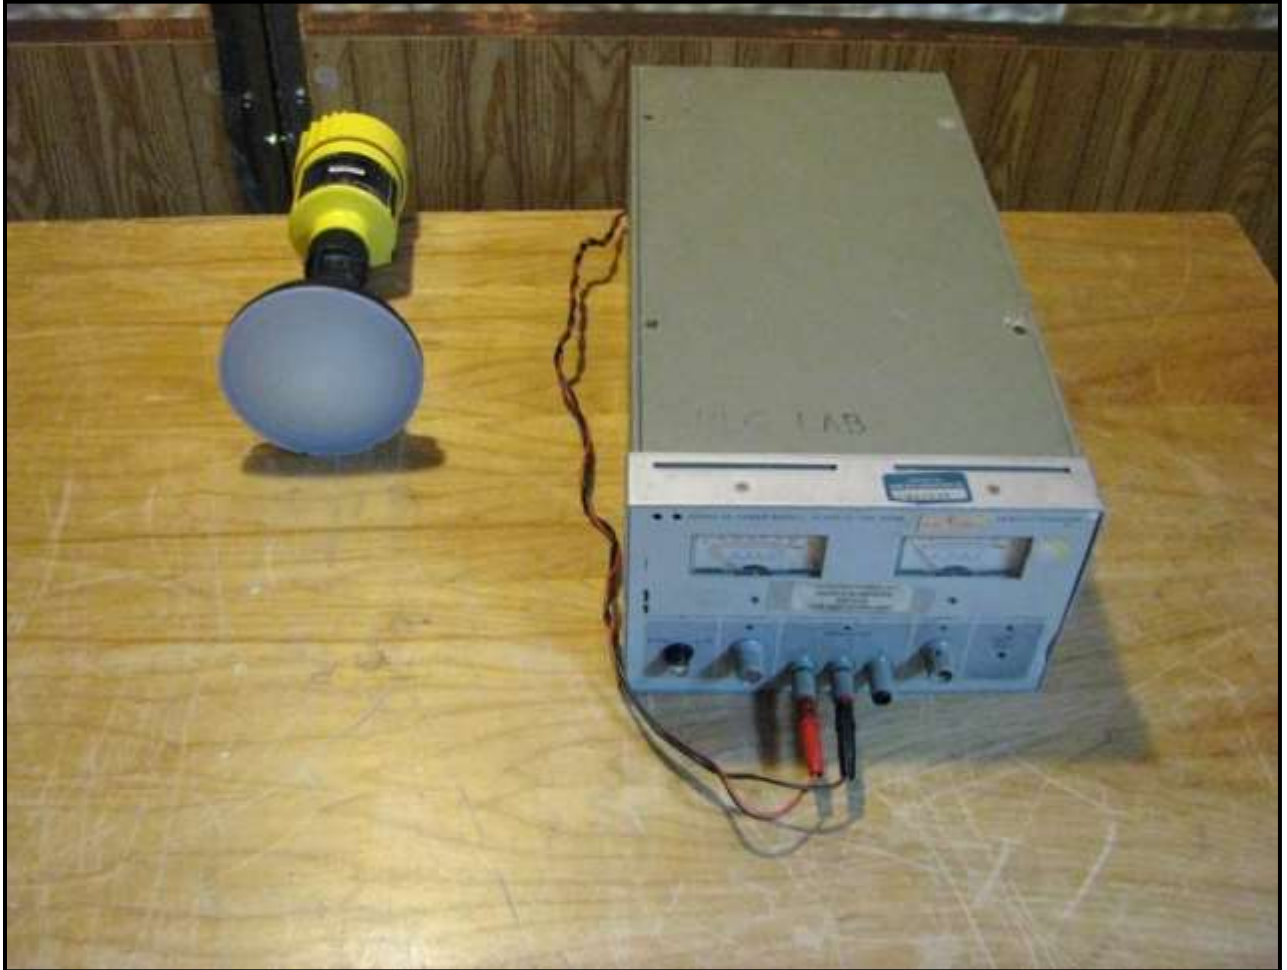
Photograph 4: Conducted Emissions – TC #1, Front View

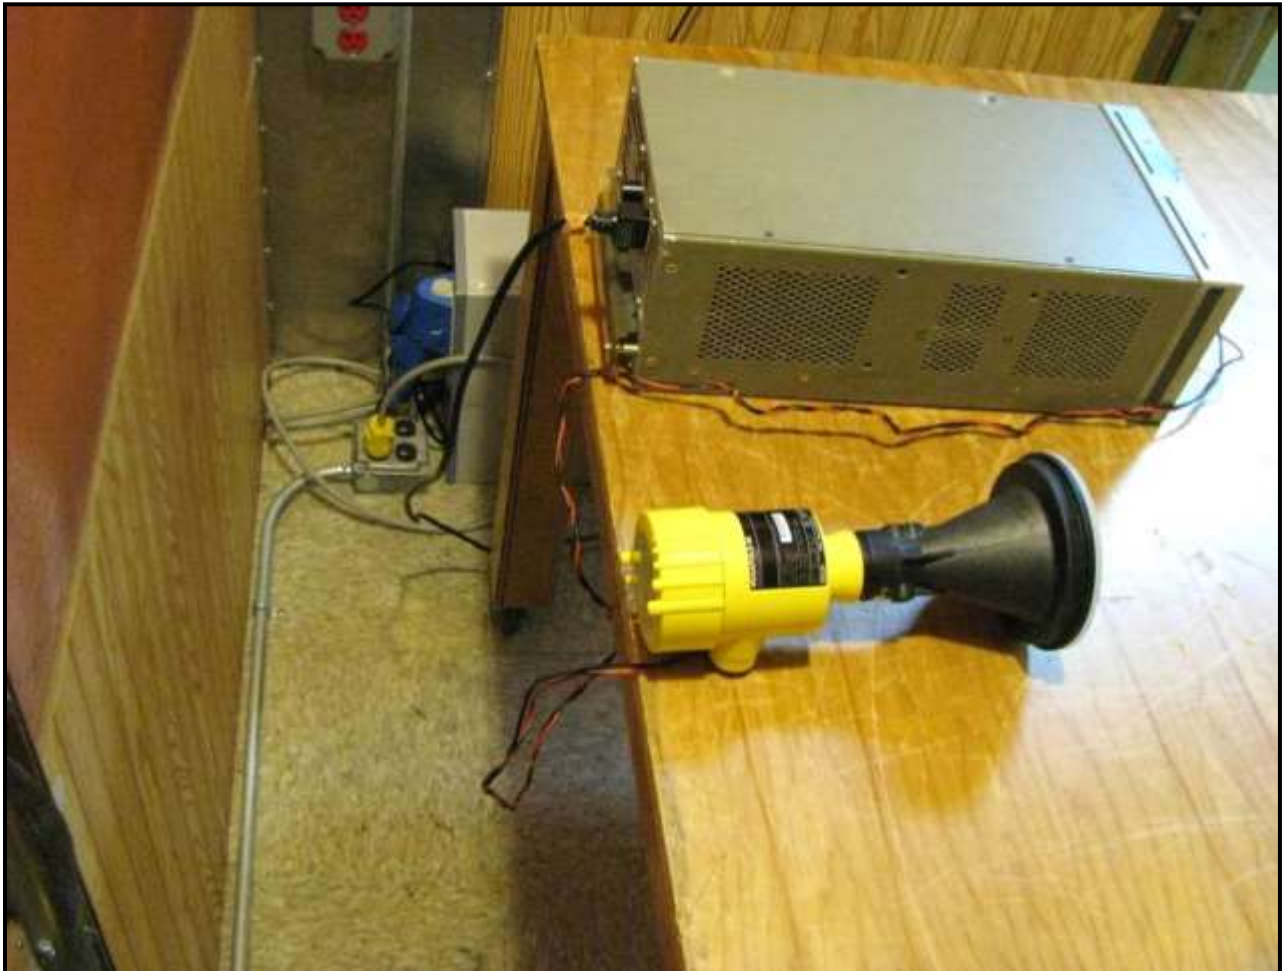
**Photograph 5: Conducted Emissions – TC #1, Rear View**

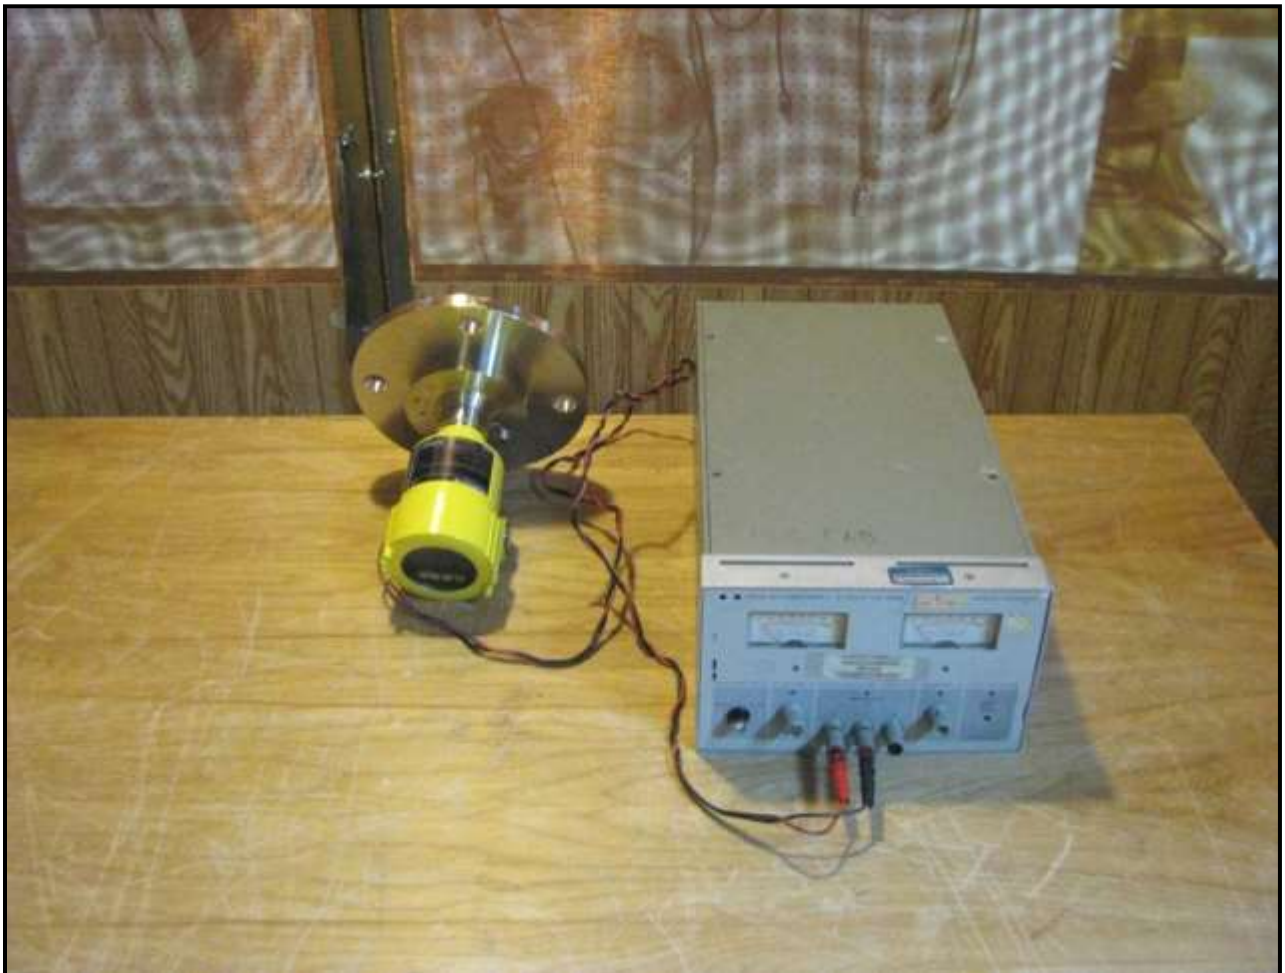
**Photograph 6: Conducted Emissions – TC #2, Front View**

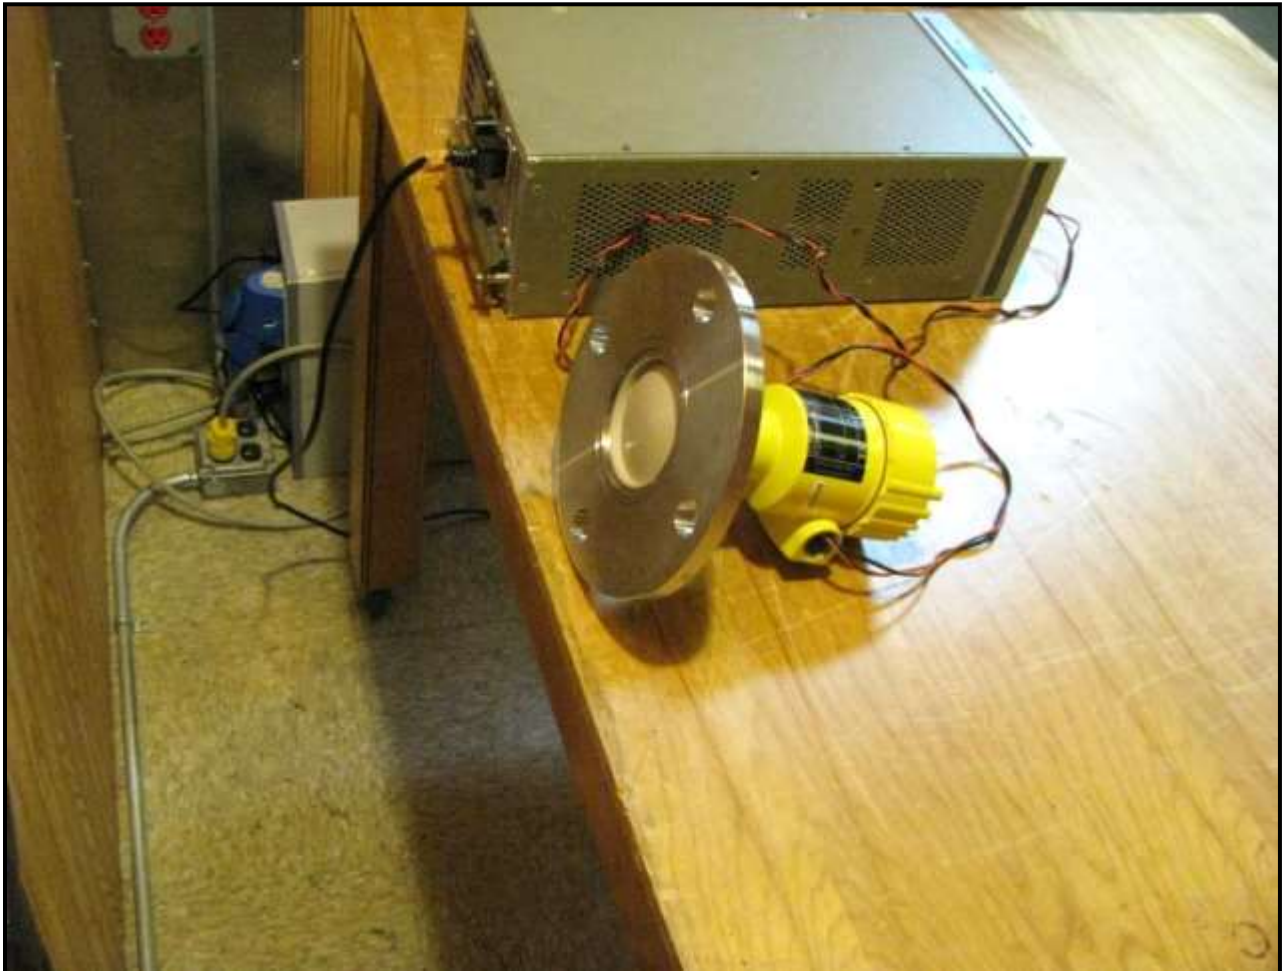
**Photograph 7: Conducted Emissions – TC #2, Rear View**

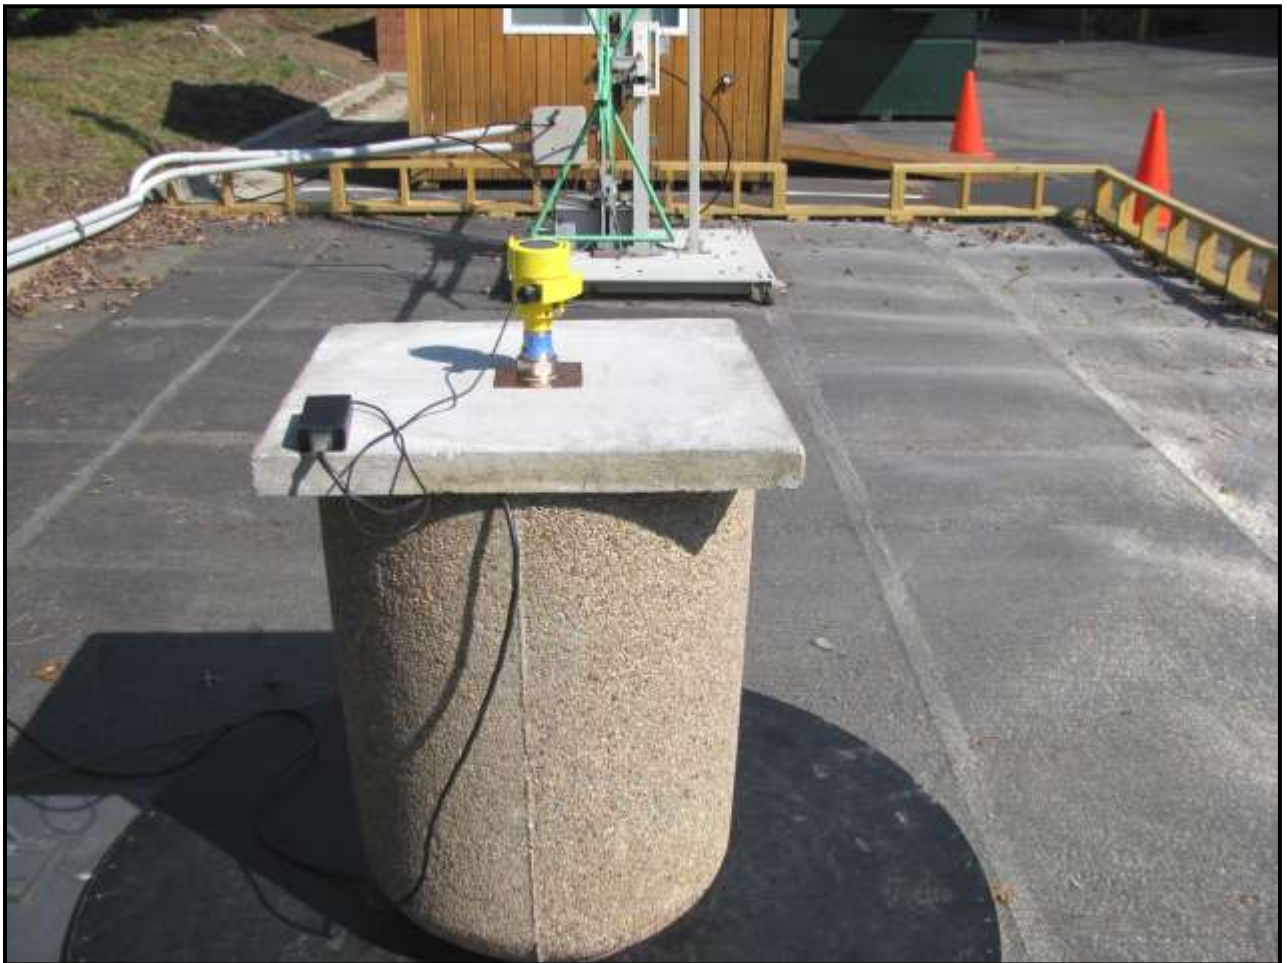
**Photograph 8: Radiated Emissions – TC #1; Concrete Container**

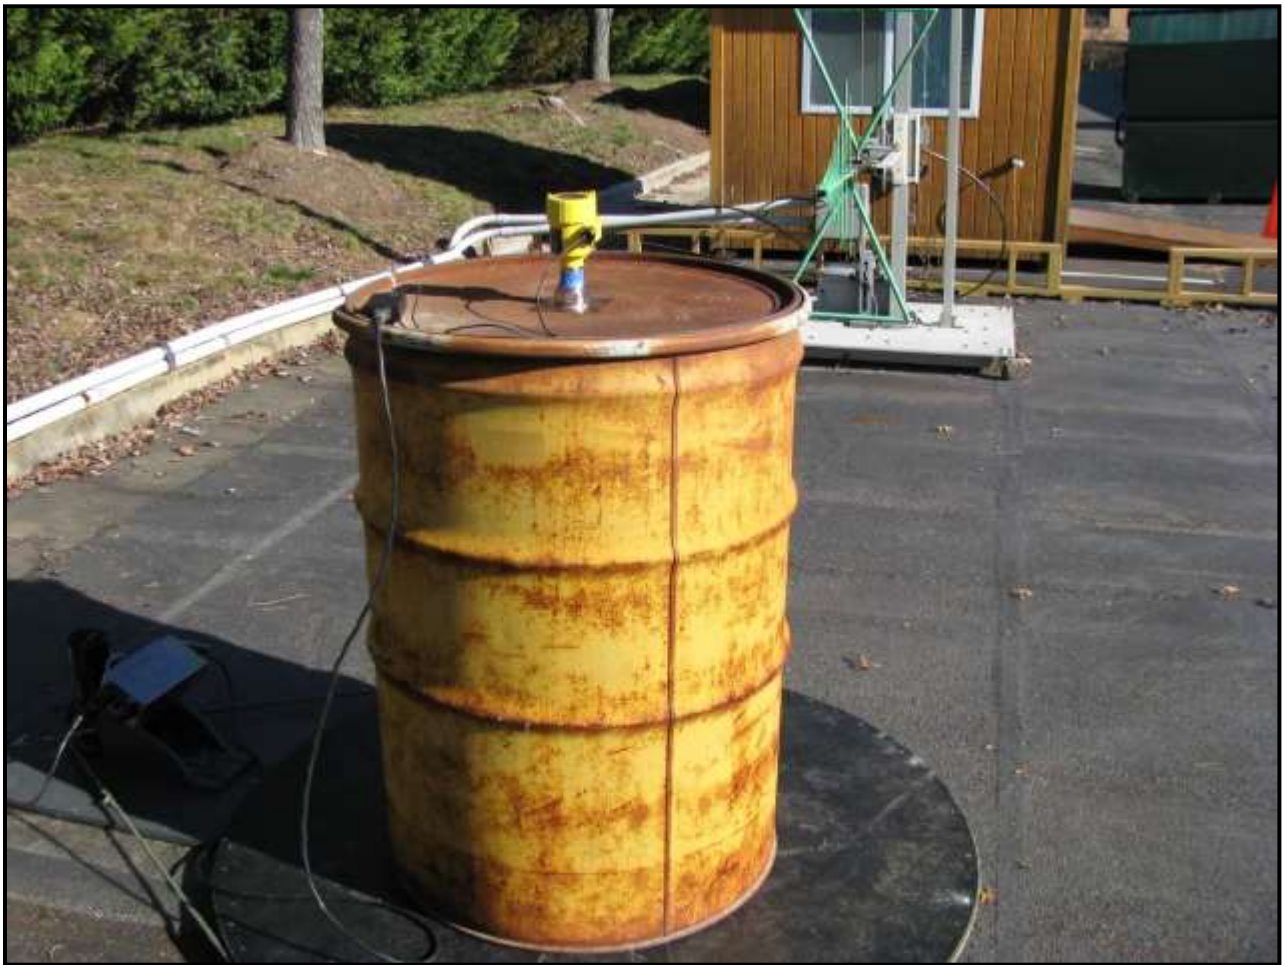
**Photograph 9: Radiated Emissions – TC #1; Metal Container**

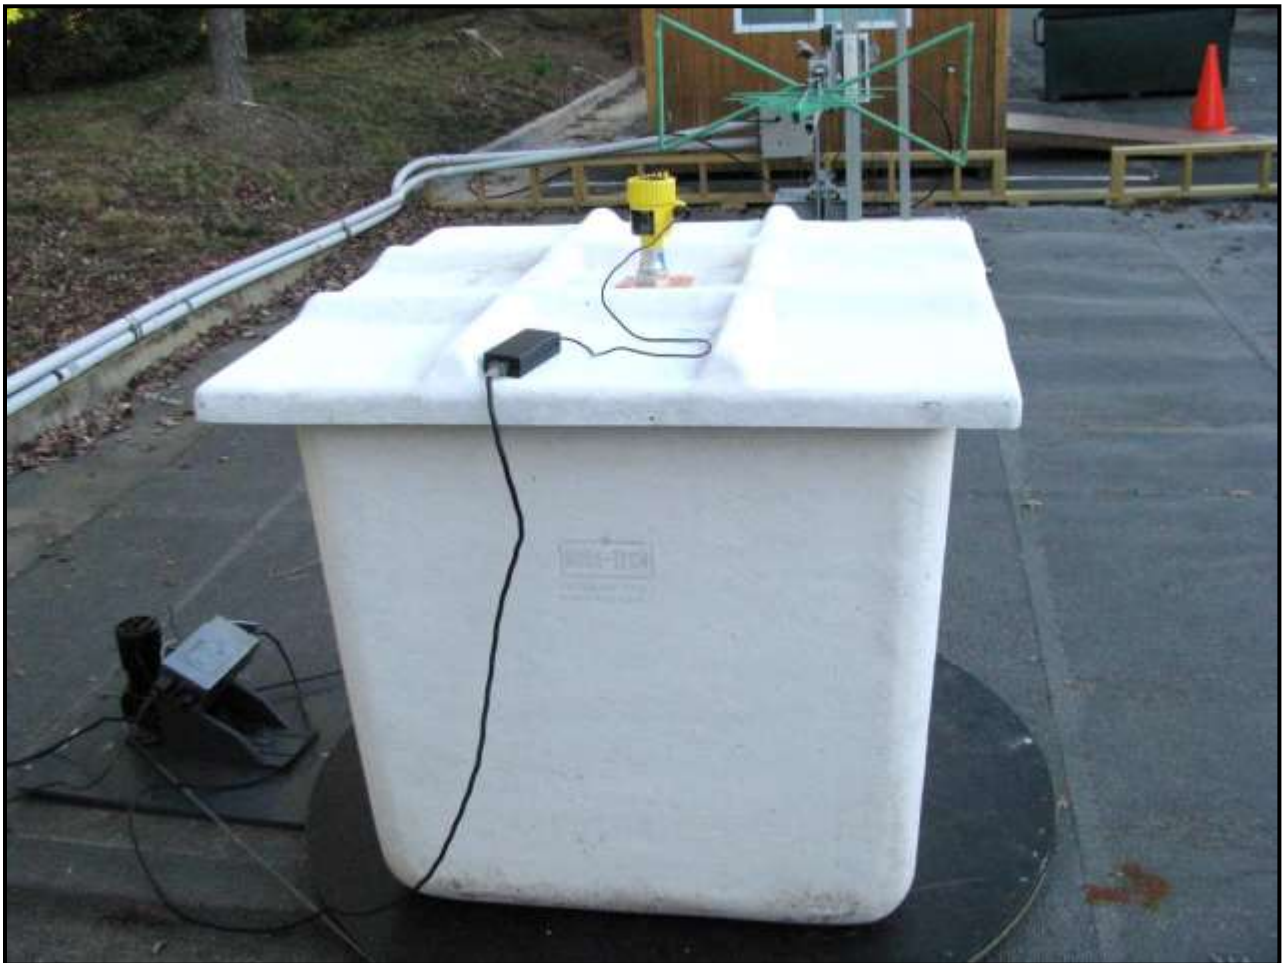
**Photograph 10: Radiated Emissions – TC #1; Fiberglass Container**

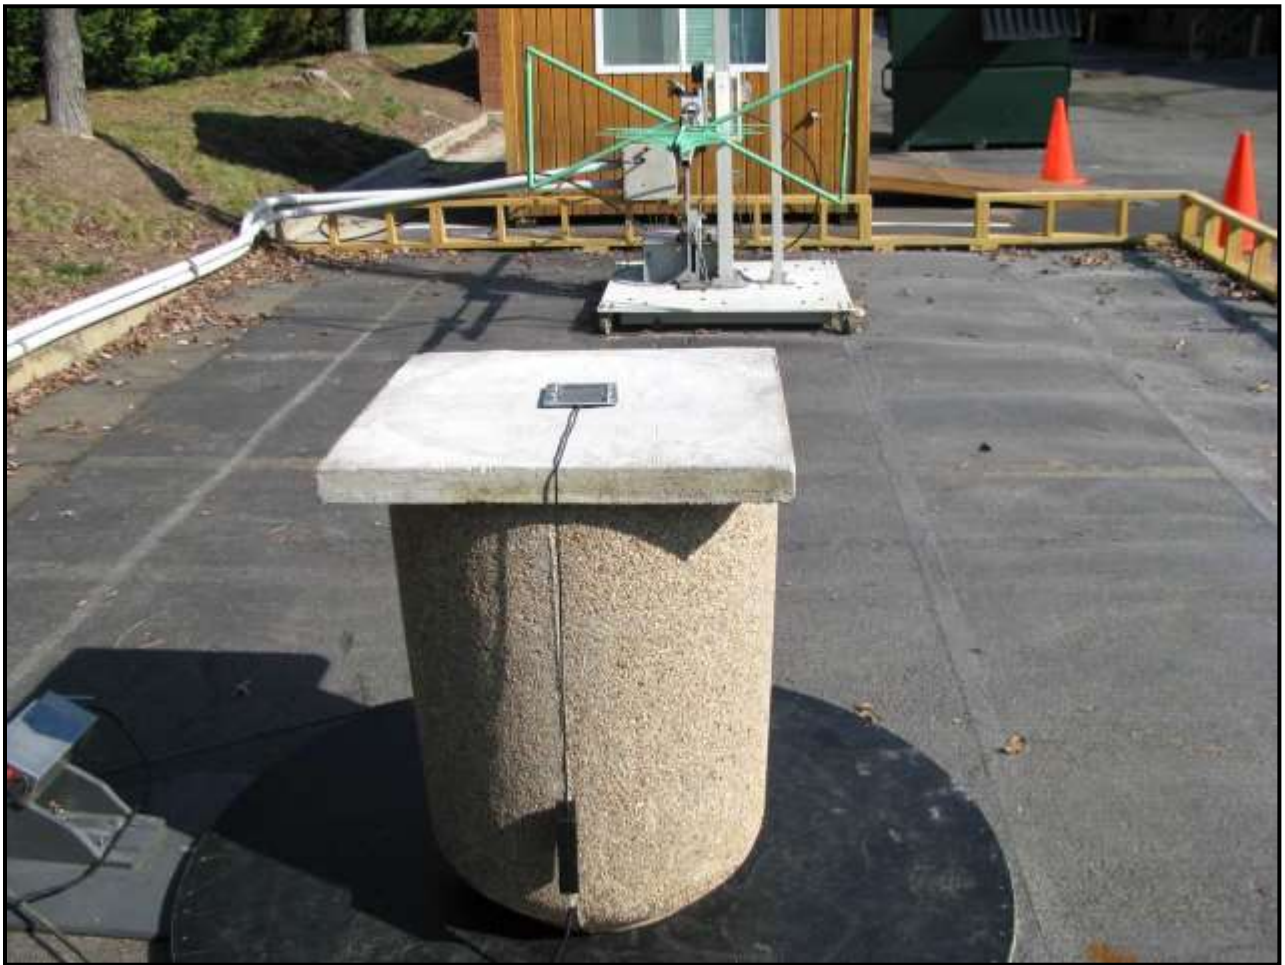
**Photograph 11: Radiated Emissions – TC #2; Concrete Container**

**Note: EUT mounted inside container with swivel bracket**

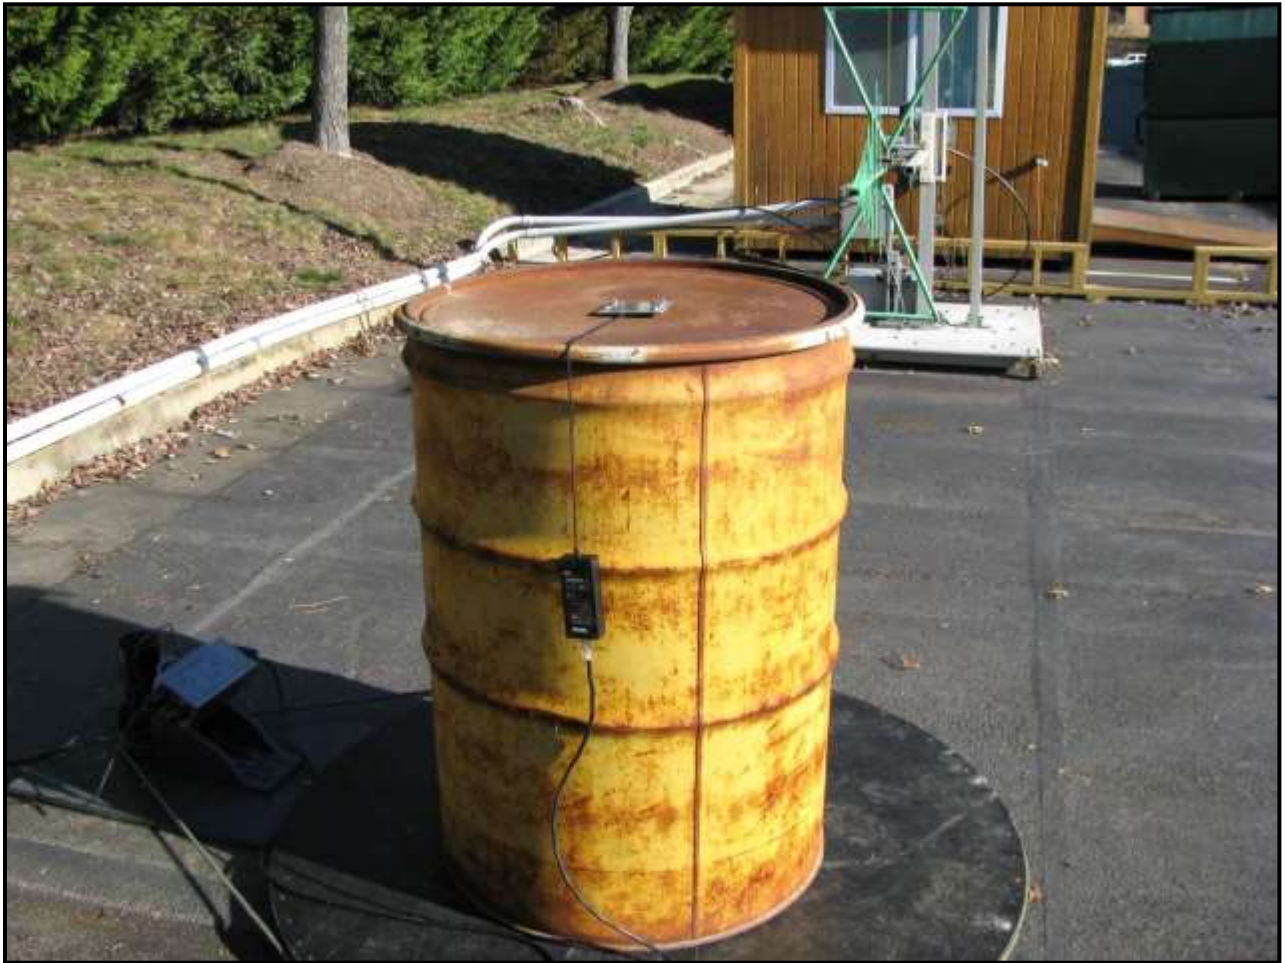
**Photograph 12: Radiated Emissions – TC #2; Metal Container**

**Note: EUT mounted inside container with swivel bracket**

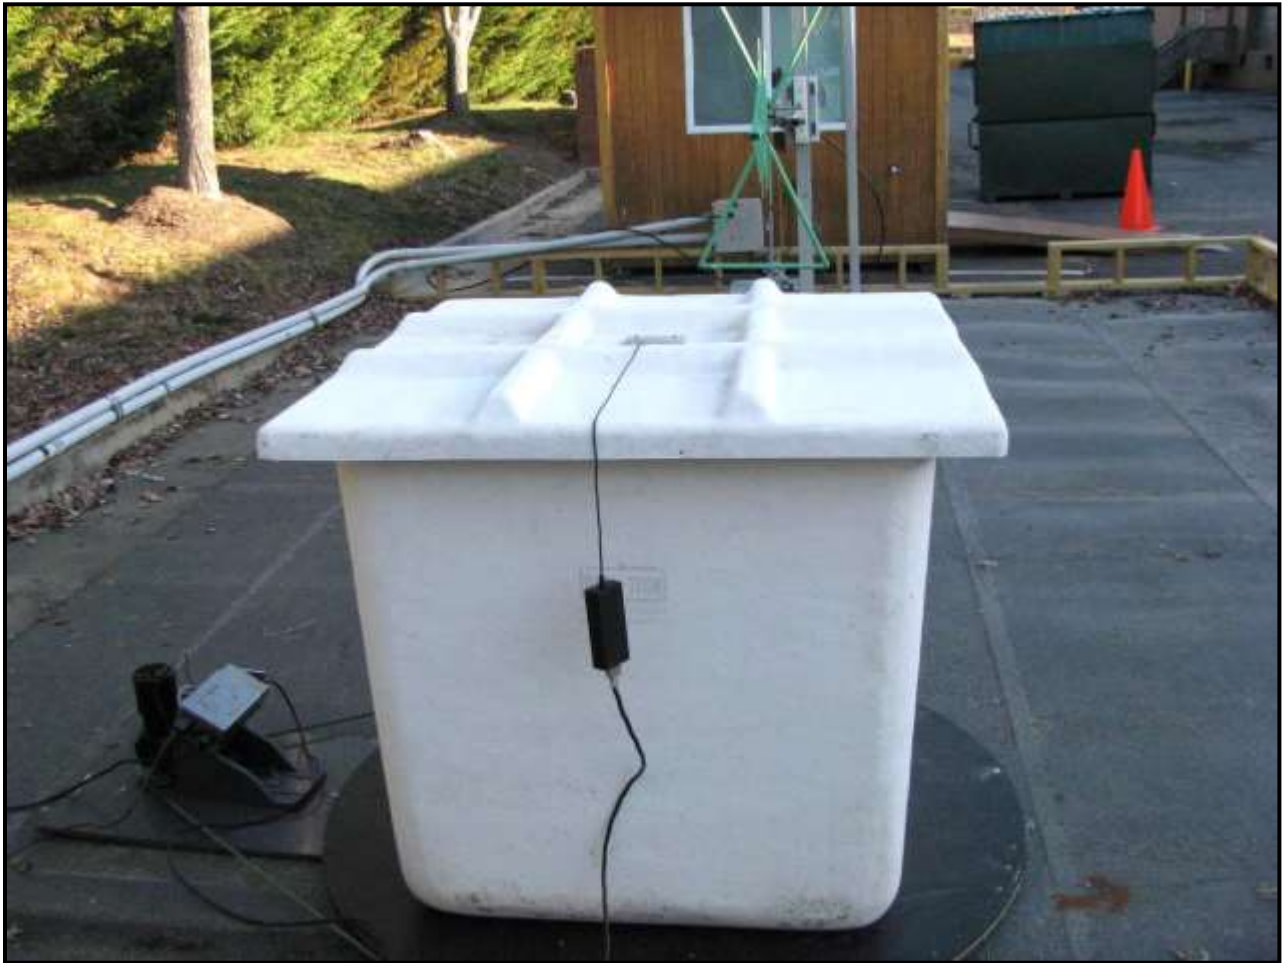
**Photograph 13: Radiated Emissions – TC #2; Fiberglass Container**

**Note: EUT mounted inside container with swivel bracket**

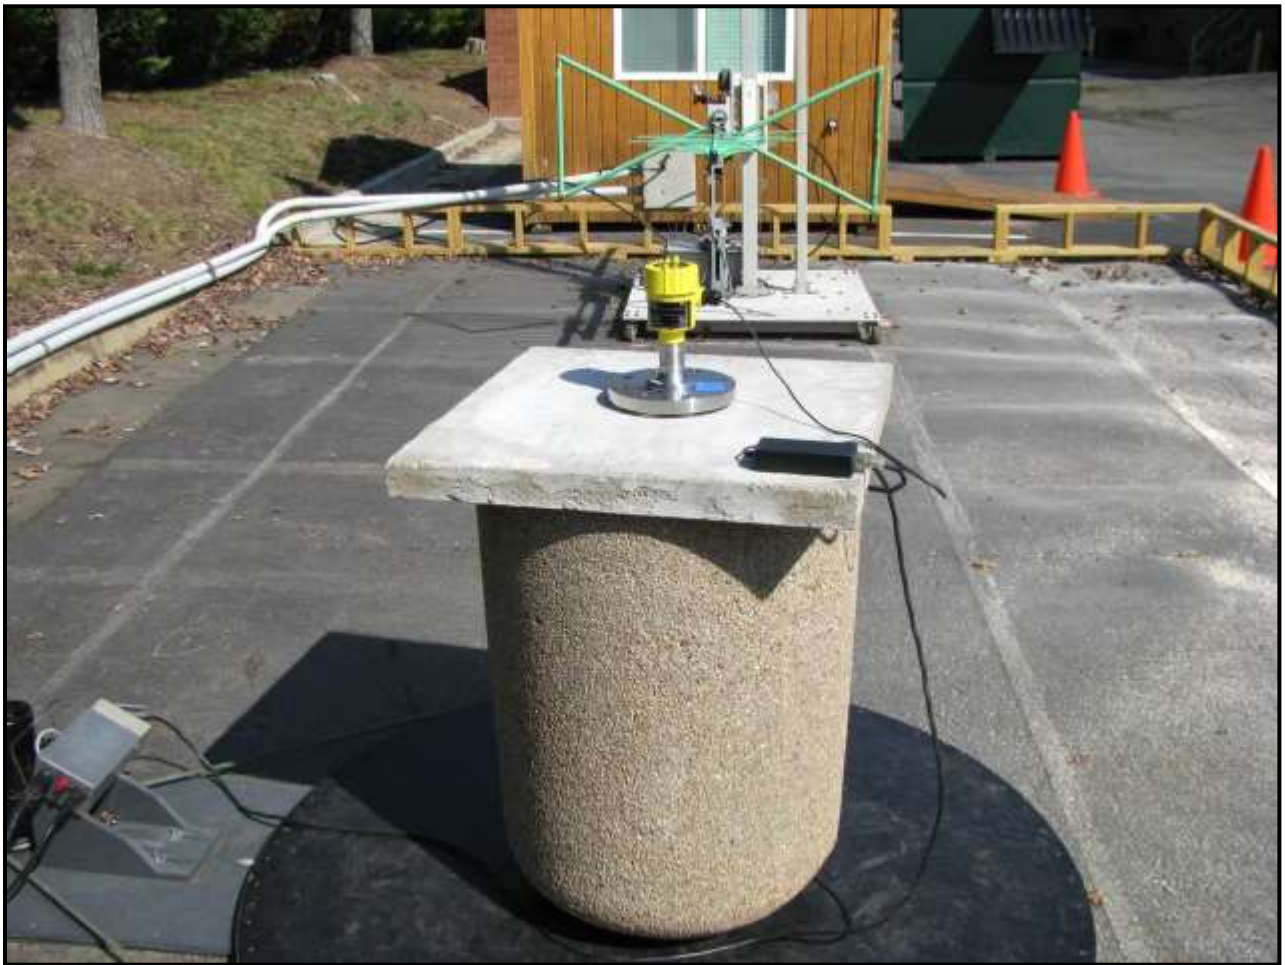
**Photograph 14:** Radiated Emissions – TC #3; Concrete Container

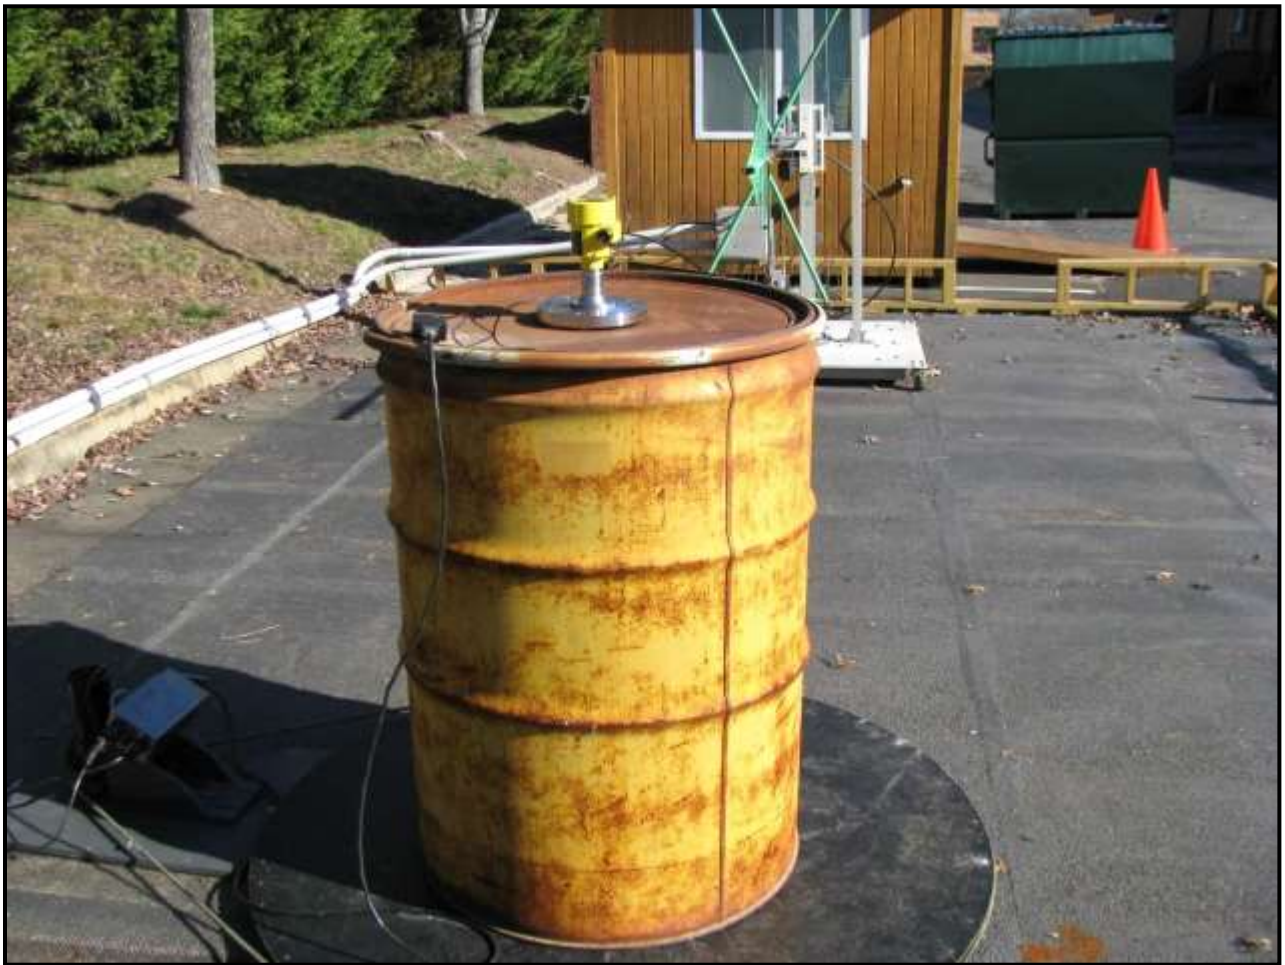
**Photograph 15: Radiated Emissions – TC #3; Metal Container**

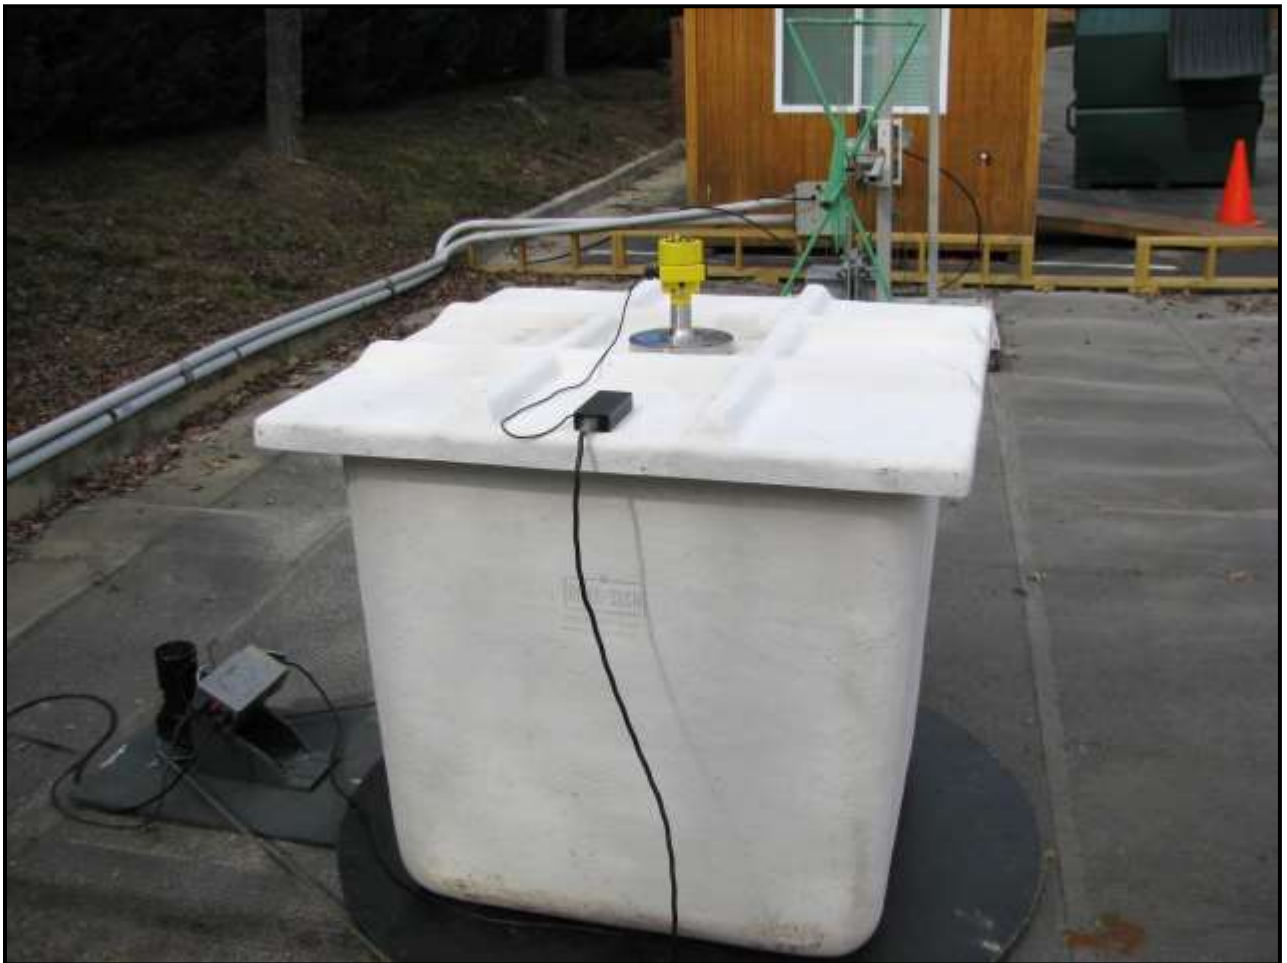
**Photograph 16:**      **Radiated Emissions – TC #3; Fiberglass Container**
