## Test Graphs

Product: TPMS Diagnostic Tool

Model: TKTT6

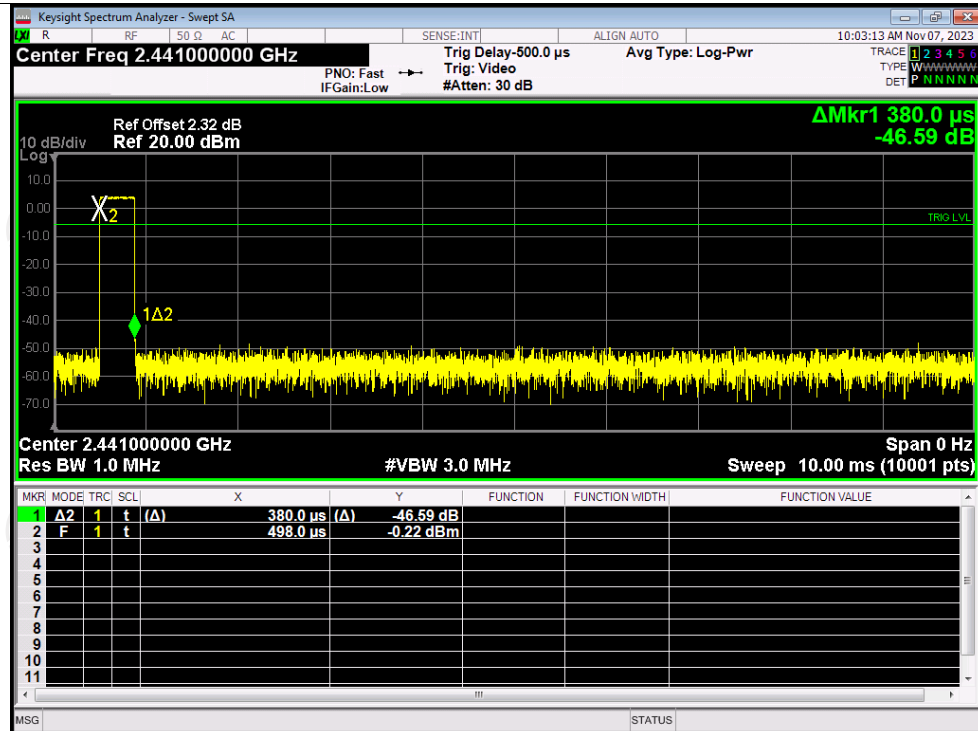
### Dwell NVNT 1-DH1 2441MHz One Burst

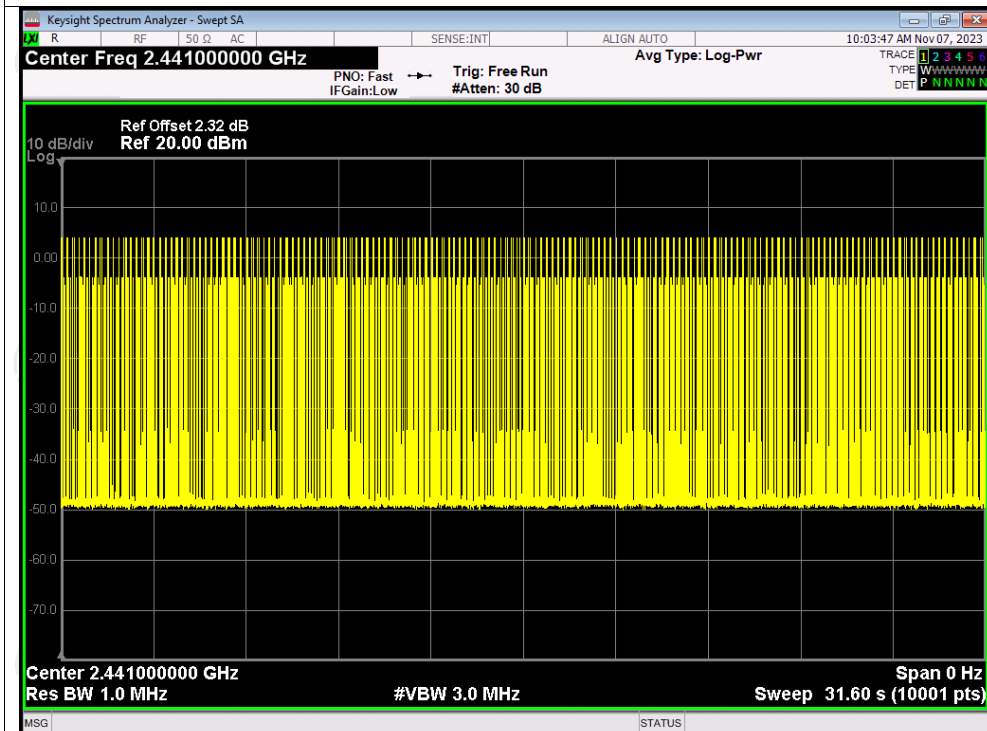
### Dwell NVNT 1-DH1 2441MHz Accumulated

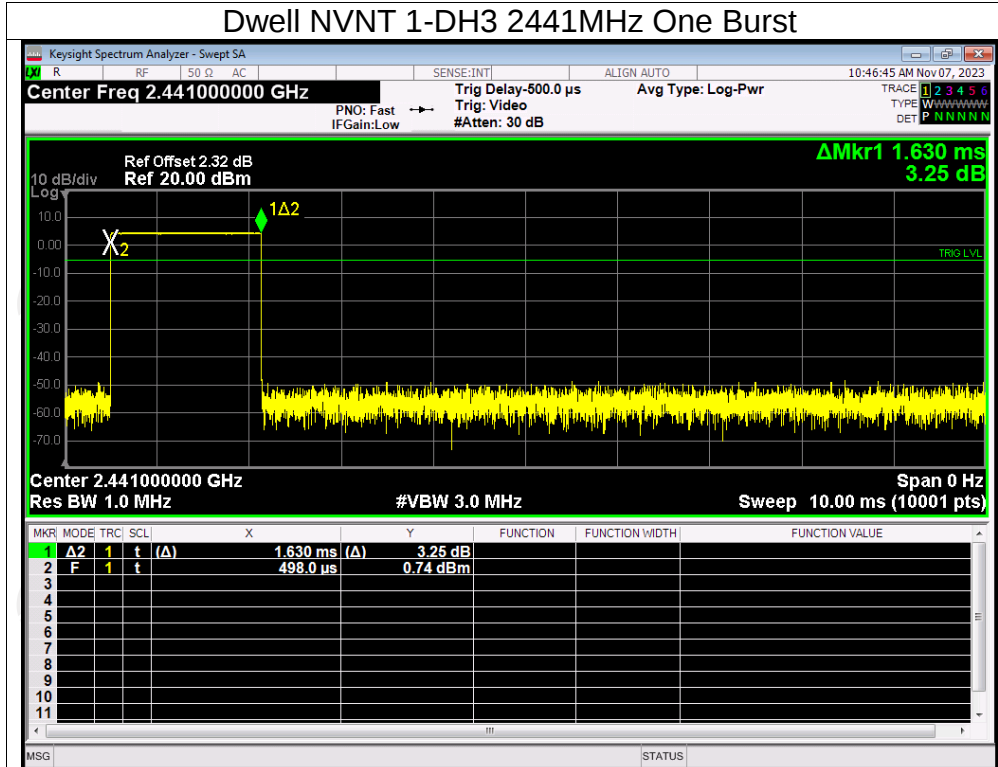
## Dwell NVNT 1-DH3 2441MHz One Burst

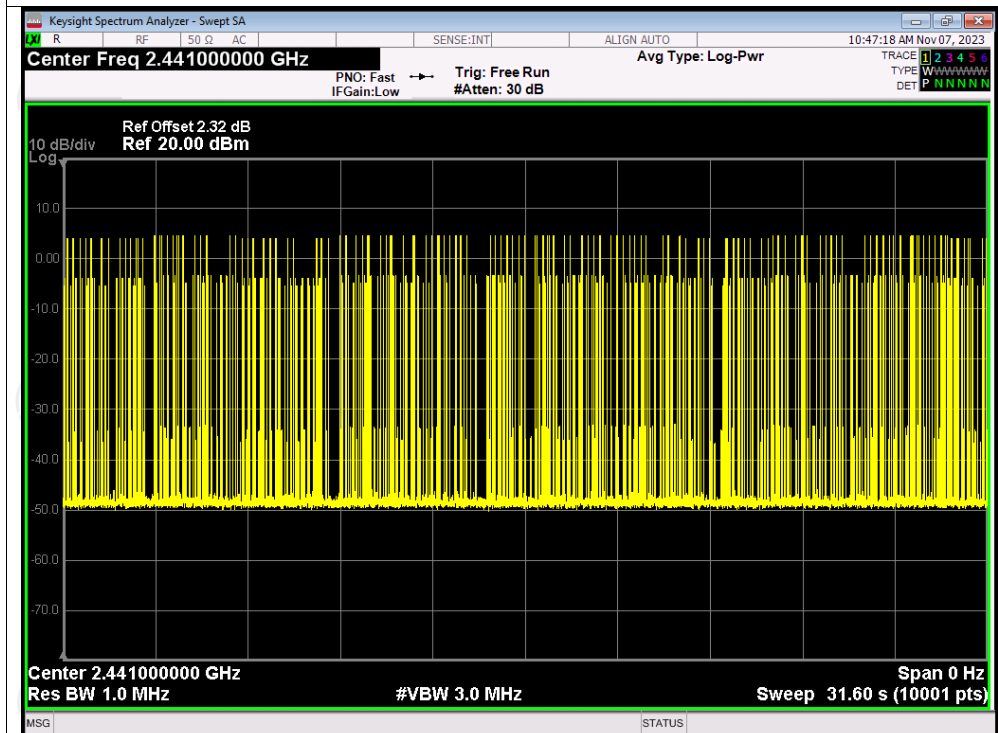
## Dwell NVNT 1-DH3 2441MHz Accumulated

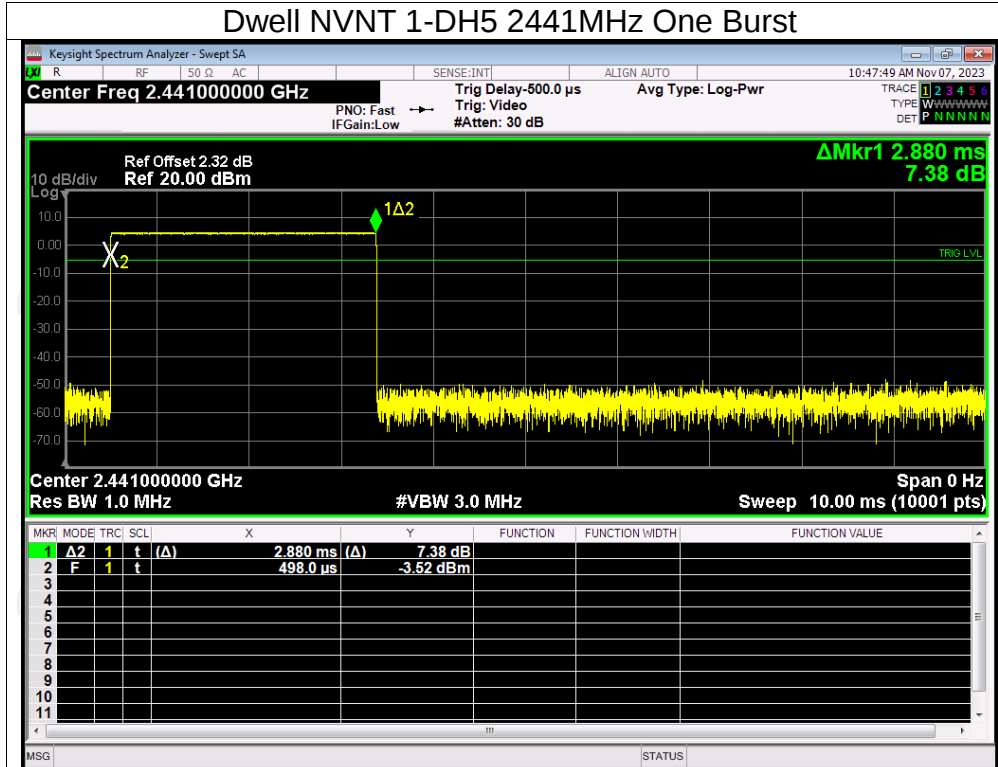
## Dwell NVNT 1-DH5 2441MHz One Burst

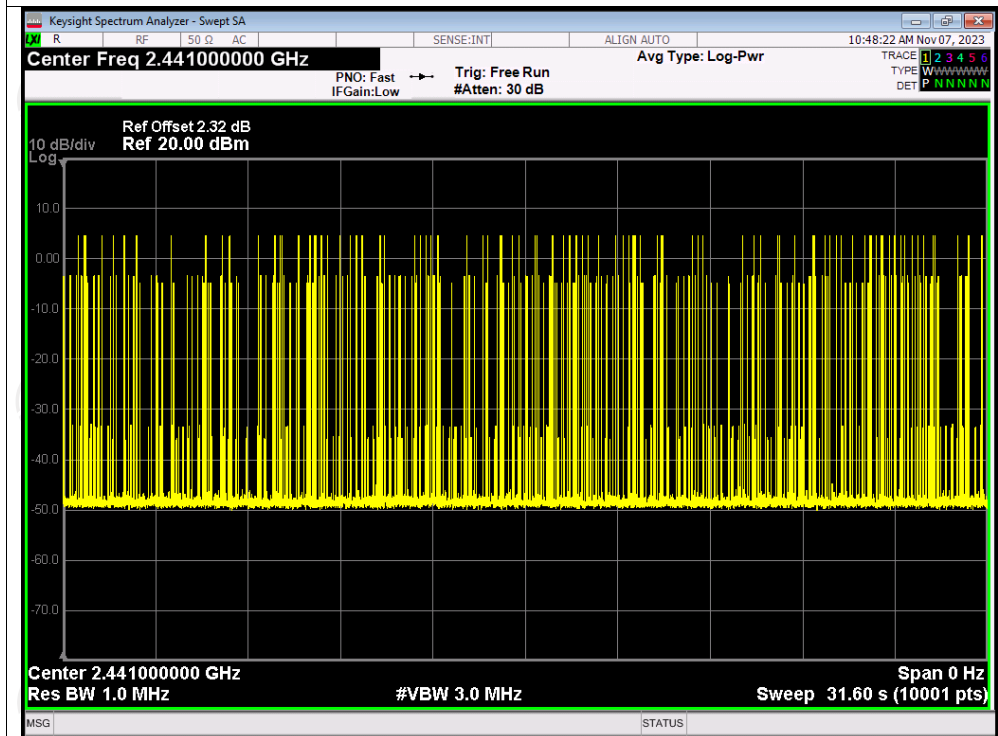
## Dwell NVNT 1-DH5 2441MHz Accumulated

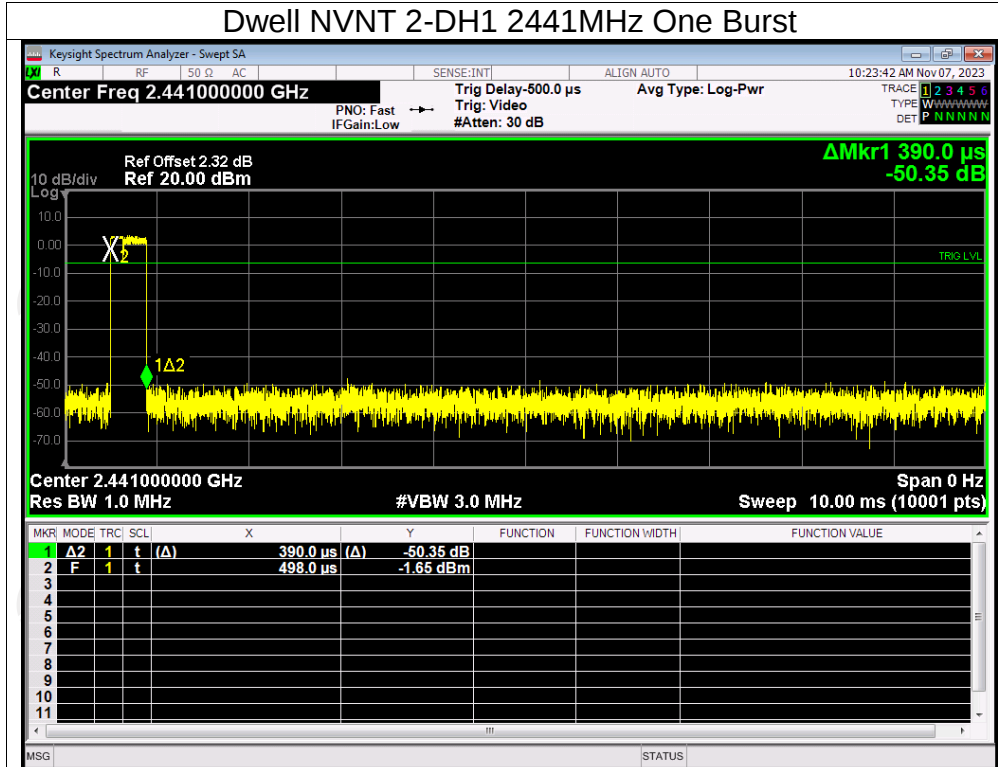
## Dwell NVNT 2-DH1 2441MHz One Burst

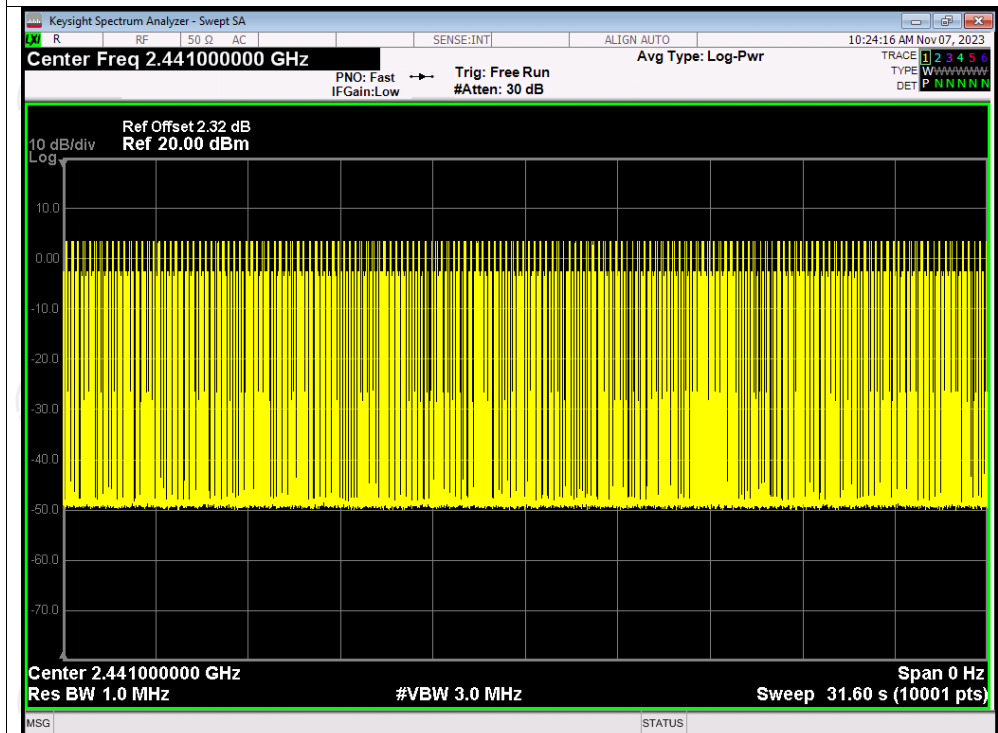
## Dwell NVNT 2-DH1 2441MHz Accumulated

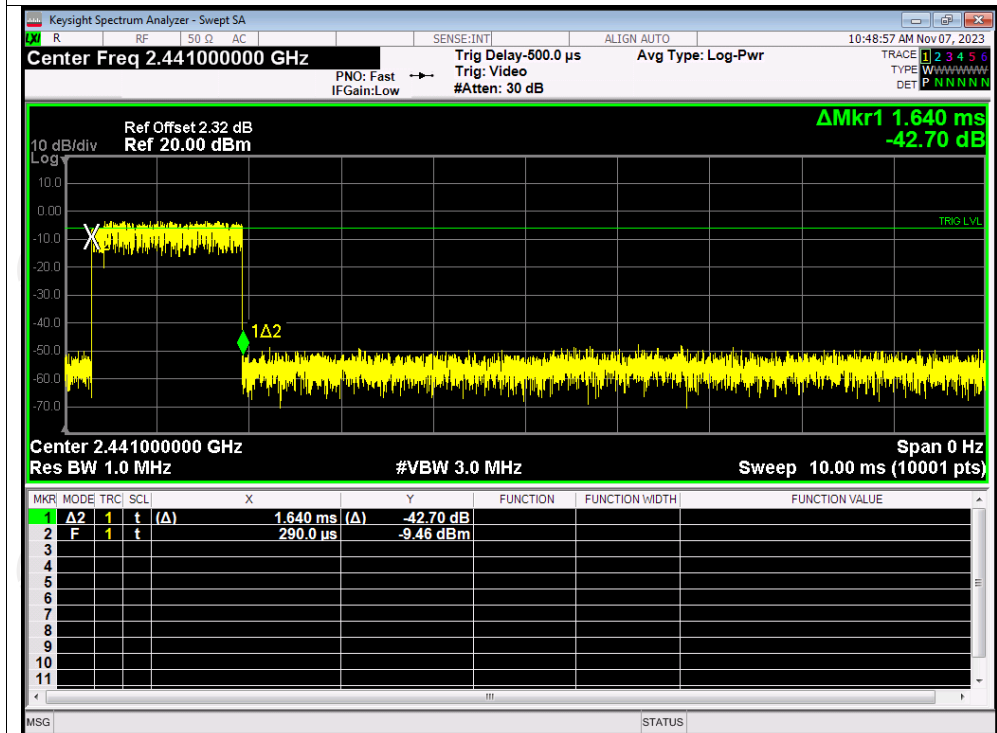
## Dwell NVNT 2-DH3 2441MHz One Burst

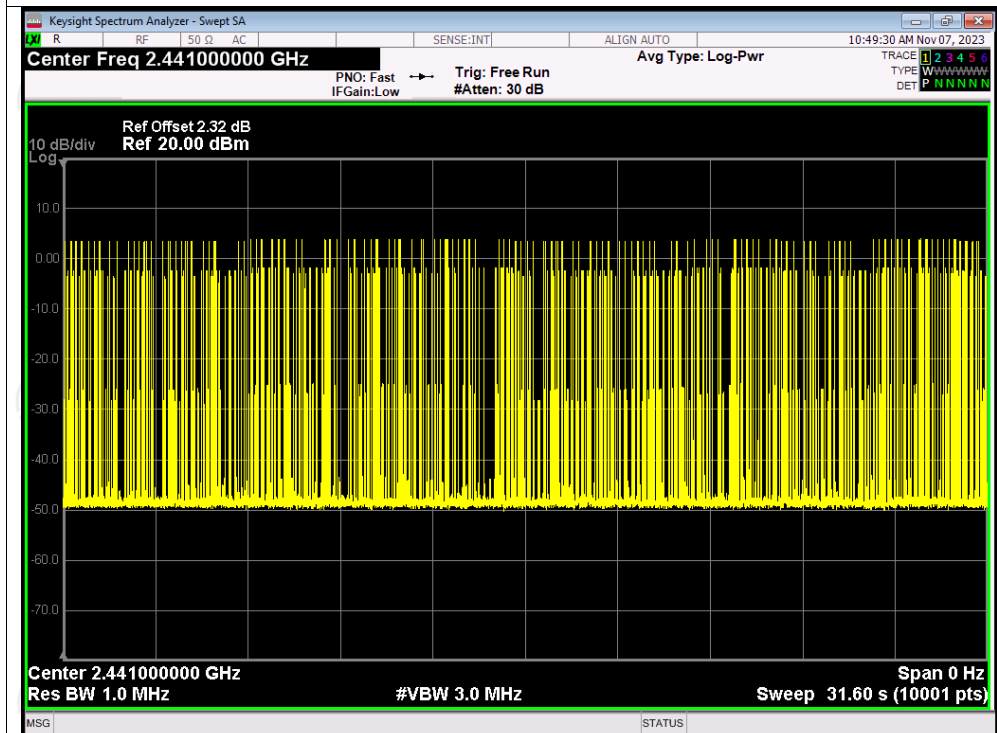
## Dwell NVNT 2-DH3 2441MHz Accumulated

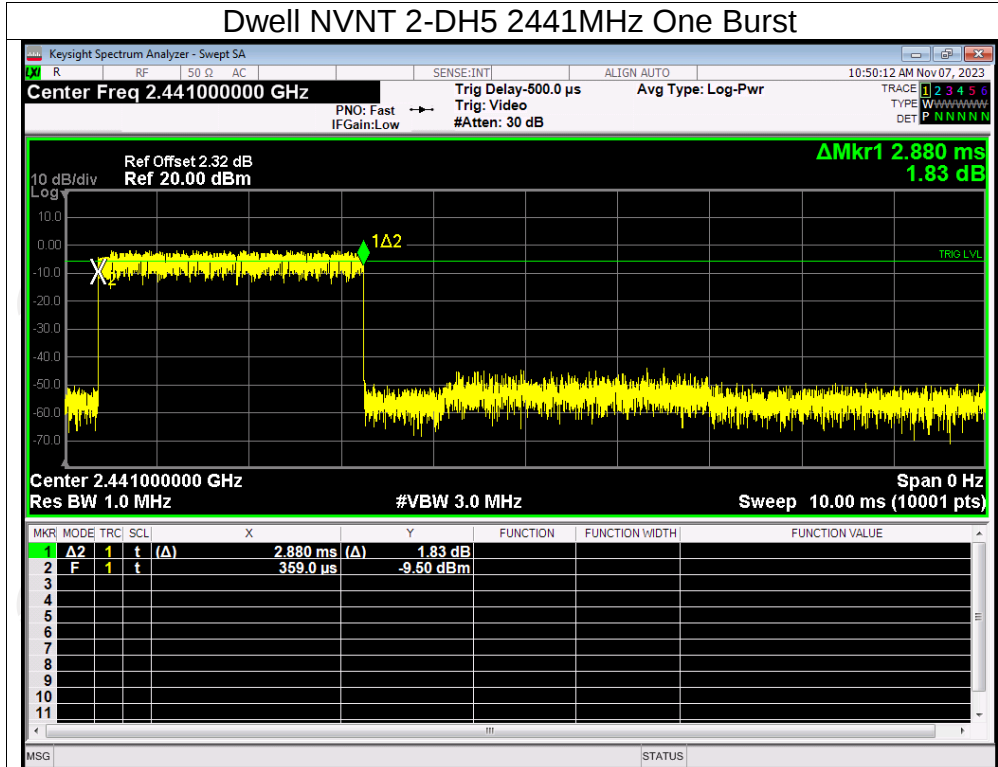
## Dwell NVNT 2-DH5 2441MHz One Burst

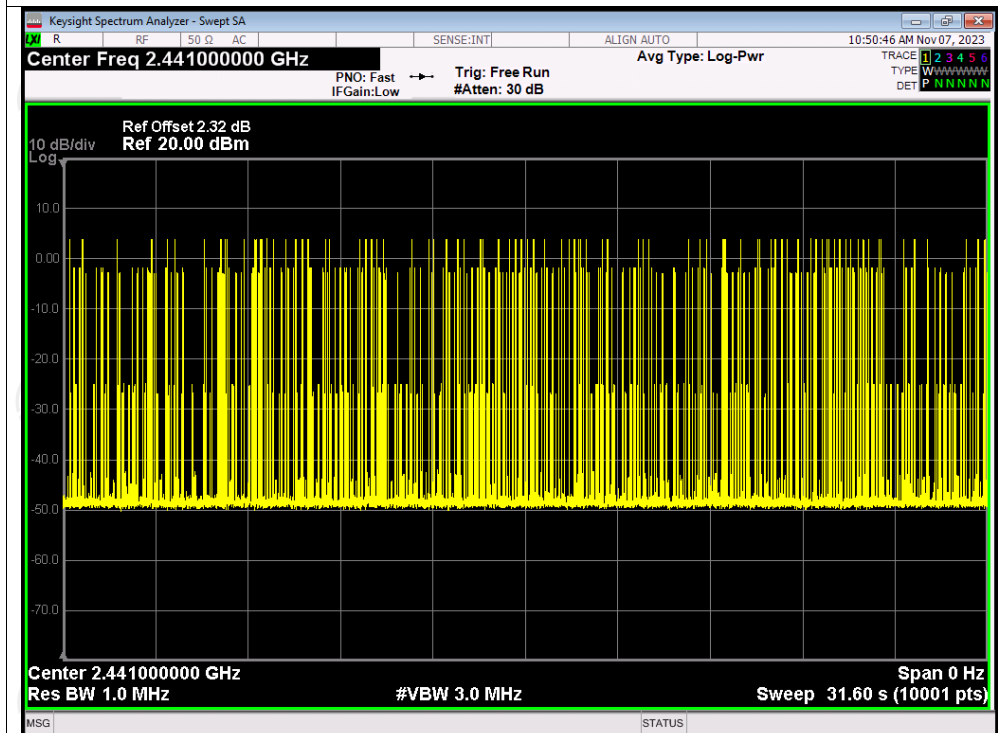
## Dwell NVNT 2-DH5 2441MHz Accumulated

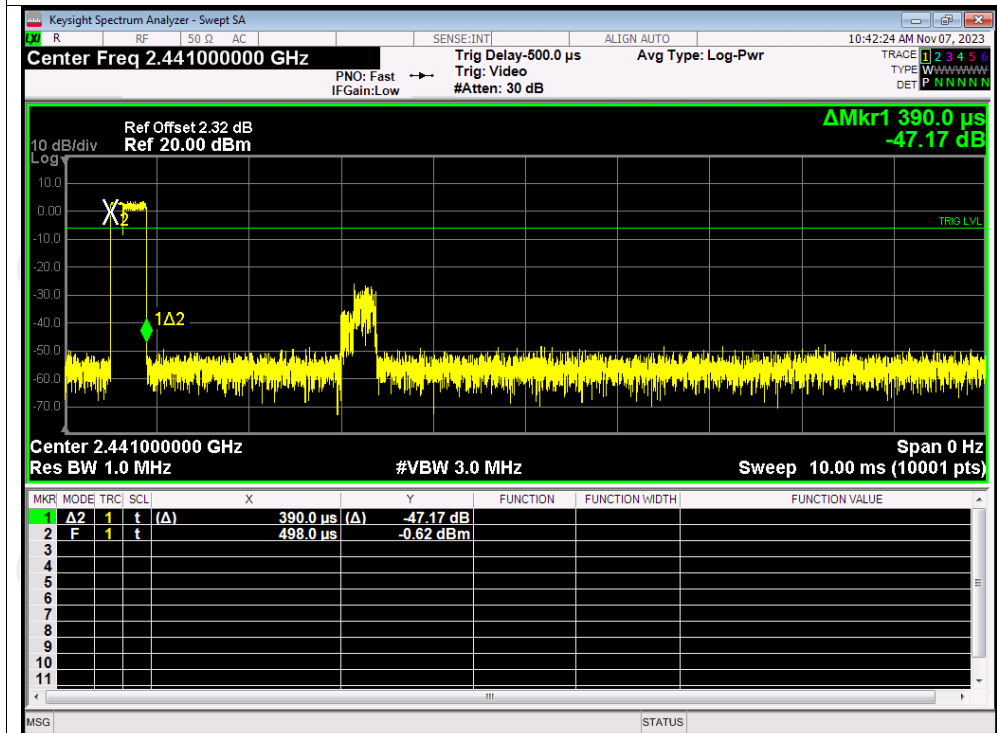
## Dwell NVNT 3-DH1 2441MHz One Burst

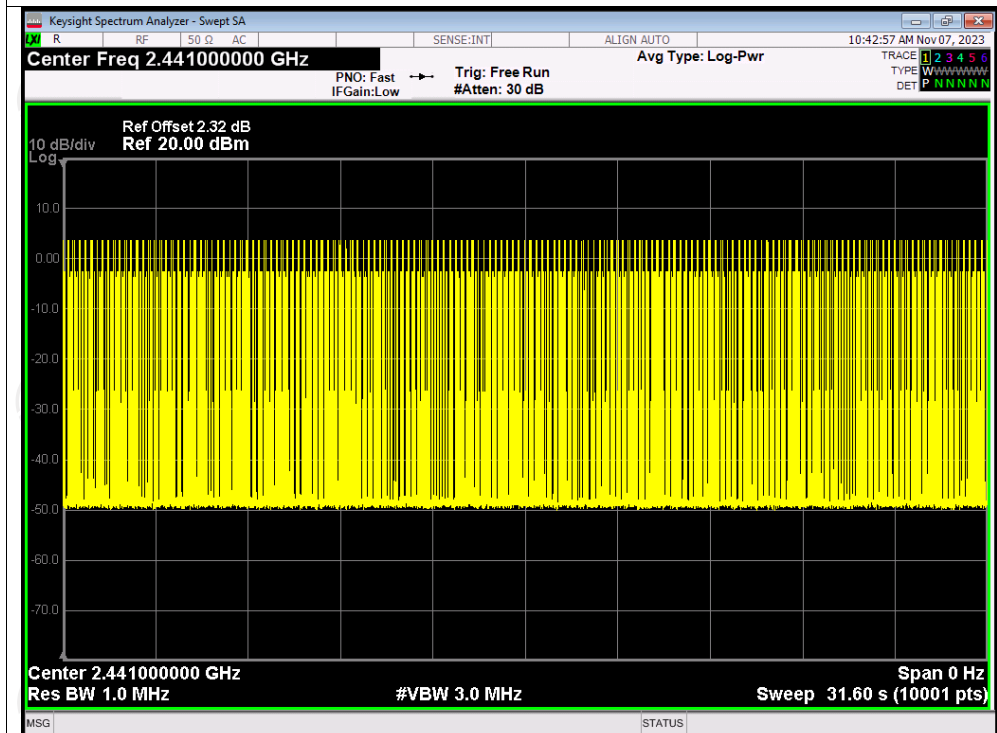
## Dwell NVNT 3-DH1 2441MHz Accumulated

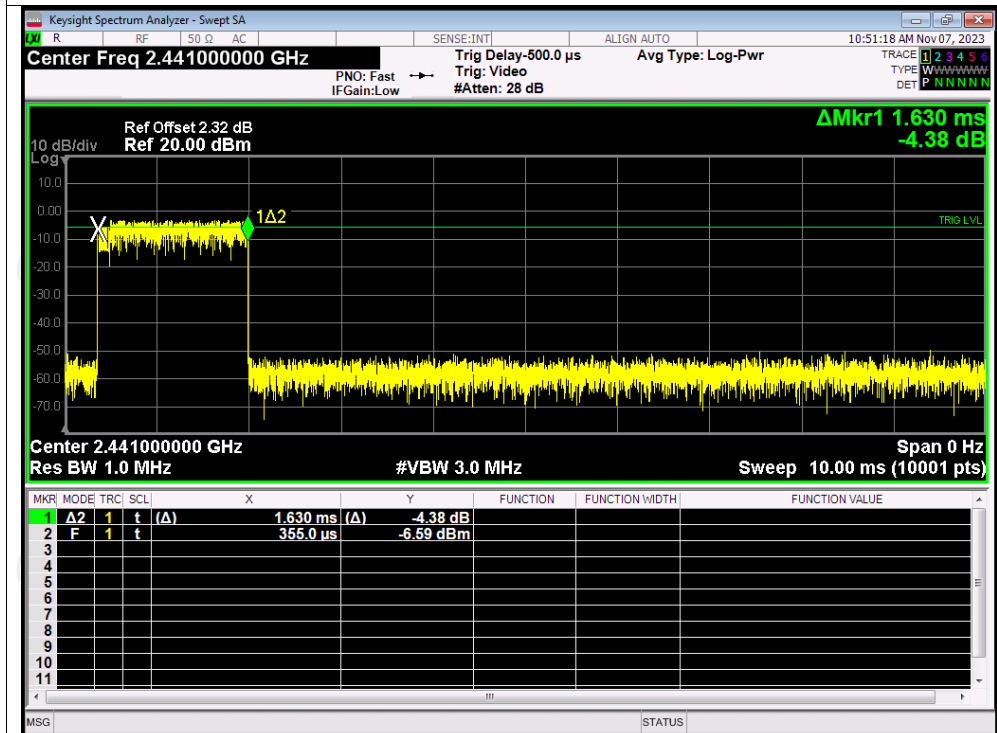
## Dwell NVNT 3-DH3 2441MHz One Burst

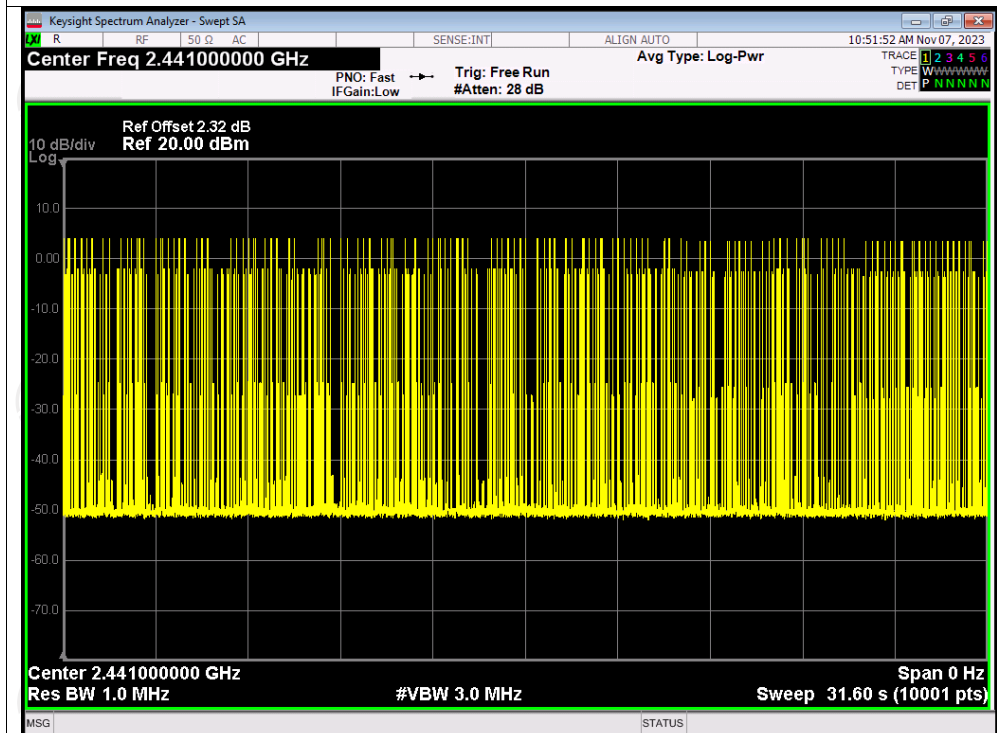
## Dwell NVNT 3-DH3 2441MHz Accumulated

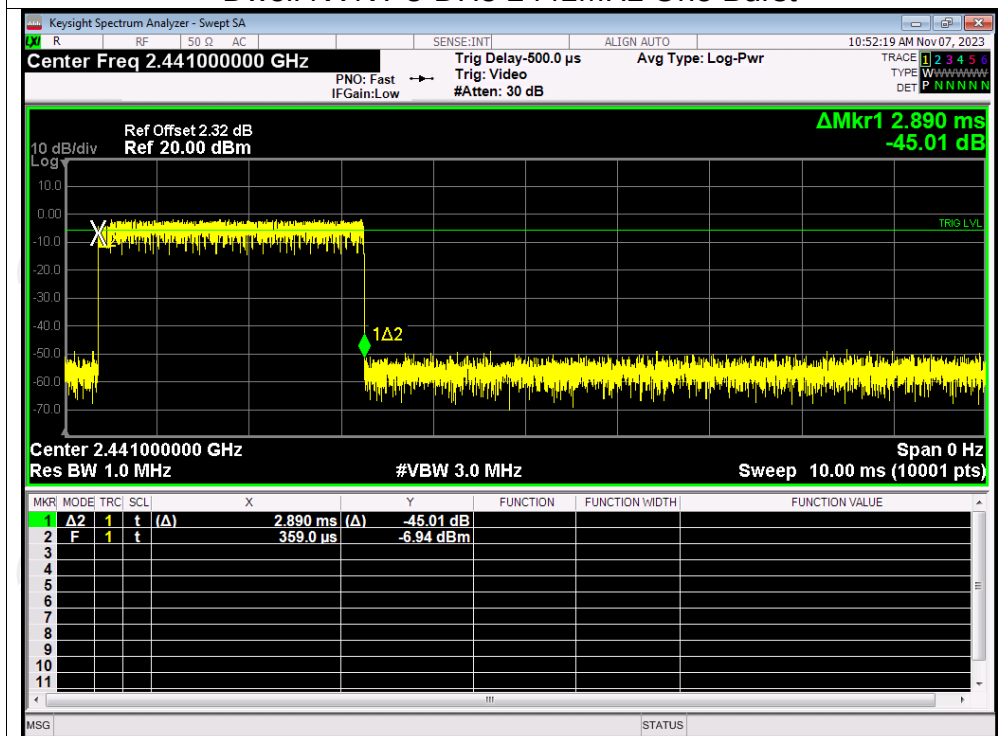
## Dwell NVNT 3-DH5 2441MHz One Burst

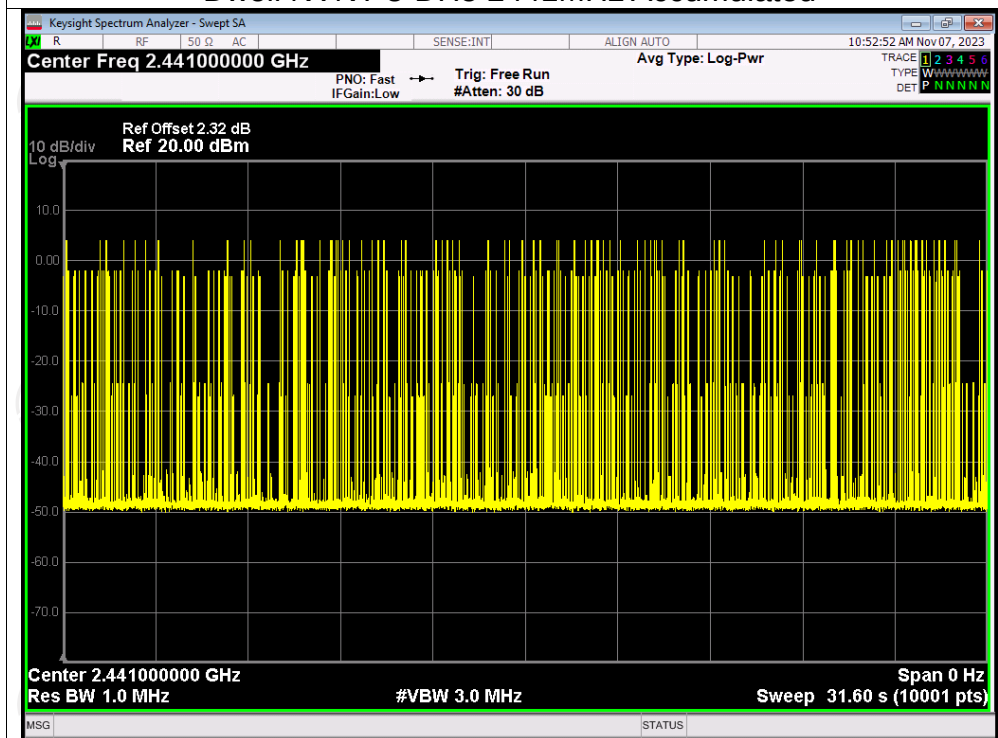
## Dwell NVNT 3-DH5 2441MHz Accumulated

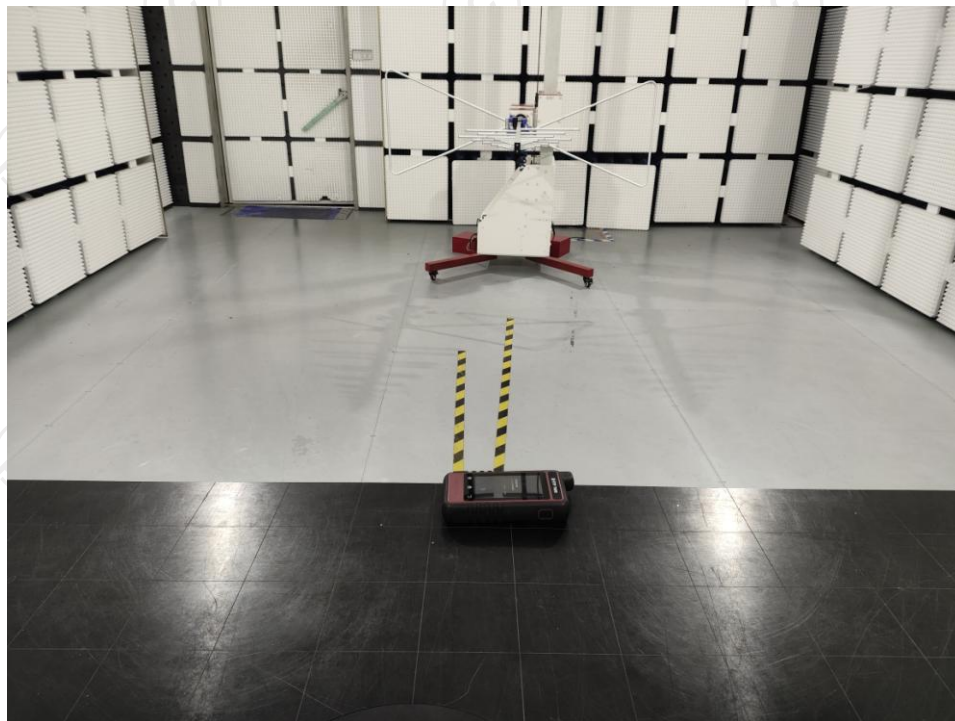
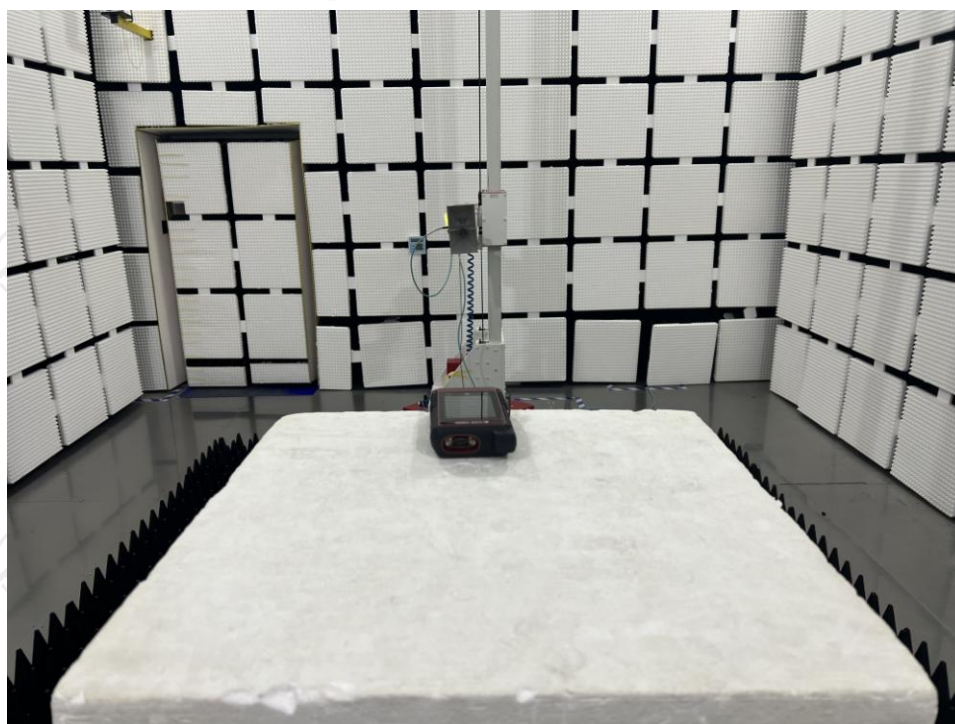
Radiated Emission

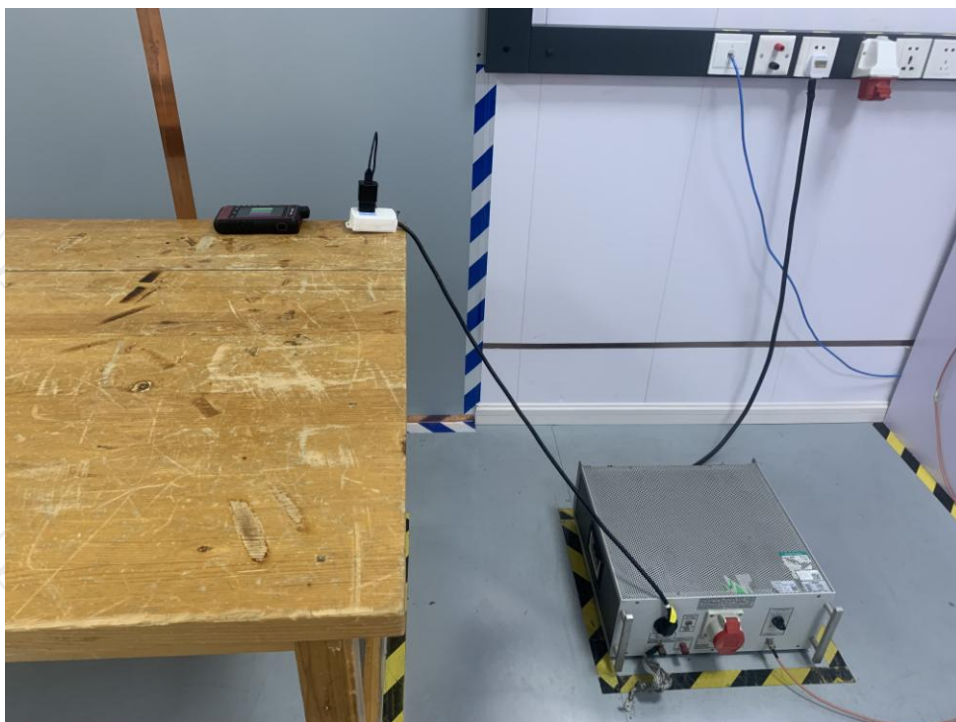
### Conducted Emission
