## **SAR Test Setup Photograph**

Report No.: 1909RSU027-UT

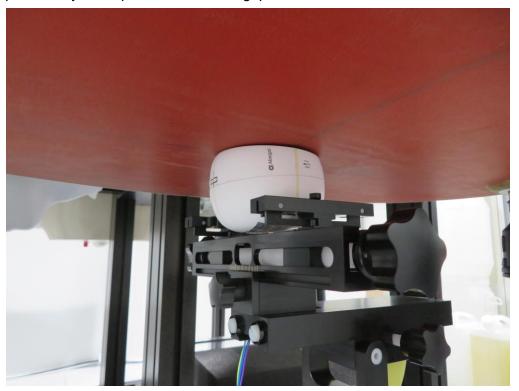
Description: Body Front position with 0mm gap

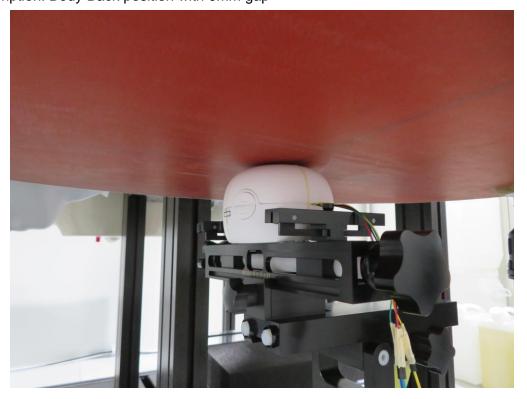
Description: Body Back position with 0mm gap

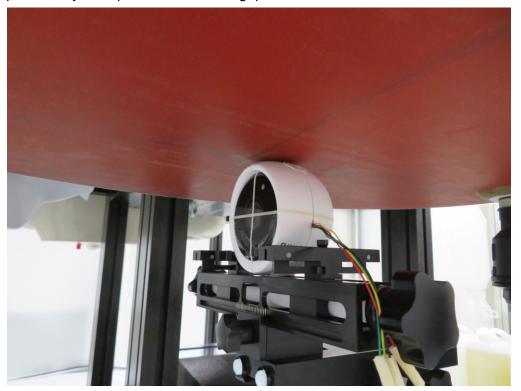
Description: Body Side position with 0mm gap
