Dwell NVNT 1-DH3 2441MHz Ant1 One Burst

## APPENDIX A: PHOTOGRAPHS OF TEST SETUP

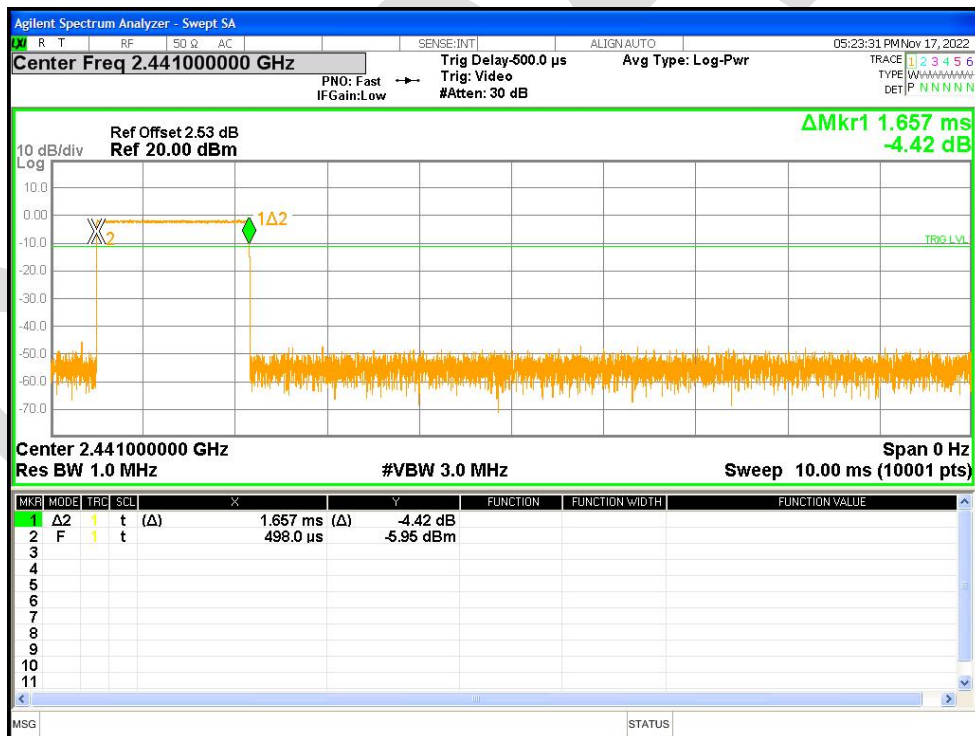
Dwell NVNT 1-DH3 2441MHz Ant1 Accumulated

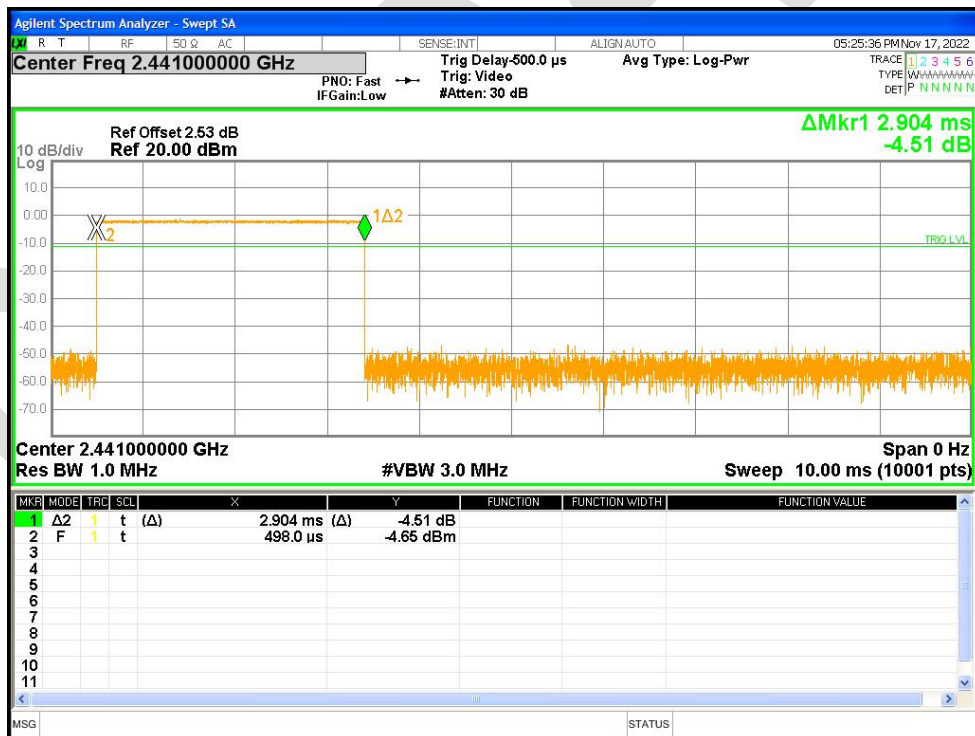
Dwell NVNT 1-DH5 2441MHz Ant1 Accumulated

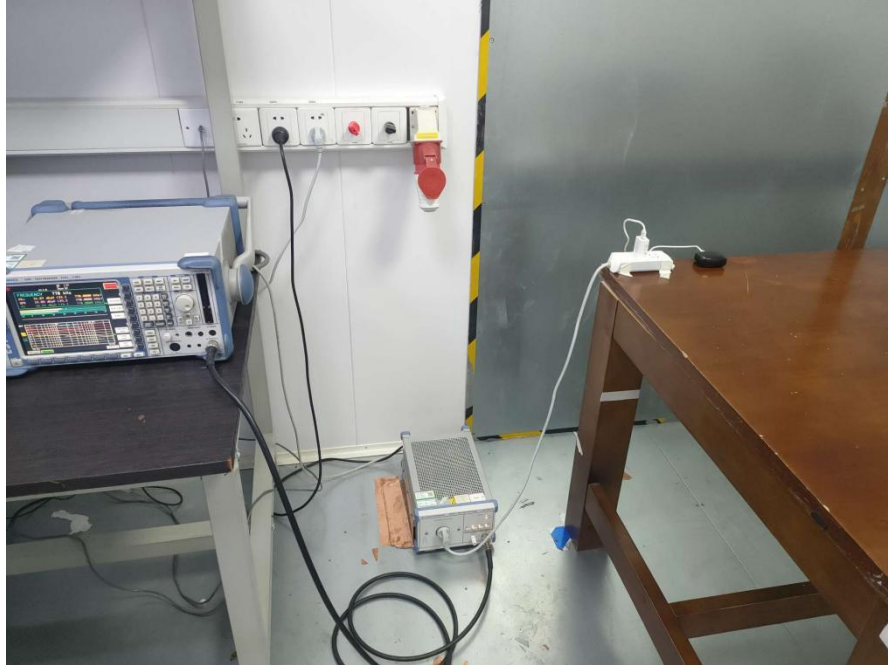
### Conducted Emissions at AC Power Line (150kHz-30MHz)

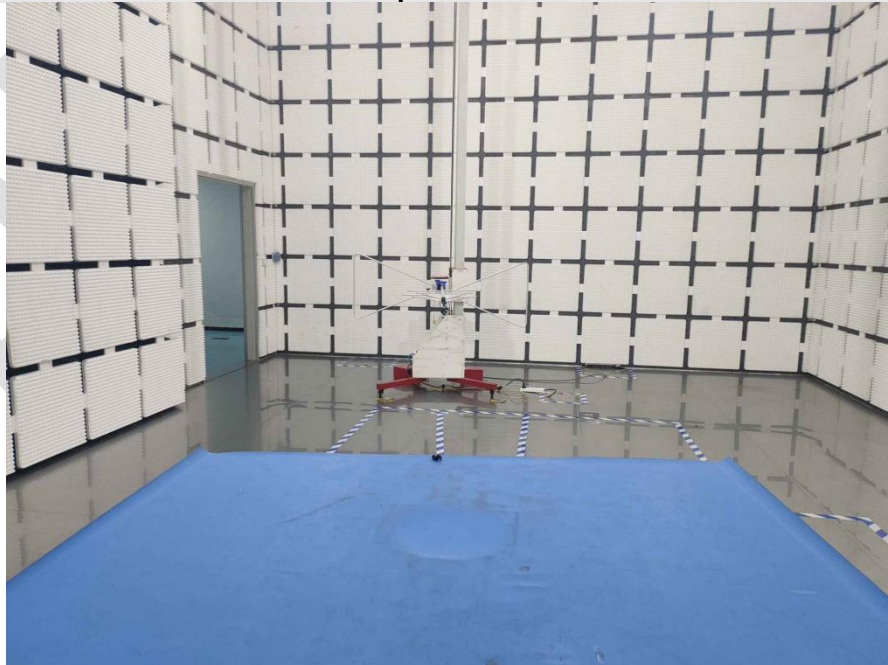
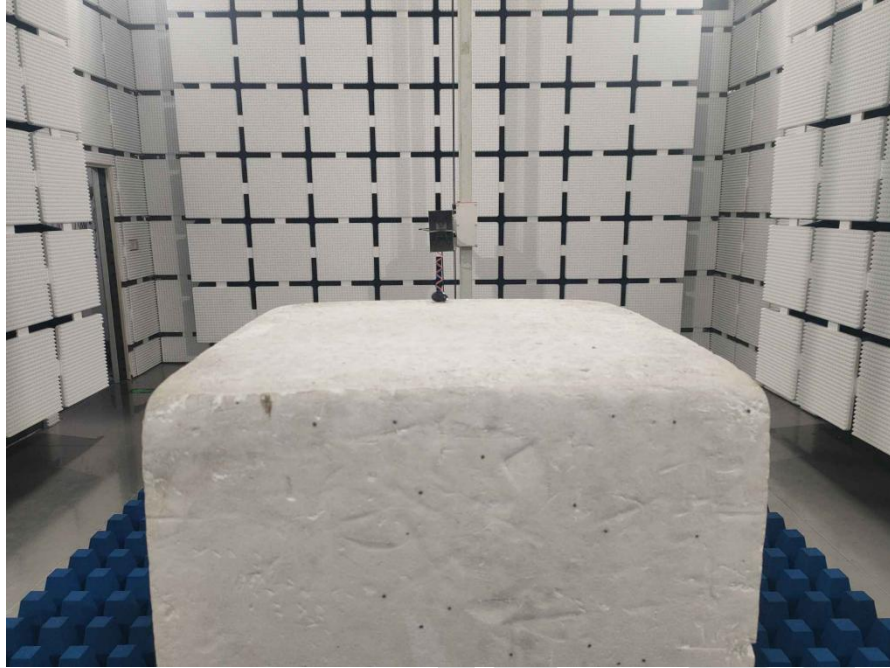
### Radiated Spurious Emissions
