## Appendix E: Band edge measurements

Appendix F: Conducted Spurious Emission  
Test Result

Appendix G: Duty Cycle  
Test Result

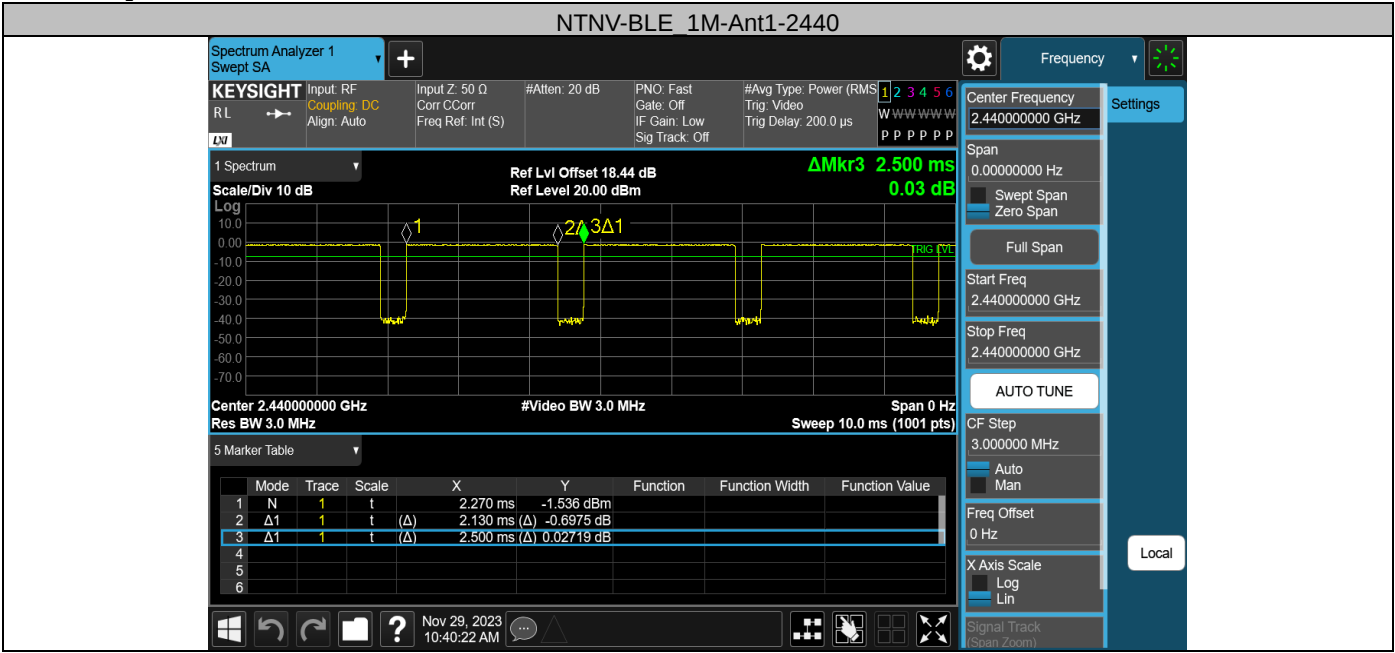
Test Graphs

| TestMode | Antenna | Frequency[MHz] | ON Time<br>[ms] | Period<br>[ms] | Duty Cycle<br>[%] | Duty Cycle<br>Factor[dB] |
|---|---|---|---|---|---|---|
| BLE 1M | Ant1 | 2440 | 2.13 | 2.50 | 85.20 | 0.70 |

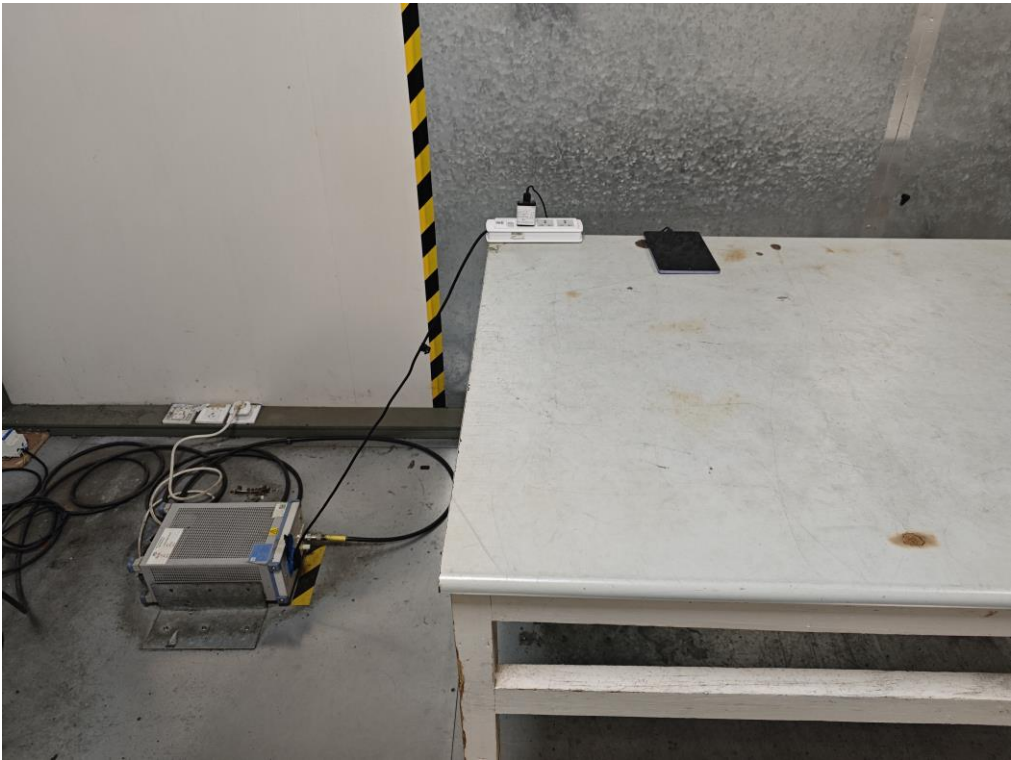
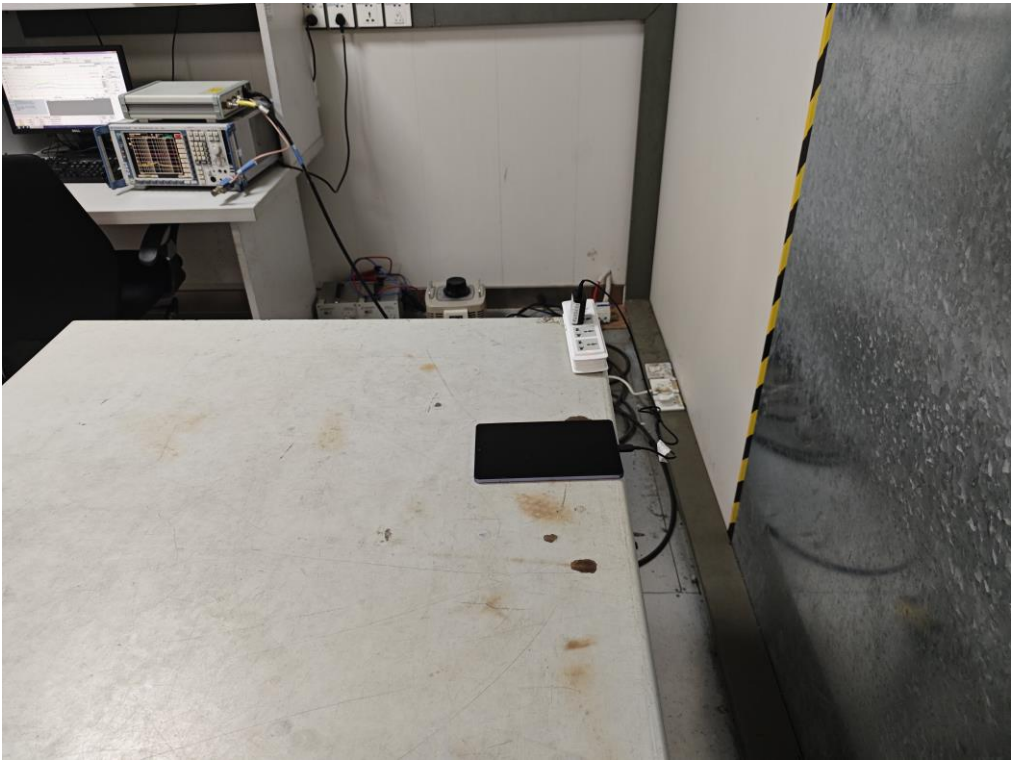
Conducted Test

12. TEST SETUP PHOTO
