## APPENDIX 1 PHOTOS OF TEST SETUP

## APPENDIX 2 PHOTOS OF EUT CONSTRUCTIONAL DETAILS

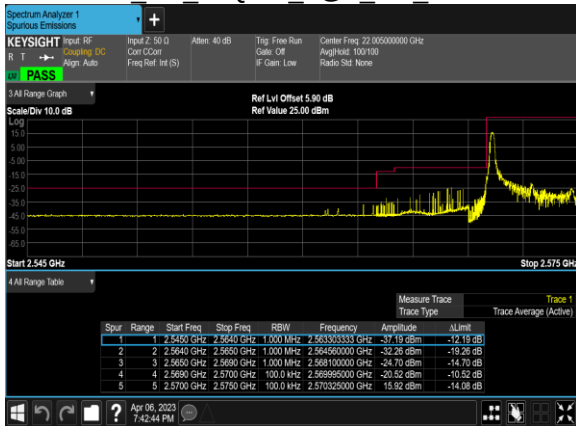
B38 5M 16QAM 1@0 CH 37775

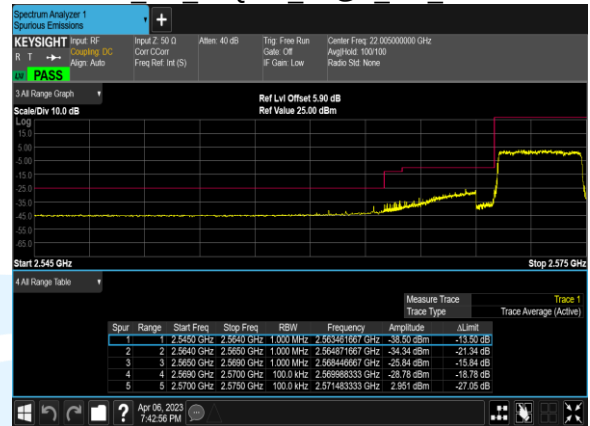
B38 5M 16QAM 25@0 CH 37775

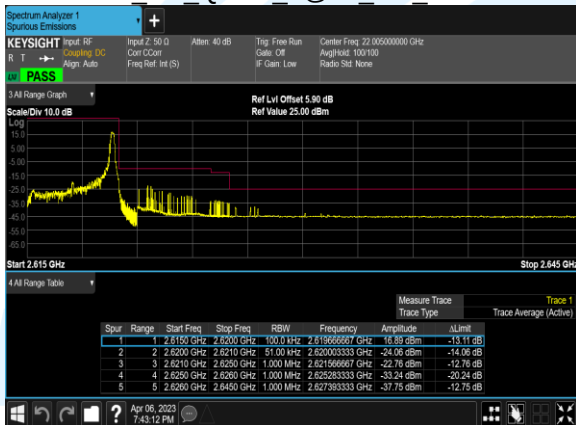
B38 5M QPSK 1@24 CH 38225

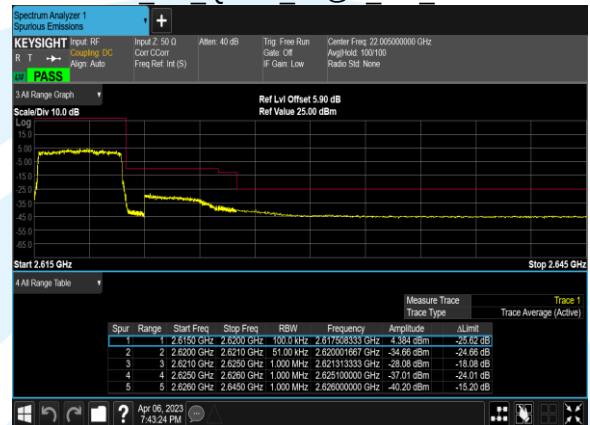
B38 5M QPSK 25@0 CH 38225

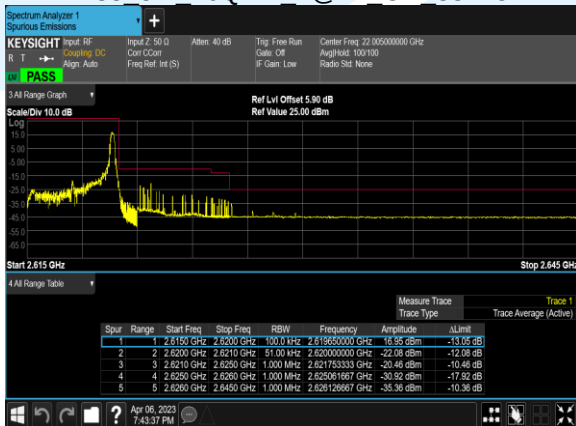
B38 5M 16QAM 1@24 CH 38225

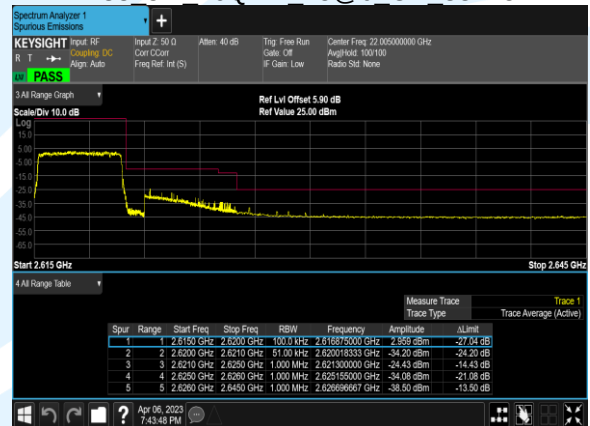
B38 5M 16QAM 25@0 CH 38225

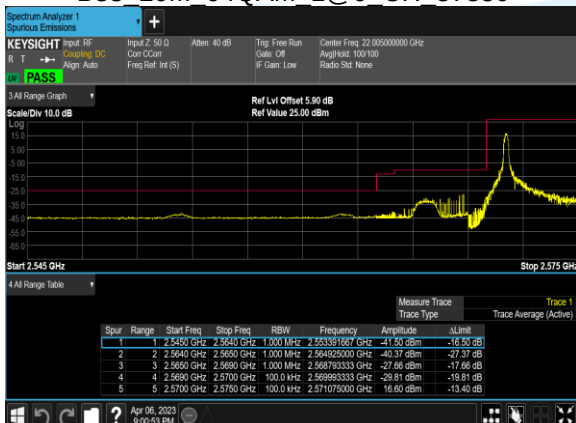
B38 20M 64QAM 1@0 CH 37850

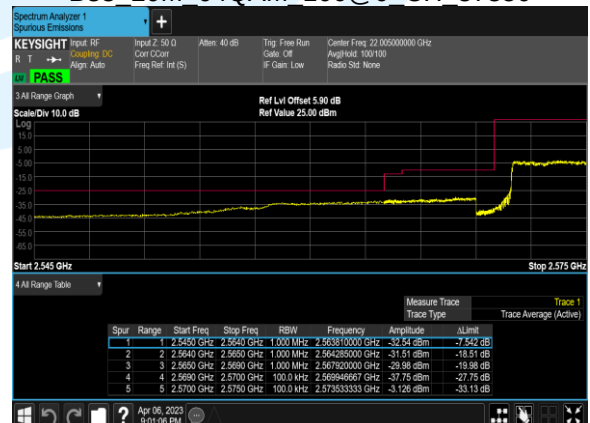
B38 20M 64QAM 100@0 CH 37850

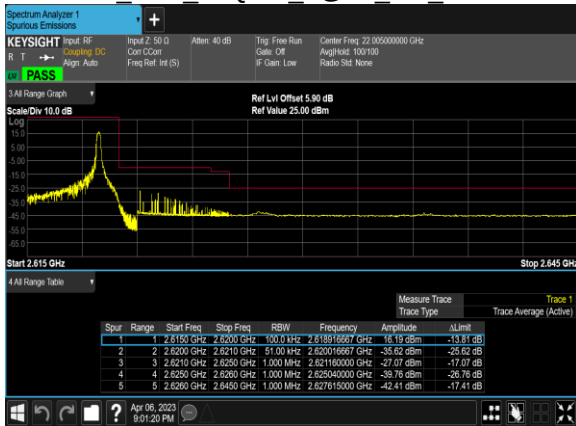
B38 20M 64QAM 1@99 CH 38150

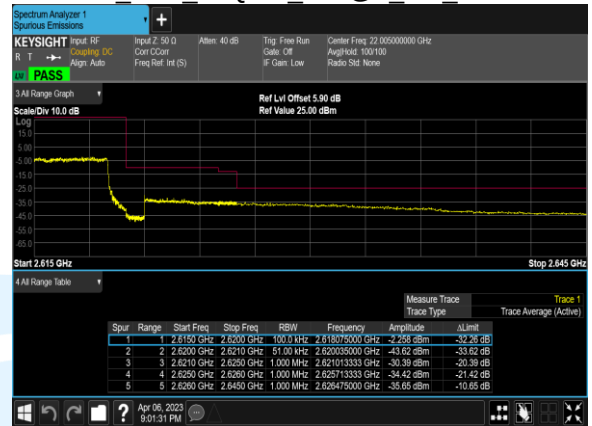
B38 20M 64QAM 100@0 CH 38150

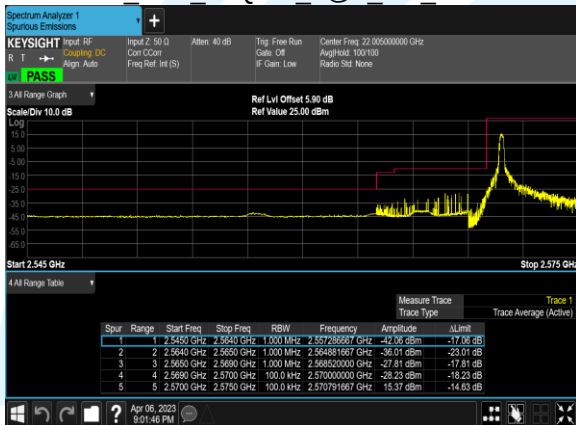
B38 15M 64QAM 1@0 CH 37825

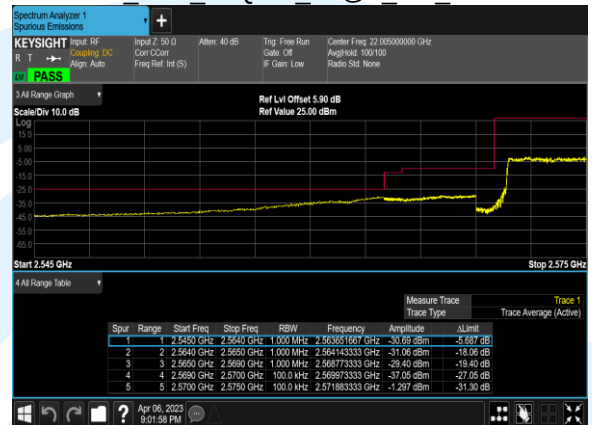
B38 15M 64QAM 75@0 CH 37825

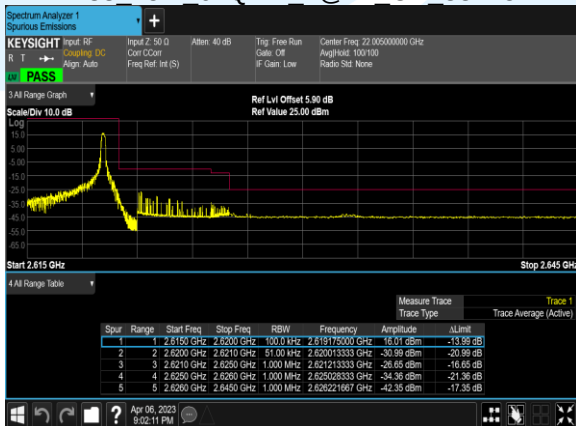
B38 15M 64QAM 1@74 CH 38175

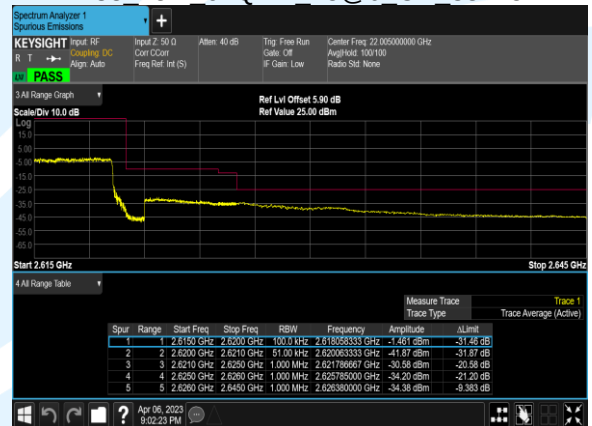
B38 15M 64QAM 75@0 CH 38175

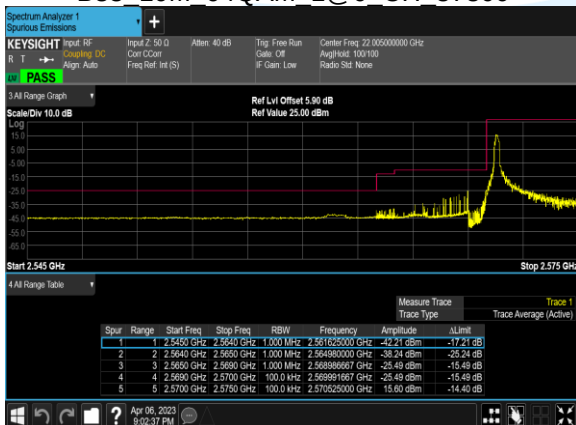
B38 10M 64QAM 1@0 CH 37800

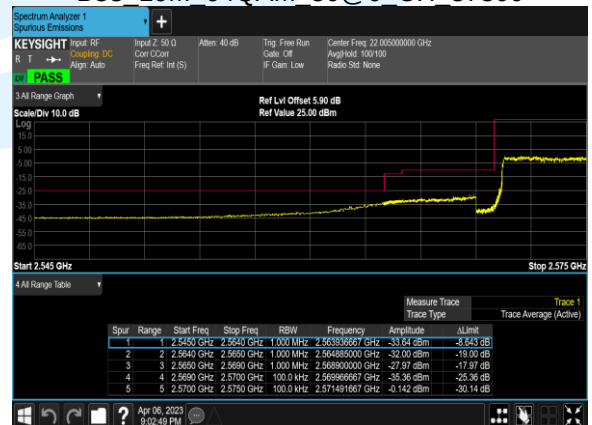
B38 10M 64QAM 50@0 CH 37800

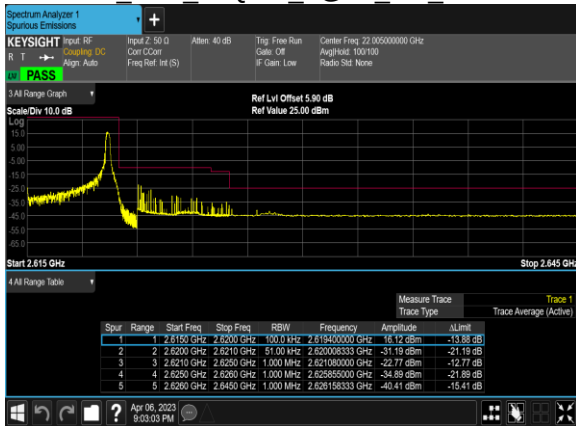
B38 10M 64QAM 1@49 CH 38200

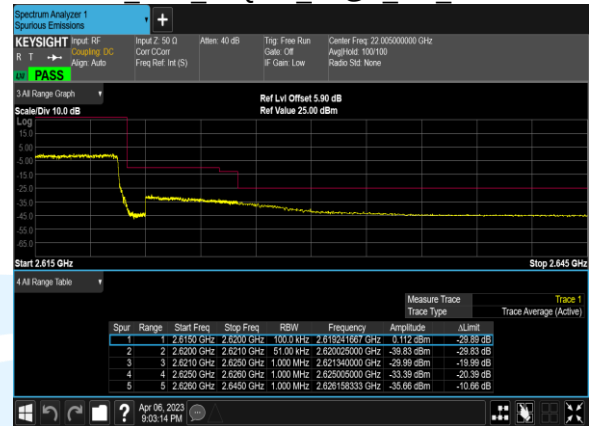
B38 10M 64QAM 50@0 CH 38200

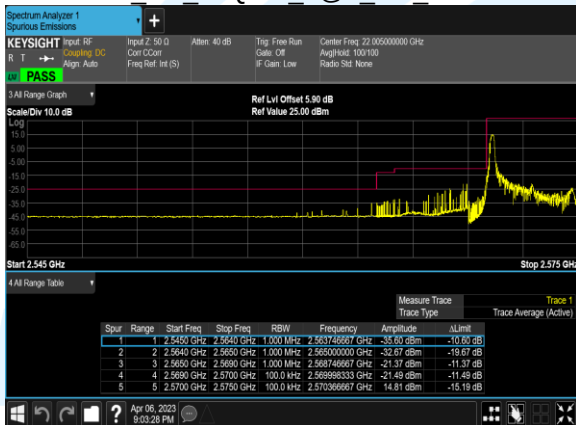
B38 5M 64QAM 1@0 CH 37775

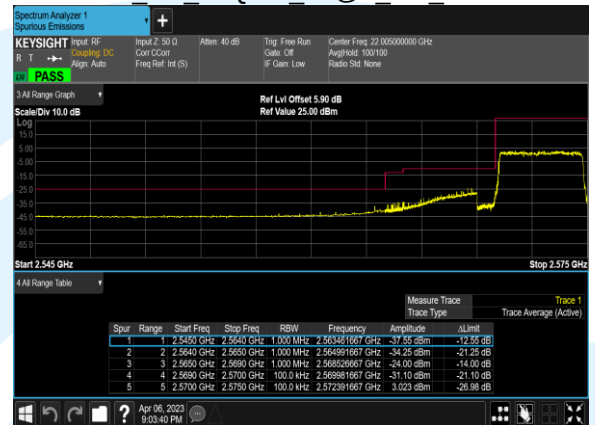
B38 5M 64QAM 25@0 CH 37775

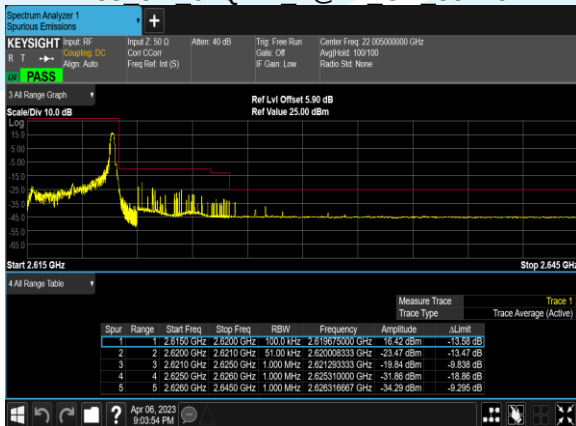
B38 5M 64QAM 1@24 CH 38225

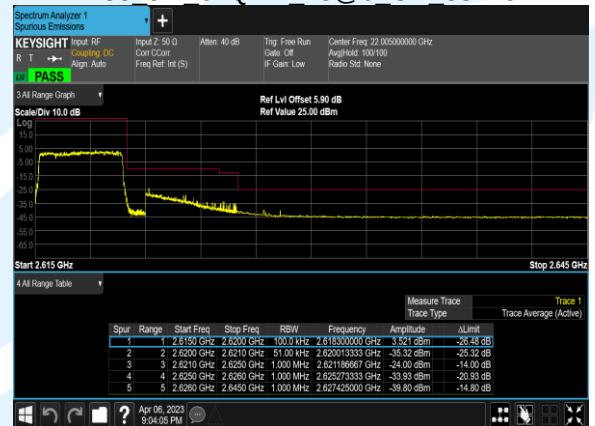
B38 5M 64QAM 25@0 CH 38225
