## APPENDIX A: PHOTOGRAPHS OF TEST SETUP

Reference to the test report No. BLA-EMC-202210-A8901

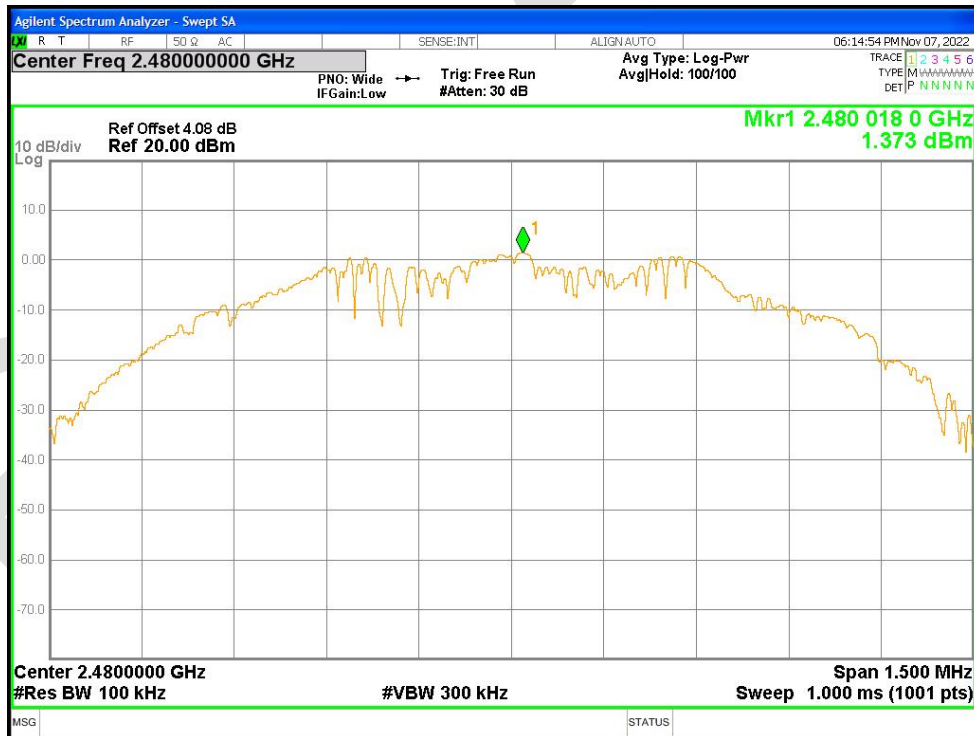
Tx. Spurious NVNT BLE 1M 2480MHz Ant1 Emission

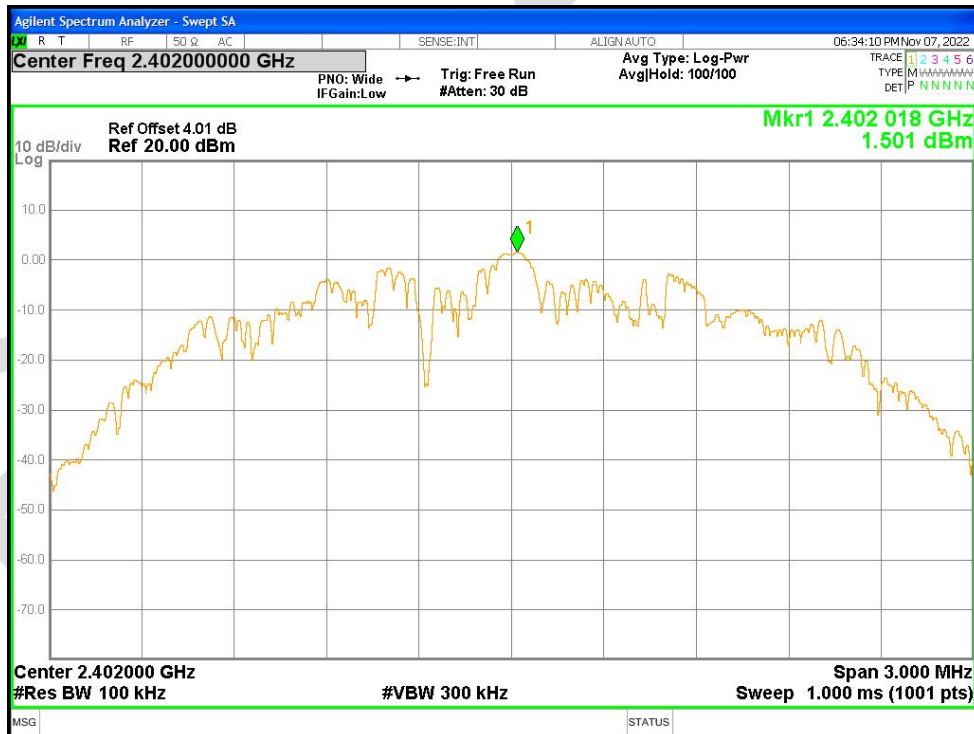
Tx. Spurious NVNT BLE 2M 2402MHz Ant1 Emission

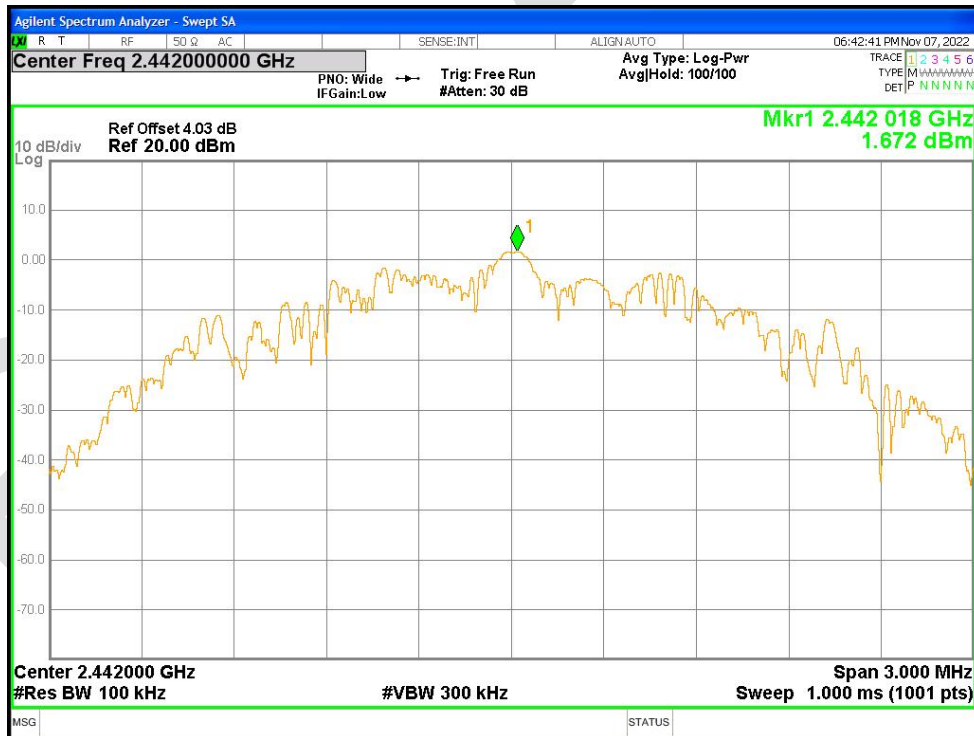
Tx. Spurious NVNT BLE 2M 2442MHz Ant1 Emission

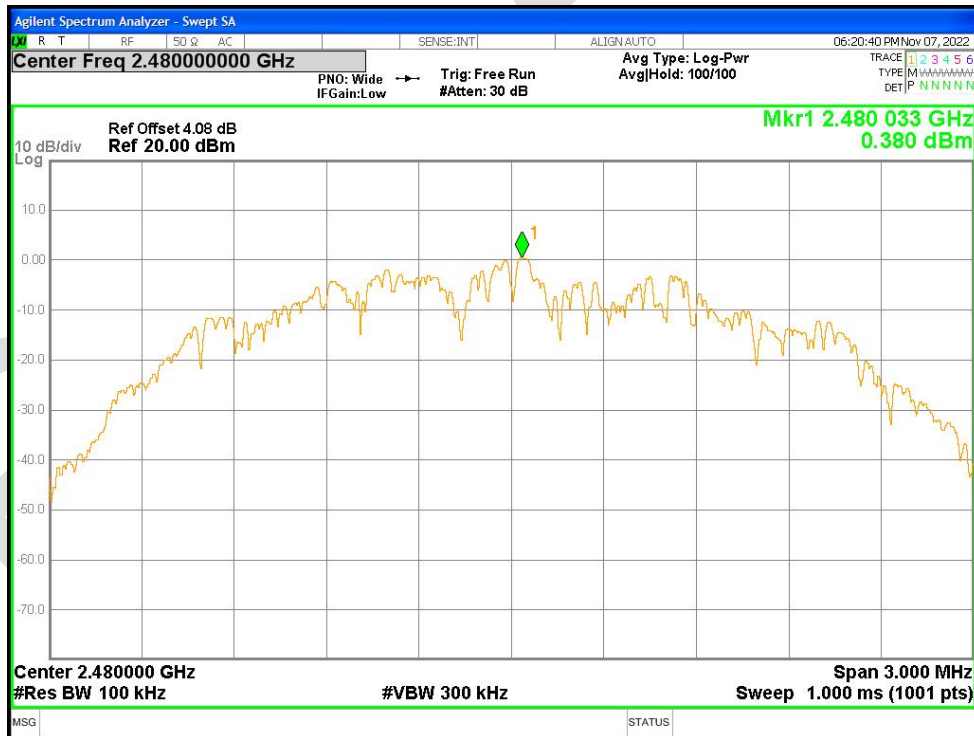
Tx. Spurious NVNT BLE 2M 2480MHz Ant1 Emission

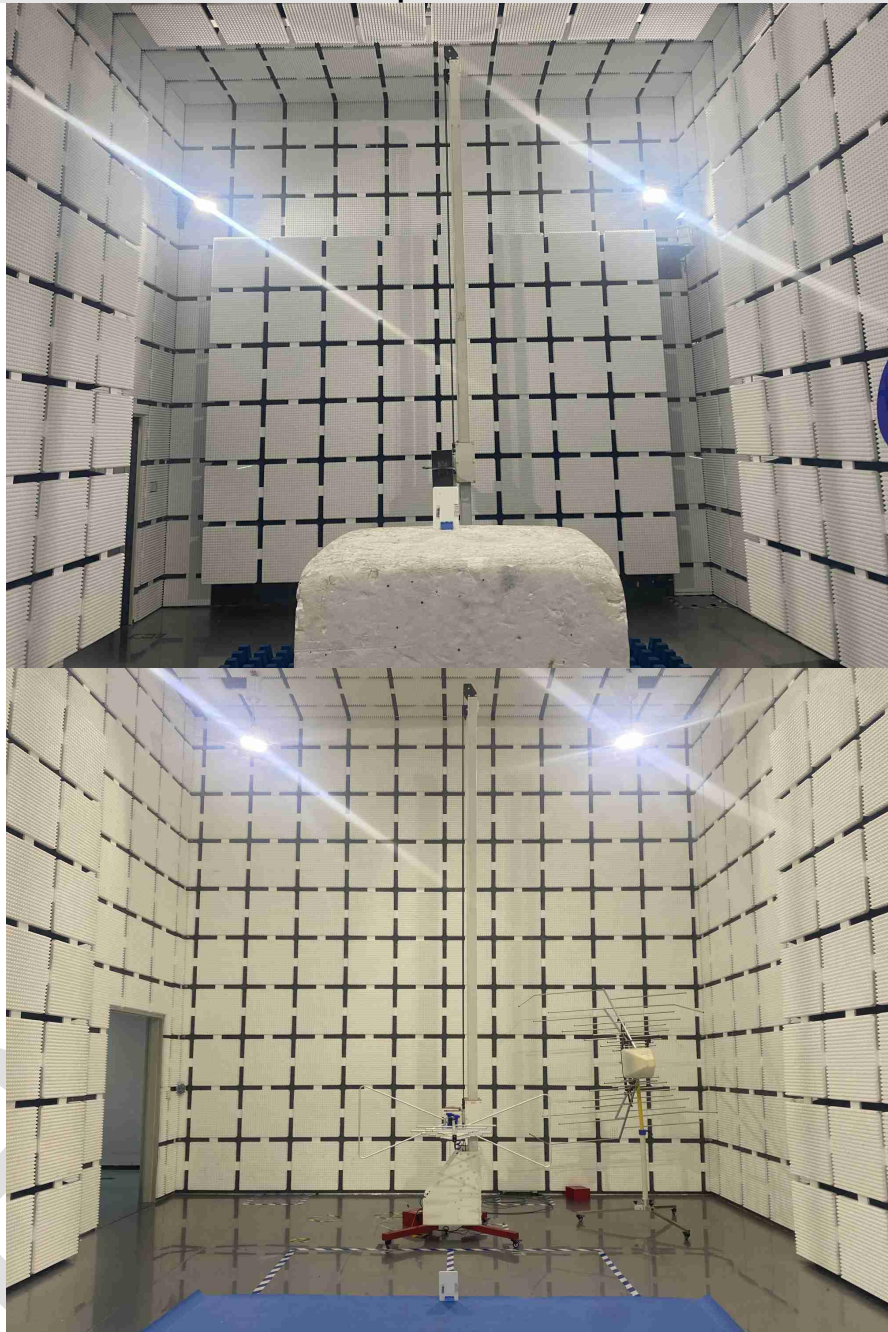
### Radiated Spurious Emissions
