### **APPENDIX 3: Photographs of test setup**

#### **Radiated Spurious Emission**

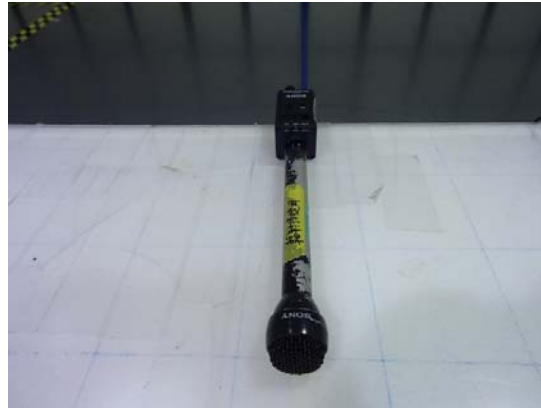
**X-axis**

**Worst Case Position**

**Below 1GHz (Horizontal: X-axis/ Vertical: Y-axis)**

**Above 1GHz (Horizontal: X-axis/ Vertical: X-axis)**
