## A.4 POWER SPECTRAL DENSITY

## Shenzhen UnionTrust Quality and Technology Co., Ltd.

UTTR-RF-RSS247-V1.1

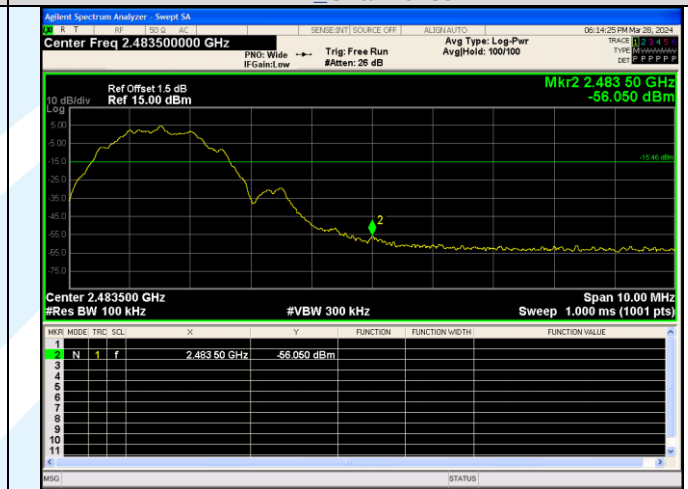
Out Of Band Emission  
2LE\_Channel 39
