# Radiated Emission Measurement

Condition : FCC\_part 15 RE-Class C\_Above 1GHz\_PK

EUT : W6M22311-23090

Test Mode : TX 802.11b CH6

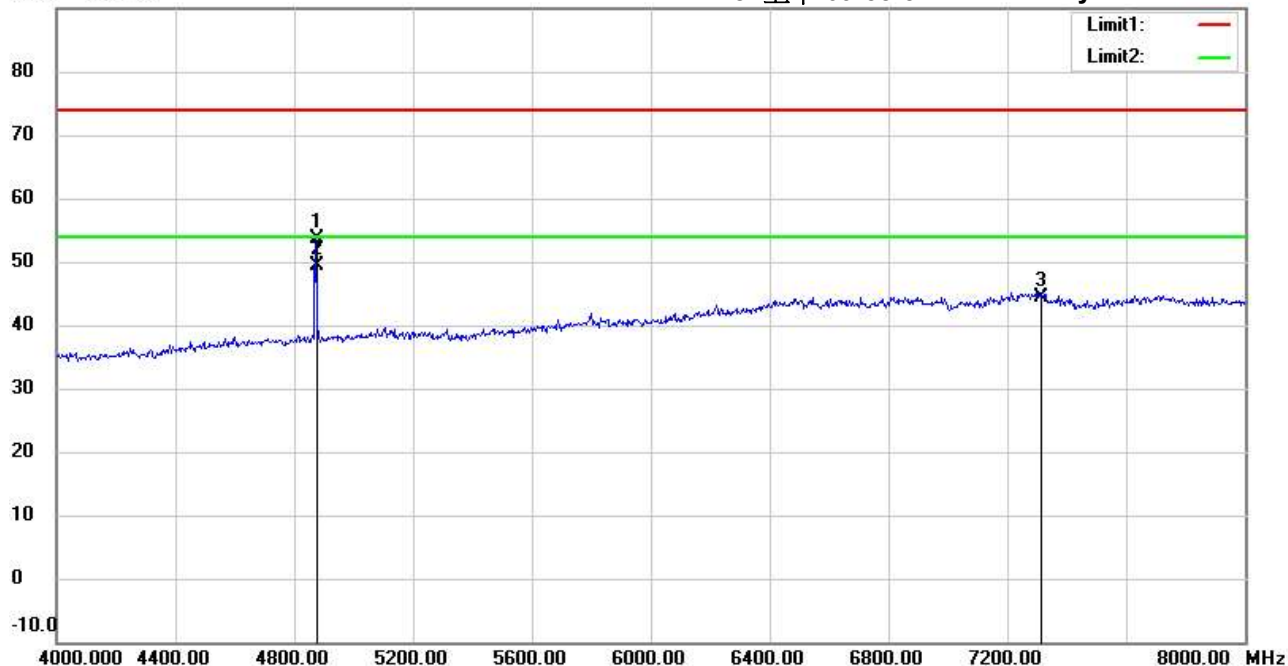
Condition : FCC\_part 15 RE-Class C\_Above 1GHz\_PK

Test Mode : TX 802.11b CH6

Polarization: Vertical

| Mk. | Frequency (MHz) | Reading (dBuV) | Detector | Corr. factor (dB/m) | Result (dBuV/m) | Limit (dBuV/m) | Ant.Pos (cm) | Tab.Pos (deg.) | Margin (dB) | Comment |
|---|---|---|---|---|---|---|---|---|---|---|
| | 4874.000 | 48.41 | peak | 5.21 | 53.62 | 74.00 | 150 | 117 | -20.38 | |
| * | 4874.000 | 44.09 | AVG | 5.21 | 49.30 | 54.00 | 150 | 117 | -4.70 | |
| | 7311.000 | 32.59 | peak | 11.70 | 44.29 | 74.00 | 150 | 60 | -29.71 | |

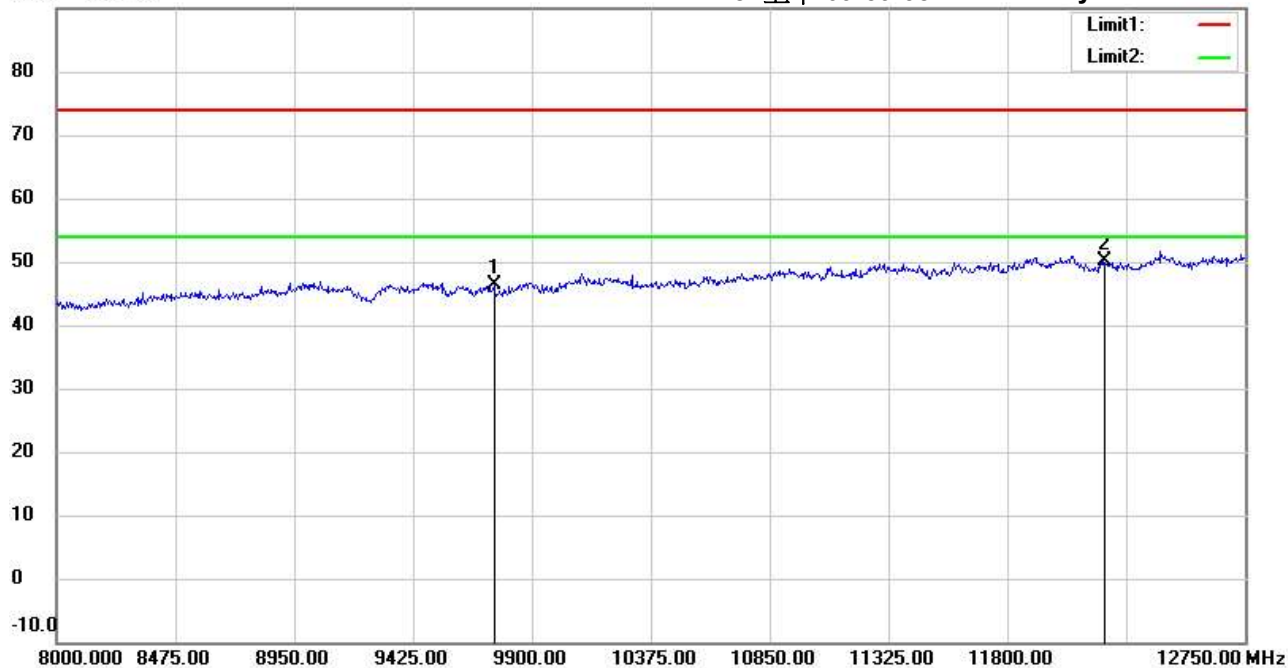
Condition : FCC\_part 15 RE-Class C\_Above 1GHz\_PK

Test Mode : TX 802.11b CH6

Polarization: Vertical

| Mk. | Frequency (MHz) | Reading (dBuV) | Detector | Corr. factor (dB/m) | Result (dBuV/m) | Limit (dBuV/m) | Ant.Pos (cm) | Tab.Pos (deg.) | Margin (dB) | Comment |
|---|---|---|---|---|---|---|---|---|---|---|
| | 9748.000 | 32.56 | peak | 13.70 | 46.26 | 74.00 | 150 | 214 | -27.74 | |
| * | 12185.000 | 33.18 | peak | 17.02 | 50.20 | 74.00 | 150 | 21 | -23.80 | |

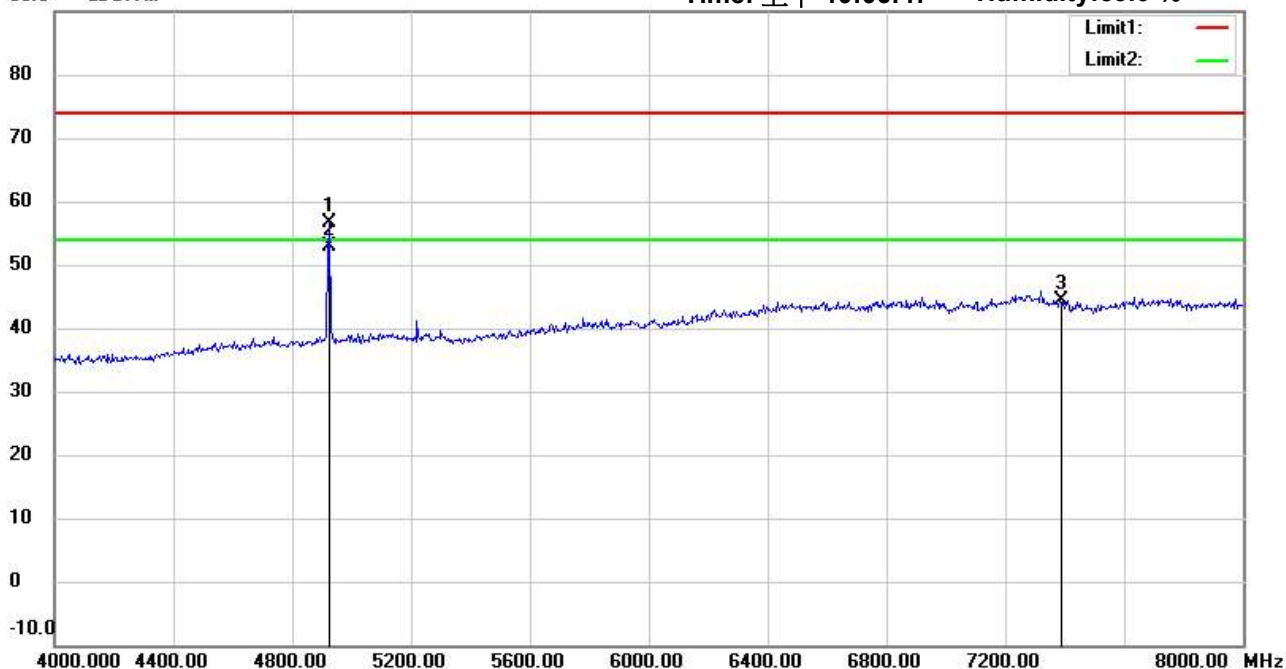
Condition : FCC\_part 15 RE-Class C\_Above 1GHz\_PK

Test Mode : TX 802.11b CH11

Polarization: **Horizontal**

| Mk. | Frequency (MHz) | Reading (dBuV) | Detector | Corr. factor (dB/m) | Result (dBuV/m) | Limit (dBuV/m) | Ant.Pos (cm) | Tab.Pos (deg.) | Margin (dB) | Comment |
|---|---|---|---|---|---|---|---|---|---|---|
| | 4924.000 | 51.28 | peak | 5.38 | 56.66 | 74.00 | 150 | 35 | -17.34 | |
| * | 4924.000 | 47.52 | AVG | 5.38 | 52.90 | 54.00 | 150 | 35 | -1.10 | |
| | 7386.000 | 32.90 | peak | 11.39 | 44.29 | 74.00 | 150 | 23 | -29.71 | |

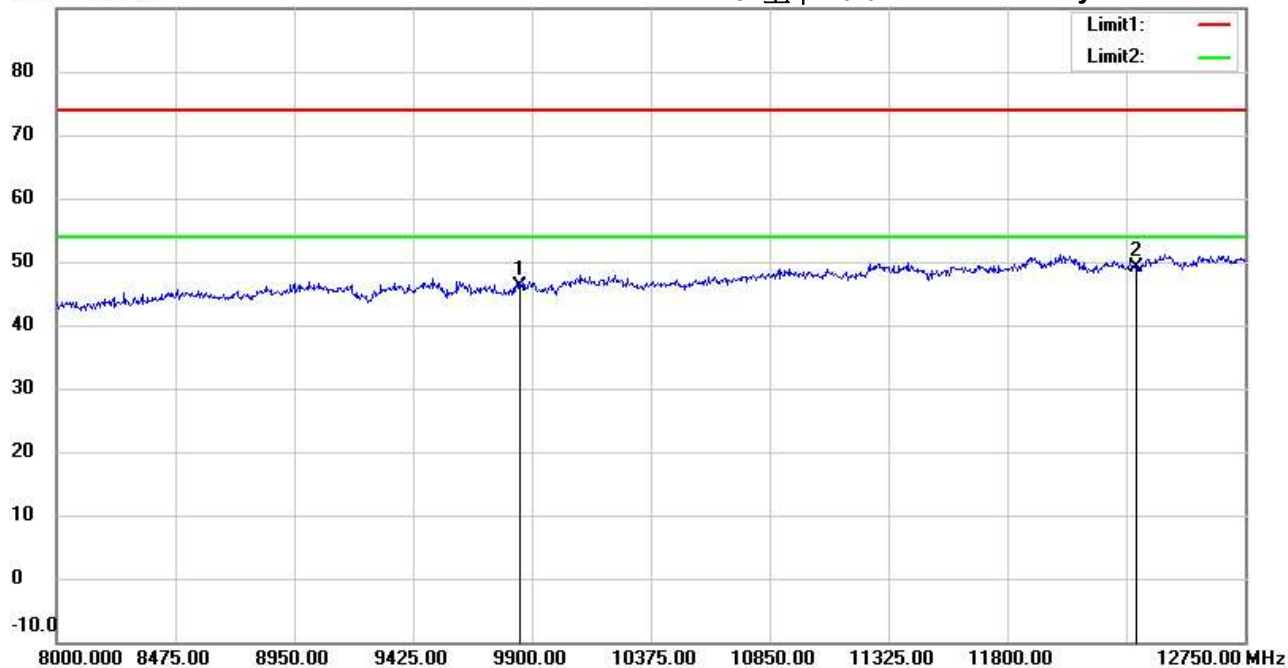
Condition : FCC\_part 15 RE-Class C\_Above 1GHz\_PK

Test Mode : TX 802.11b CH11

Polarization: **Horizontal**

| Mk. | Frequency (MHz) | Reading (dBuV) | Detector | Corr. factor (dB/m) | Result (dBuV/m) | Limit (dBuV/m) | Ant.Pos (cm) | Tab.Pos (deg.) | Margin (dB) | Comment |
|---|---|---|---|---|---|---|---|---|---|---|
| | 9848.000 | 32.15 | peak | 13.97 | 46.12 | 74.00 | 150 | 295 | -27.88 | |
| * | 12310.000 | 32.49 | peak | 16.62 | 49.11 | 74.00 | 150 | 102 | -24.89 | |

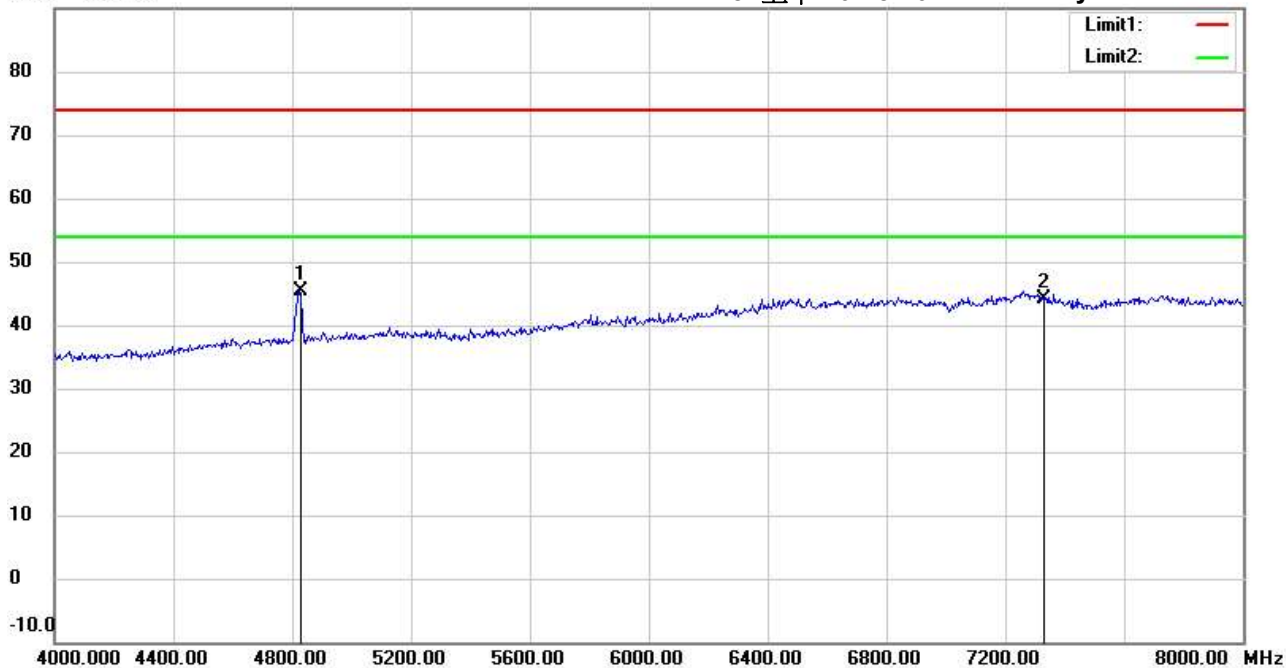
Condition : FCC\_part 15 RE-Class C\_Above 1GHz\_PK

Test Mode : TX 802.11g CH1

Polarization: **Horizontal**

| Mk. | Frequency (MHz) | Reading (dBuV) | Detector | Corr. factor (dB/m) | Result (dBuV/m) | Limit (dBuV/m) | Ant.Pos (cm) | Tab.Pos (deg.) | Margin (dB) | Comment |
|---|---|---|---|---|---|---|---|---|---|---|
| * | 4826.000 | 40.34 | peak | 5.09 | 45.43 | 74.00 | 150 | 271 | -28.57 | |
| | 7326.000 | 32.59 | peak | 11.64 | 44.23 | 74.00 | 150 | 145 | -29.77 | |

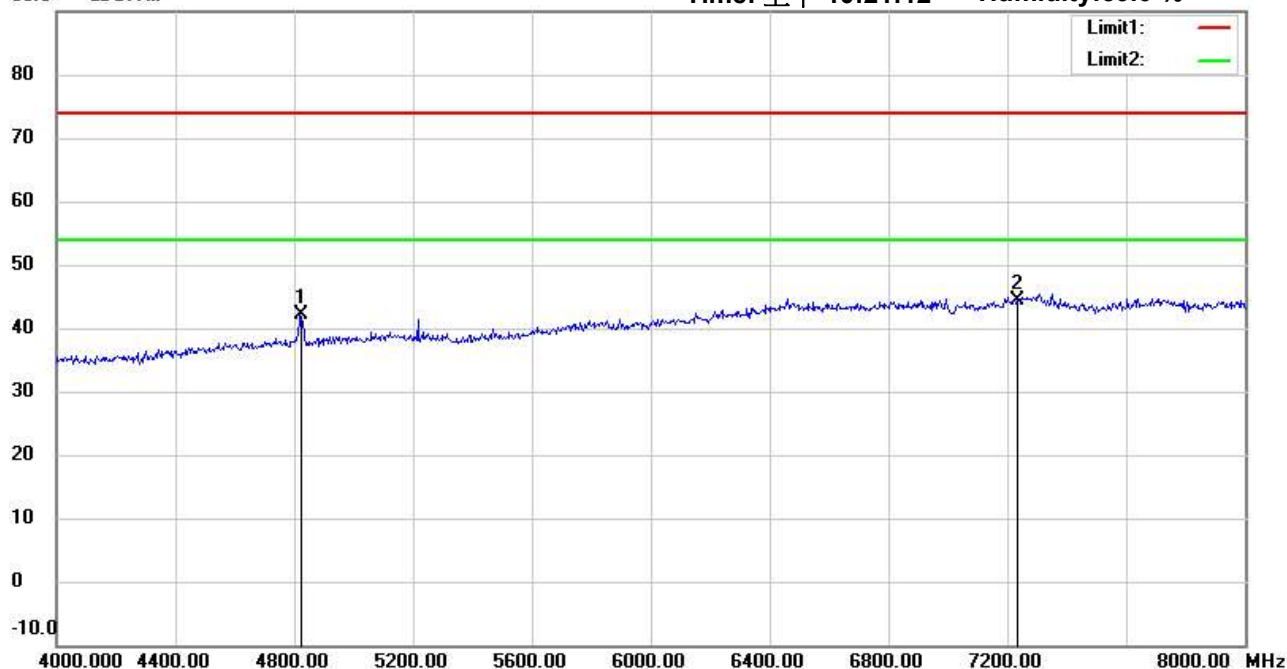
Condition : FCC\_part 15 RE-Class C\_Above 1GHz\_PK

Test Mode : TX 802.11g CH1

Polarization: Vertical

| Mk. | Frequency (MHz) | Reading (dBuV) | Detector | Corr. factor (dB/m) | Result (dBuV/m) | Limit (dBuV/m) | Ant.Pos (cm) | Tab.Pos (deg.) | Margin (dB) | Comment |
|---|---|---|---|---|---|---|---|---|---|---|
| | 4822.000 | 37.15 | peak | 5.08 | 42.23 | 74.00 | 150 | 305 | -31.77 | |
| * | 7236.000 | 32.96 | peak | 11.50 | 44.46 | 74.00 | 150 | 173 | -29.54 | |

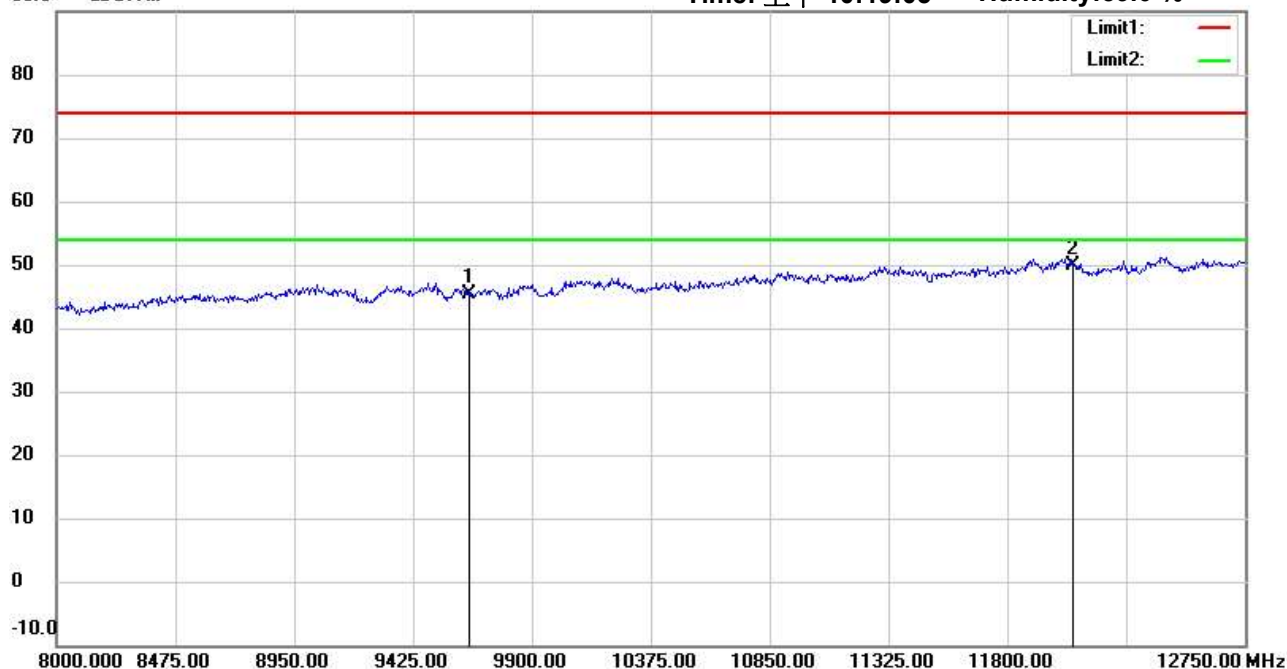
Condition : FCC\_part 15 RE-Class C\_Above 1GHz\_PK

Test Mode : TX 802.11g CH1

Polarization: **Horizontal**

| Mk. | Frequency (MHz) | Reading (dBuV) | Detector | Corr. factor (dB/m) | Result (dBuV/m) | Limit (dBuV/m) | Ant.Pos (cm) | Tab.Pos (deg.) | Margin (dB) | Comment |
|---|---|---|---|---|---|---|---|---|---|---|
| | 9648.000 | 31.86 | peak | 13.44 | 45.30 | 74.00 | 150 | 135 | -28.70 | |
| * | 12060.000 | 32.87 | peak | 17.10 | 49.97 | 74.00 | 150 | 203 | -24.03 | |

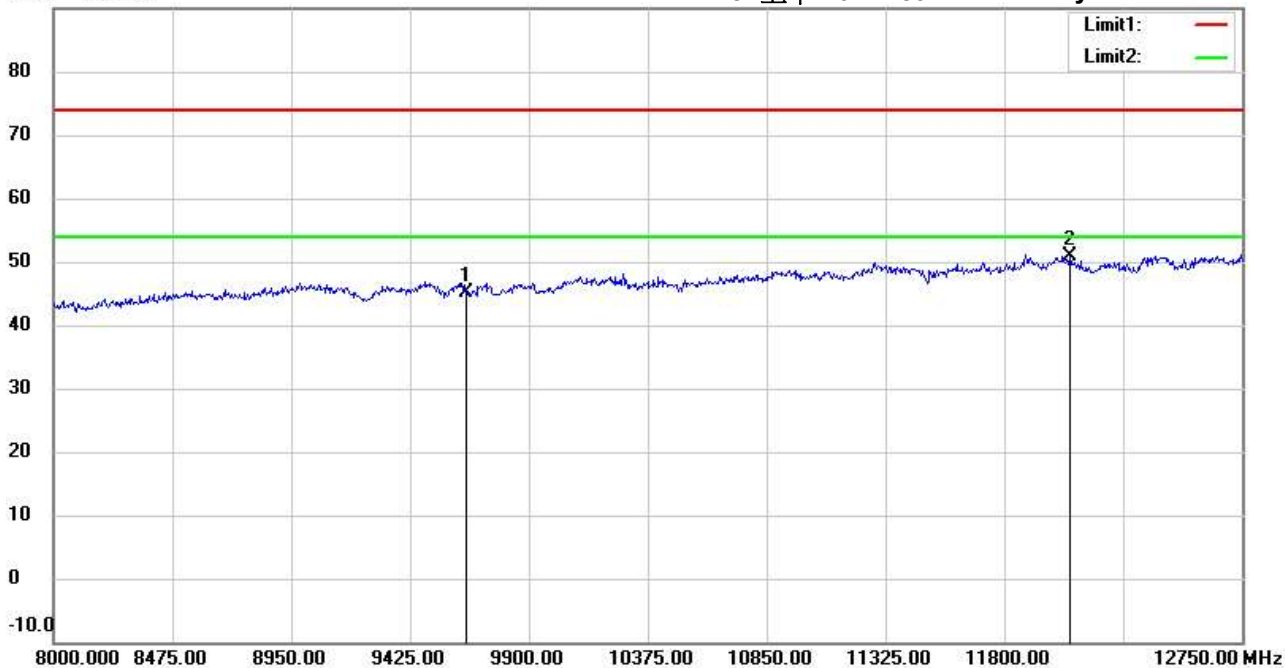
Condition : FCC\_part 15 RE-Class C\_Above 1GHz\_PK

Test Mode : TX 802.11g CH1

Polarization: Vertical

| Mk. | Frequency (MHz) | Reading (dBuV) | Detector | Corr. factor (dB/m) | Result (dBuV/m) | Limit (dBuV/m) | Ant.Pos (cm) | Tab.Pos (deg.) | Margin (dB) | Comment |
|---|---|---|---|---|---|---|---|---|---|---|
| | 9648.000 | 31.64 | peak | 13.44 | 45.08 | 74.00 | 150 | 315 | -28.92 | |
| * | 12060.000 | 33.75 | peak | 17.10 | 50.85 | 74.00 | 150 | 279 | -23.15 | |
