A TYPOGRAPHICAL ERROR WAS FOUND IN
SHEET 18 OF EXHIBIT 06 – “TEST REPORT”

EXHIBIT 6I – Transient Frequency Behavior (Note: Measurement made at 155.025 MHz)

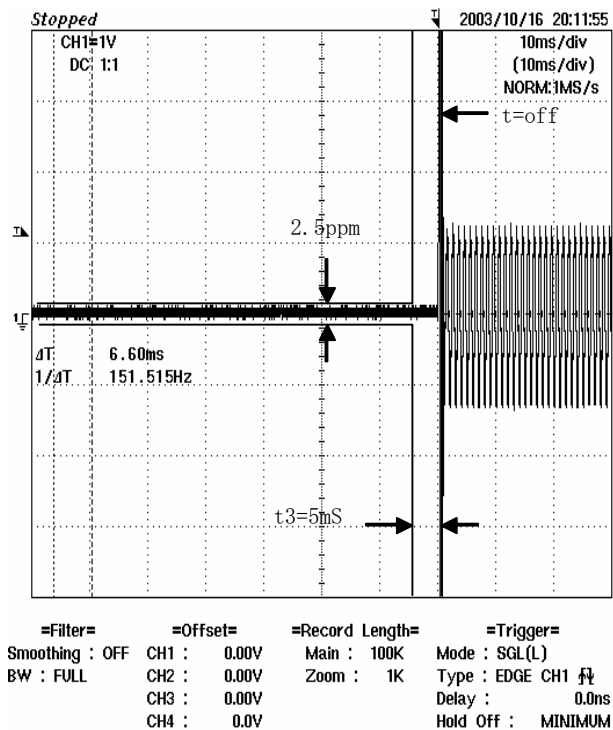
Figure 6I-2: 5 Watts, 12.5 KHz De-Key Decay Time
