**Band-edge Measurements for RF Conducted Emissions:**

## 4.7 Antenna Requirement

## 5 Test Setup Photos of the EUT

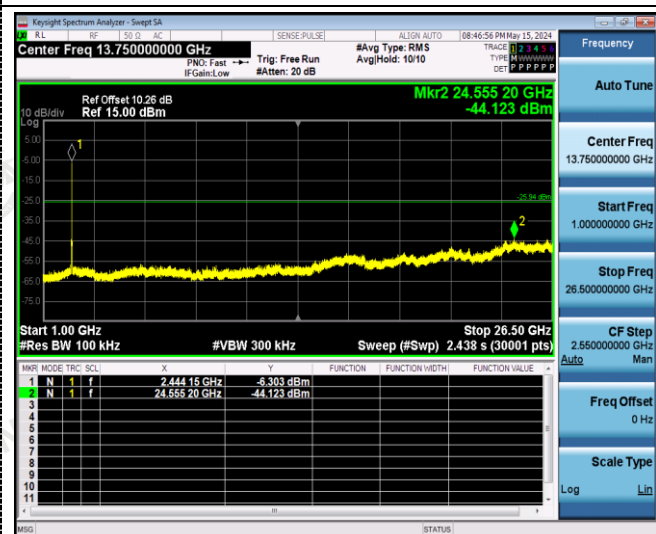
3GHz -25GHz

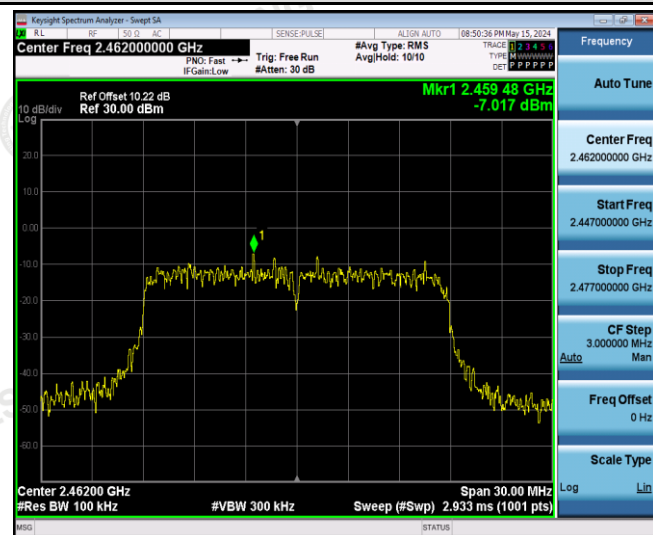
Reference  
CH11

## 802.11n20
