### **APPENDIX 3: Photographs of Test Setup**

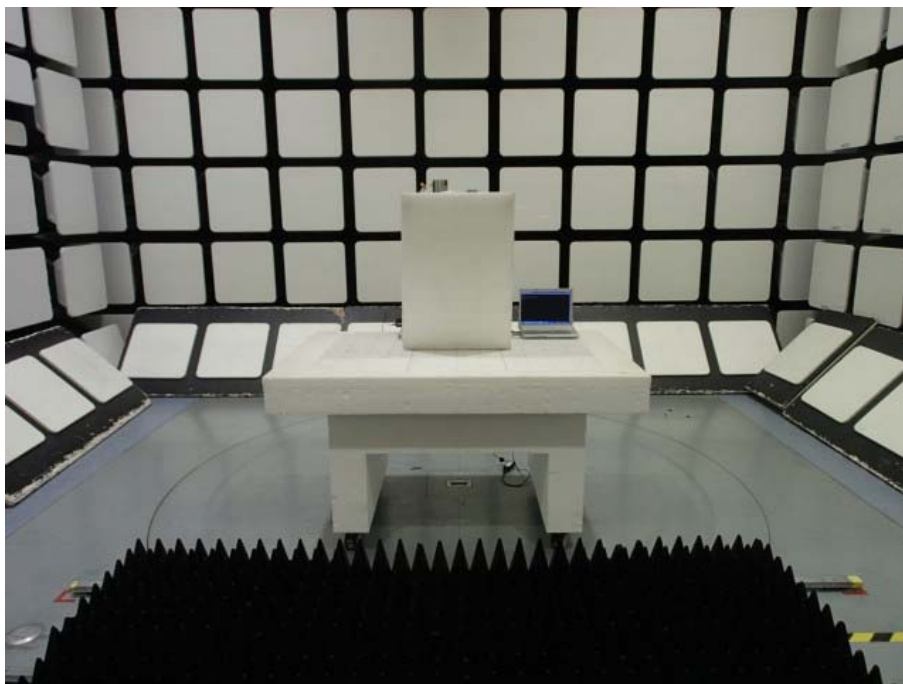
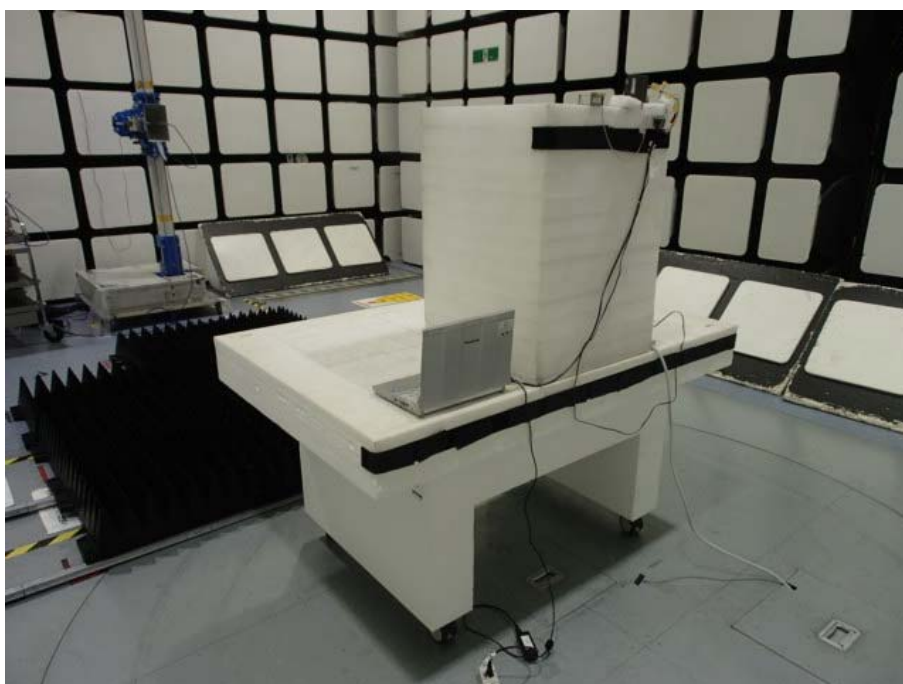
## Radiated Spurious Emission

**Worst Case Position**
