## 6 Photographs of the Test Set-Up

**Prüfbericht - Nr.: CN22AG77 001**  
Test report no.

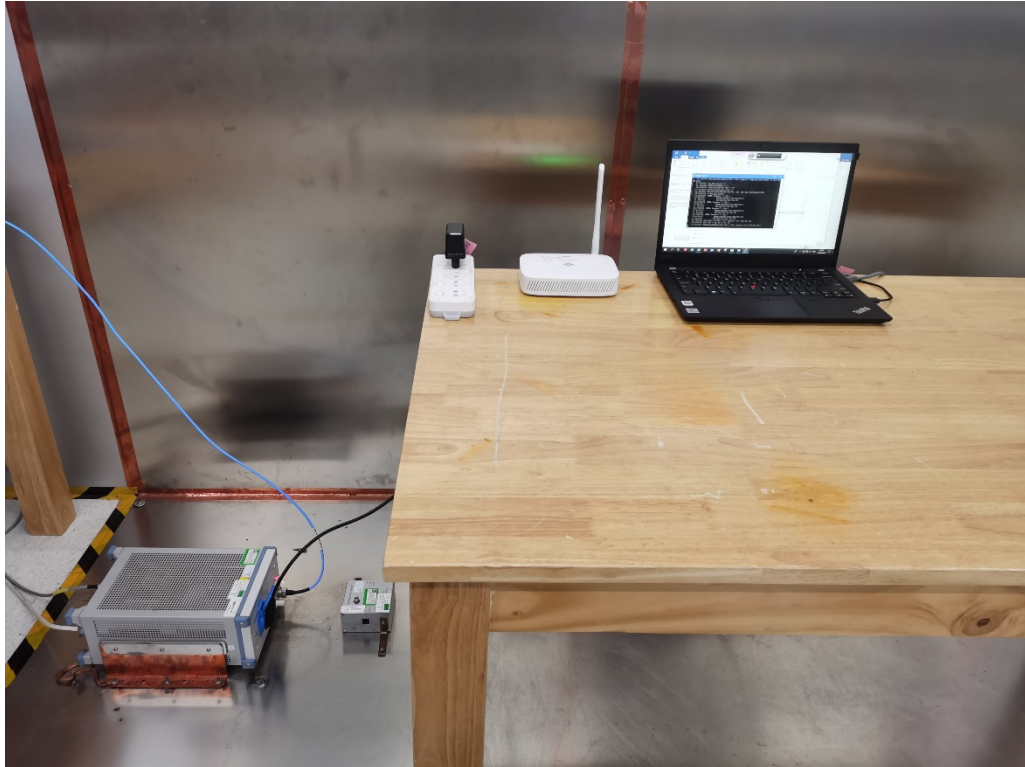
**Photograph 3: Set-up for Conducted Emissions, AC Mains**
