6. Photographs of test setup

The following photographs show the arrangement of the worst case.

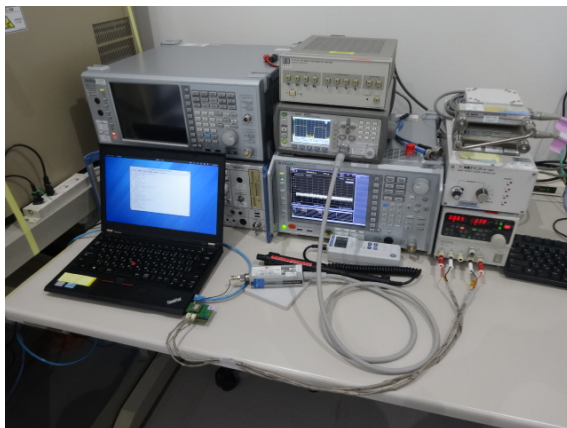
Maximum Peak Conducted Output Power

6.2. Antenna-port Conducted Measurements Photo(s)

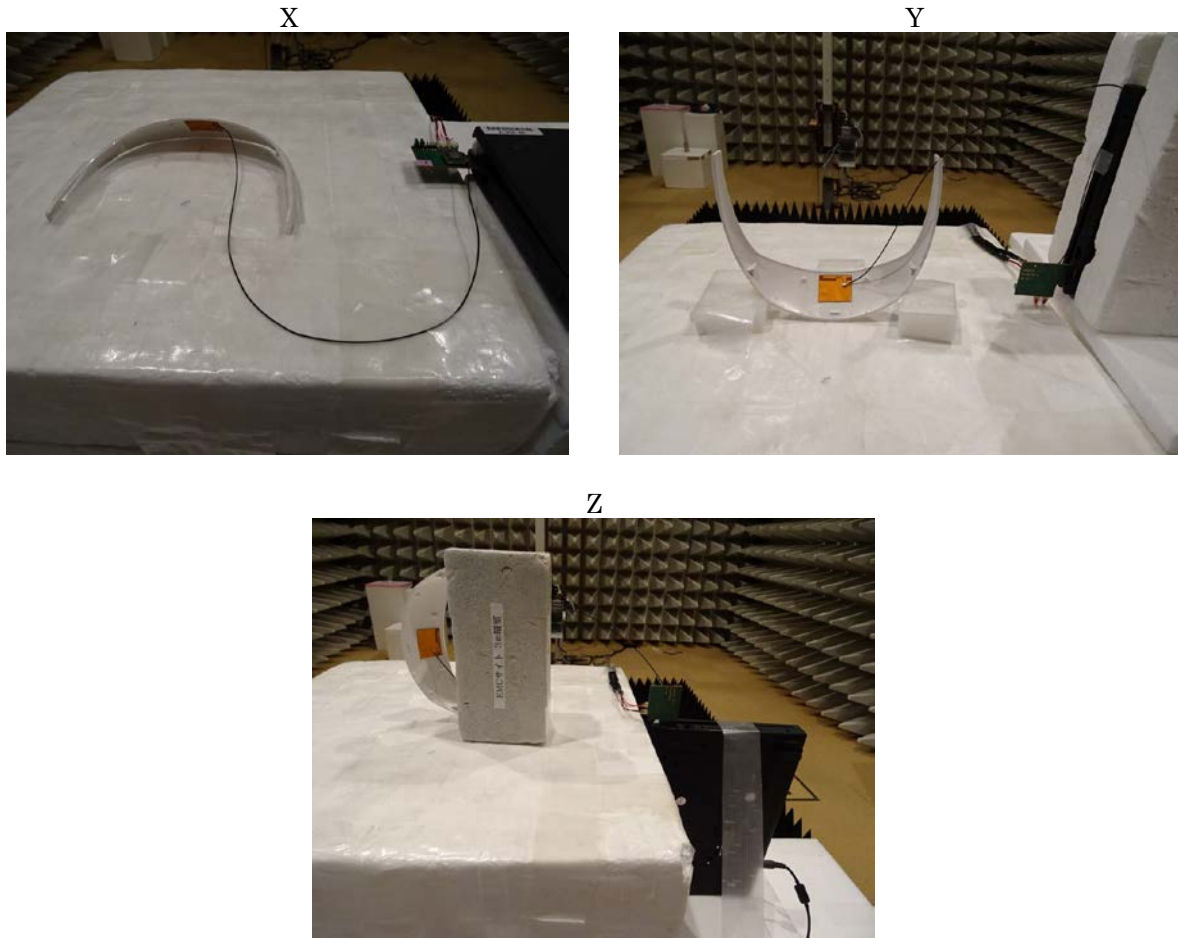
<EUT Axis>

The antenna was tested with attached to supporting jig that does not affect EMC characteristic in order to place for each axis.
