## APPENDIX A: PHOTOGRAPHS OF TEST SETUP

Reference to the test report No. BLA-EMC-202303-A2201

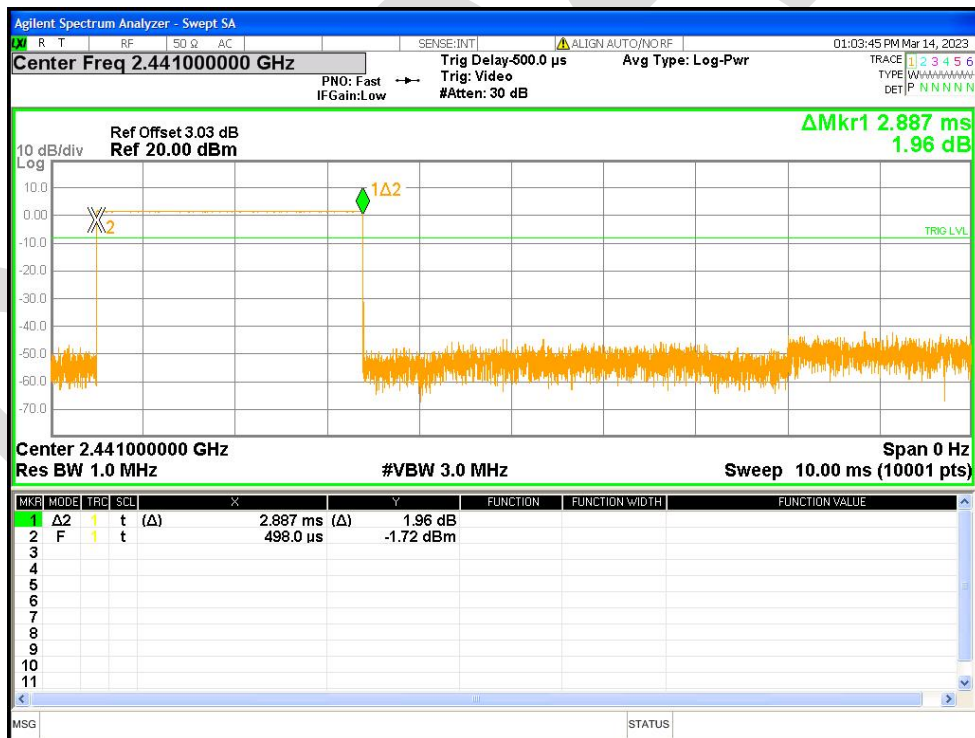
Dwell NVNT 1-DH5 2441MHz Ant1 Accumulated

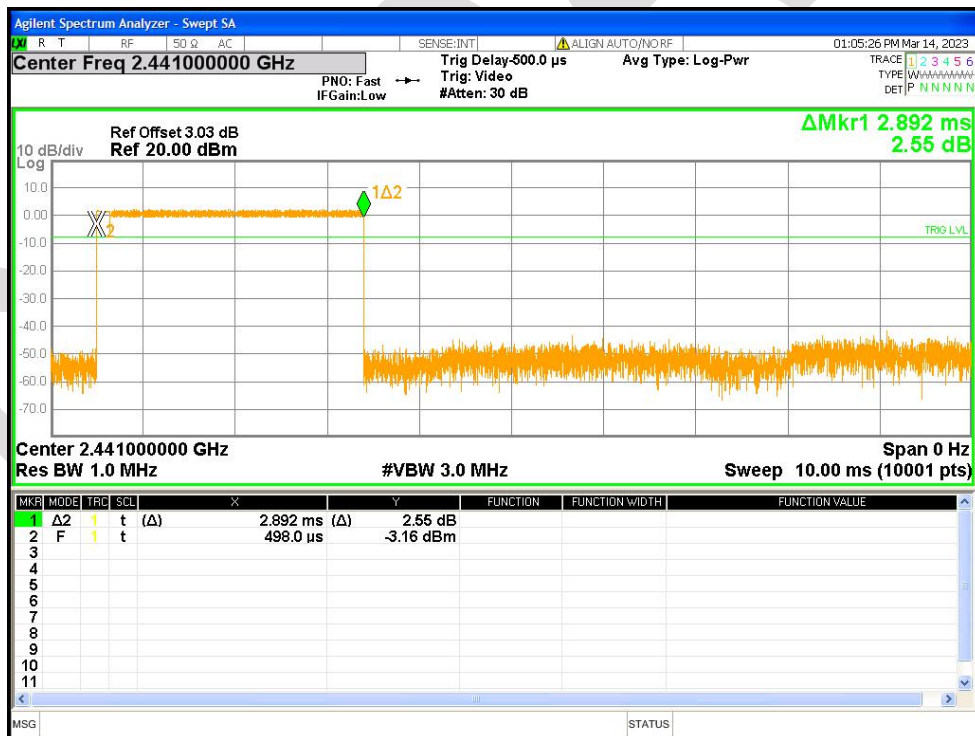
Dwell NVNT 2-DH5 2441MHz Ant1 Accumulated

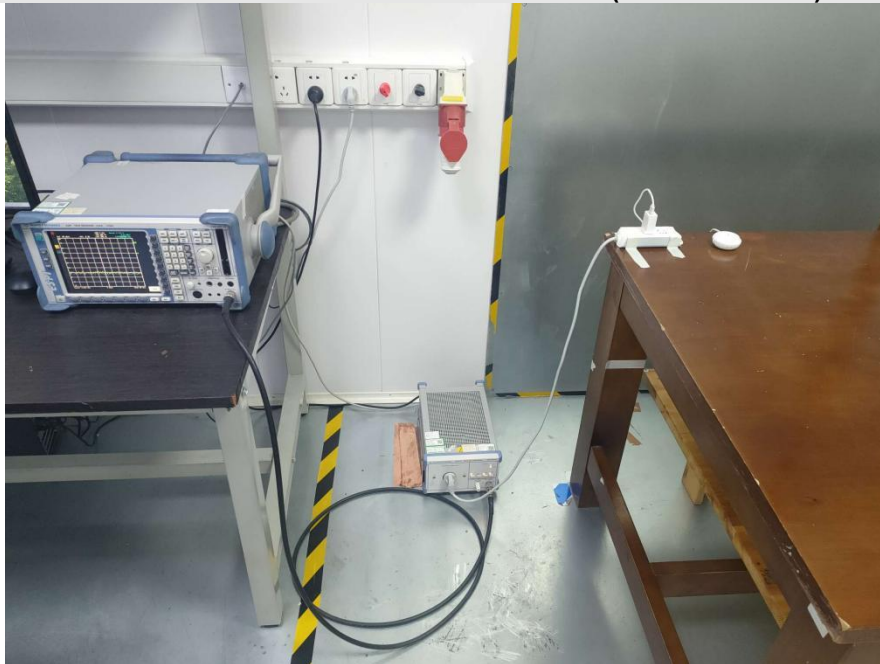
### Conducted Emissions at AC Power Line (150kHz-30MHz)

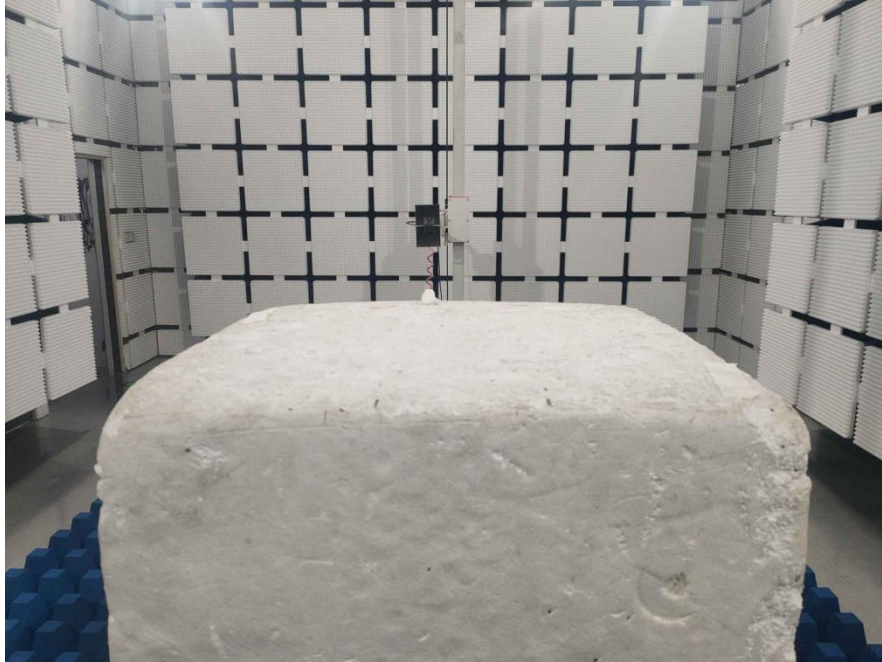
### Radiated Spurious Emissions
