Photos of Link 3 internals front and back with radios and antennas identified.

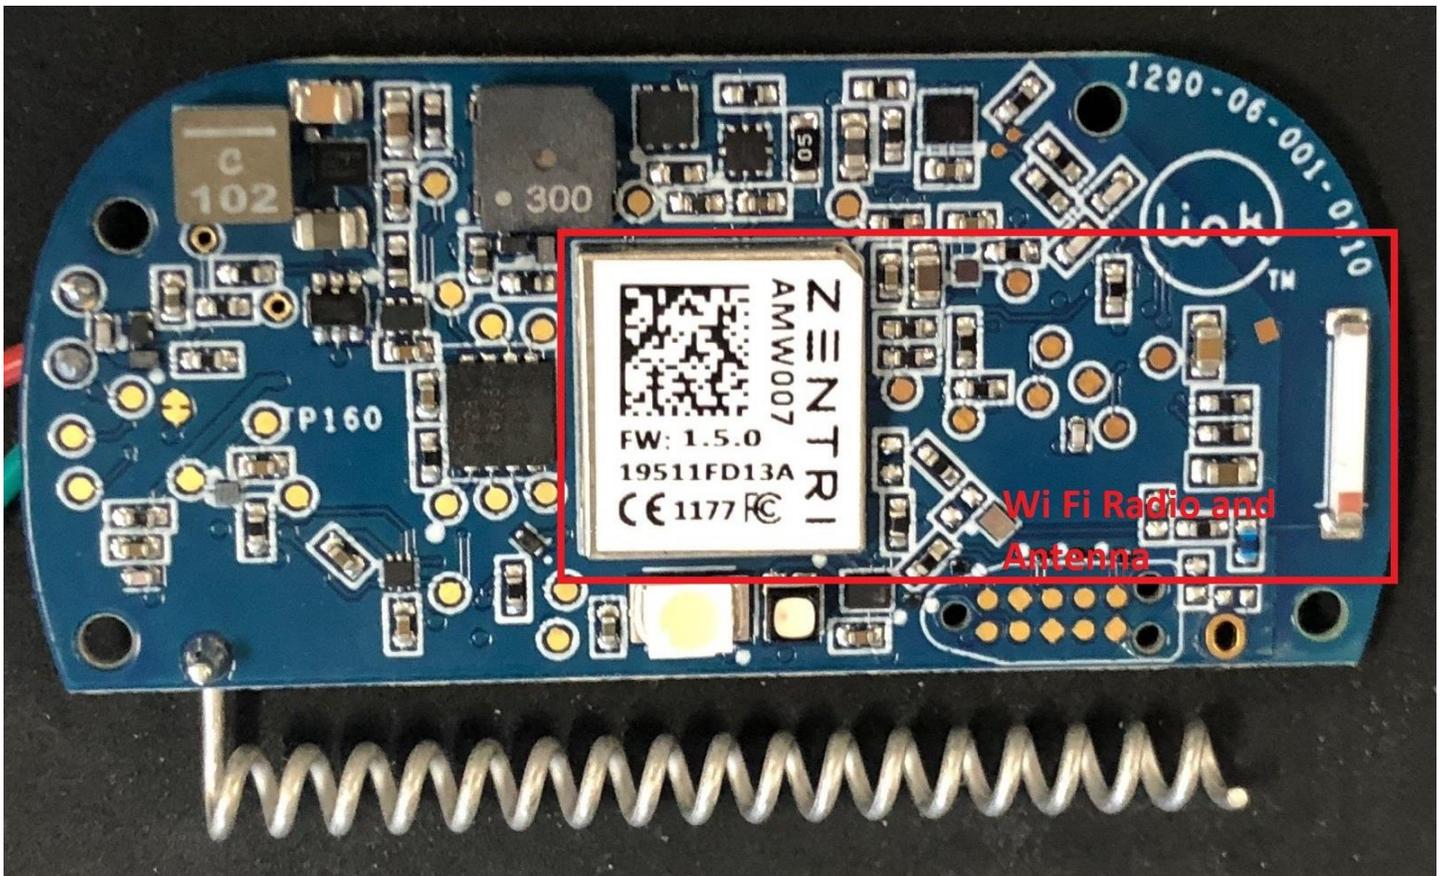
Front side of PCB showing Wi Fi Radio and antenna.

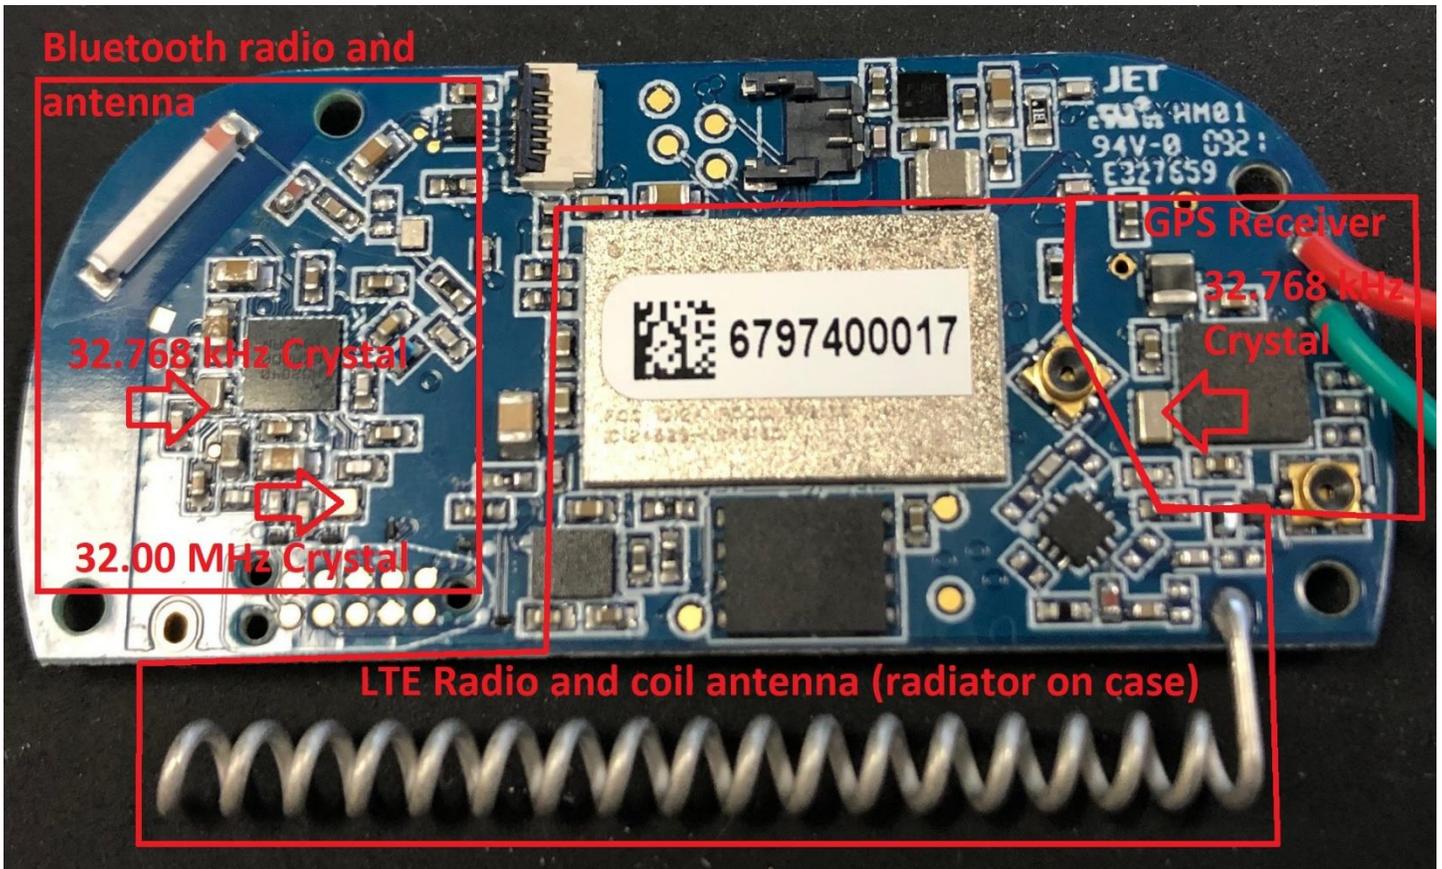
Back of PCB showing Bluetooth, LTE radios and GPS receivers.

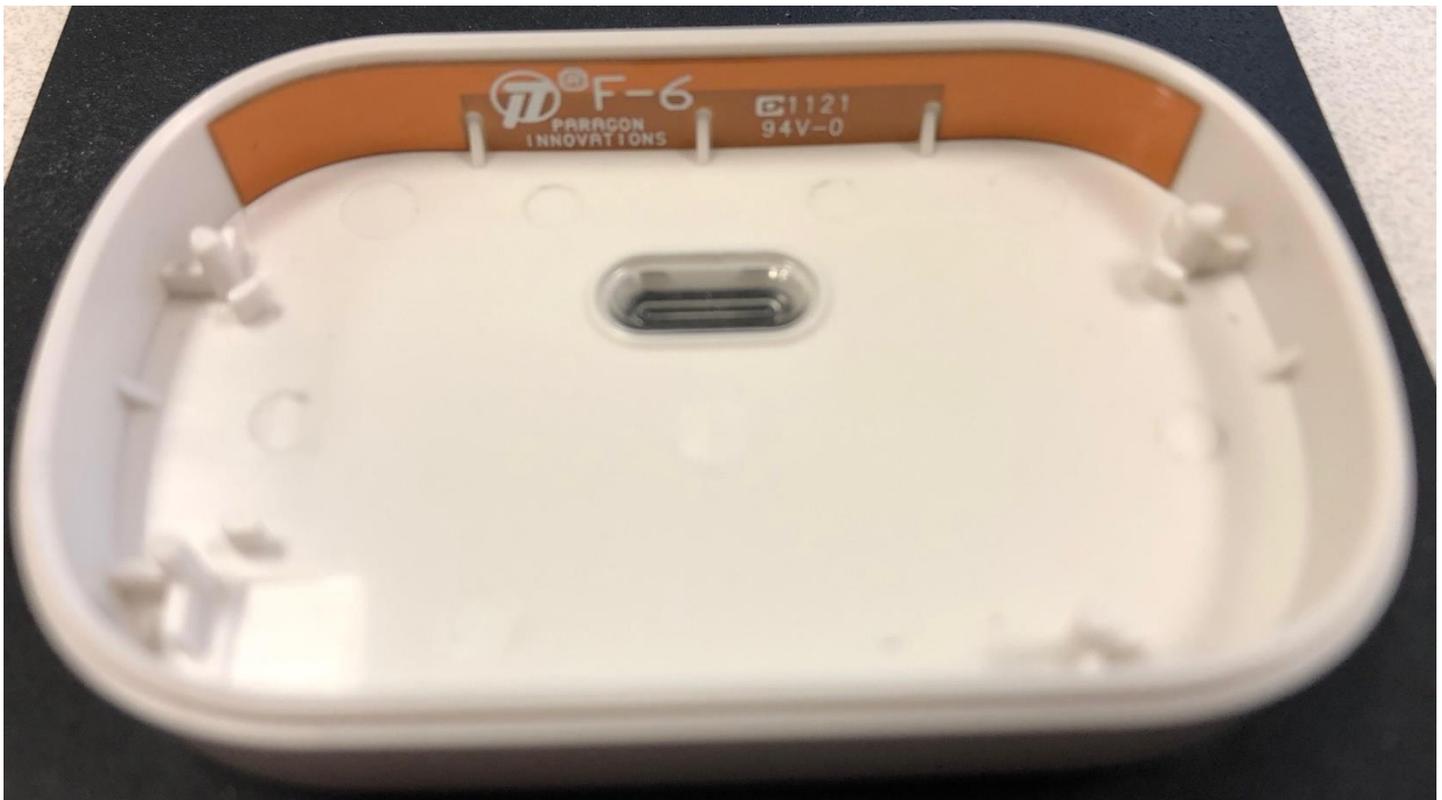
Radiator installed in case.
