8) Internal Photos

Cloud Connector US

Pictures of part 100600 Connector-Main-CPUPower (US)

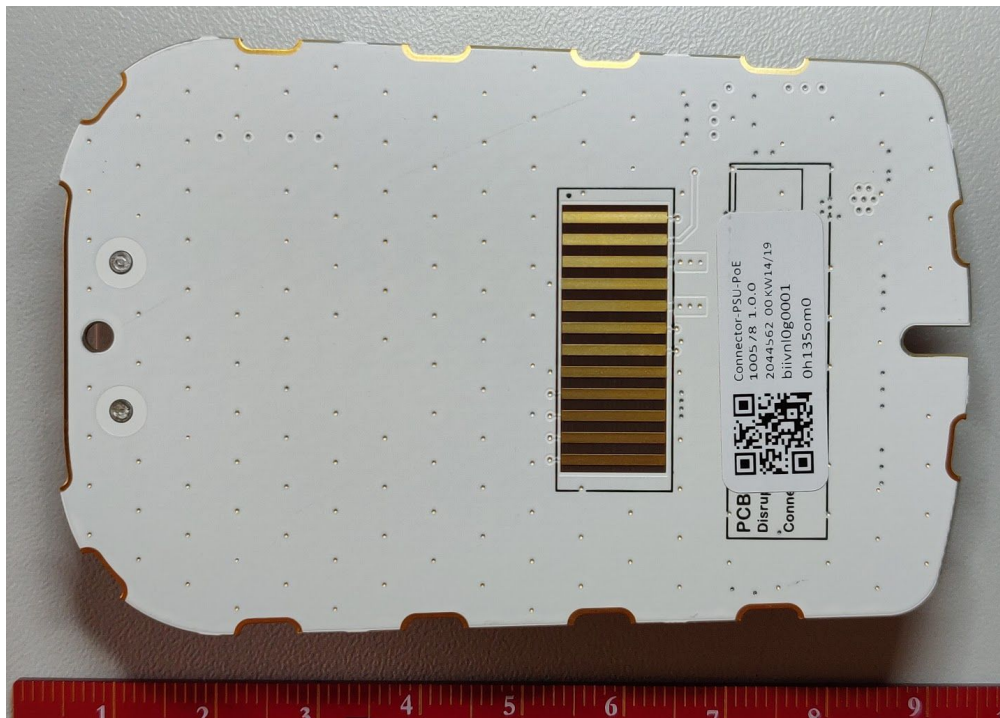
Figure 8: Picture of **top** of PN100578 Connector-PSU-PoE PCBA
