# Radiated Emission Measurement

Condition : FCC\_part 15E RE\_Above 1GHz\_PK

EUT : W6M22311-23090

Test Mode : TX 802.11a CH149

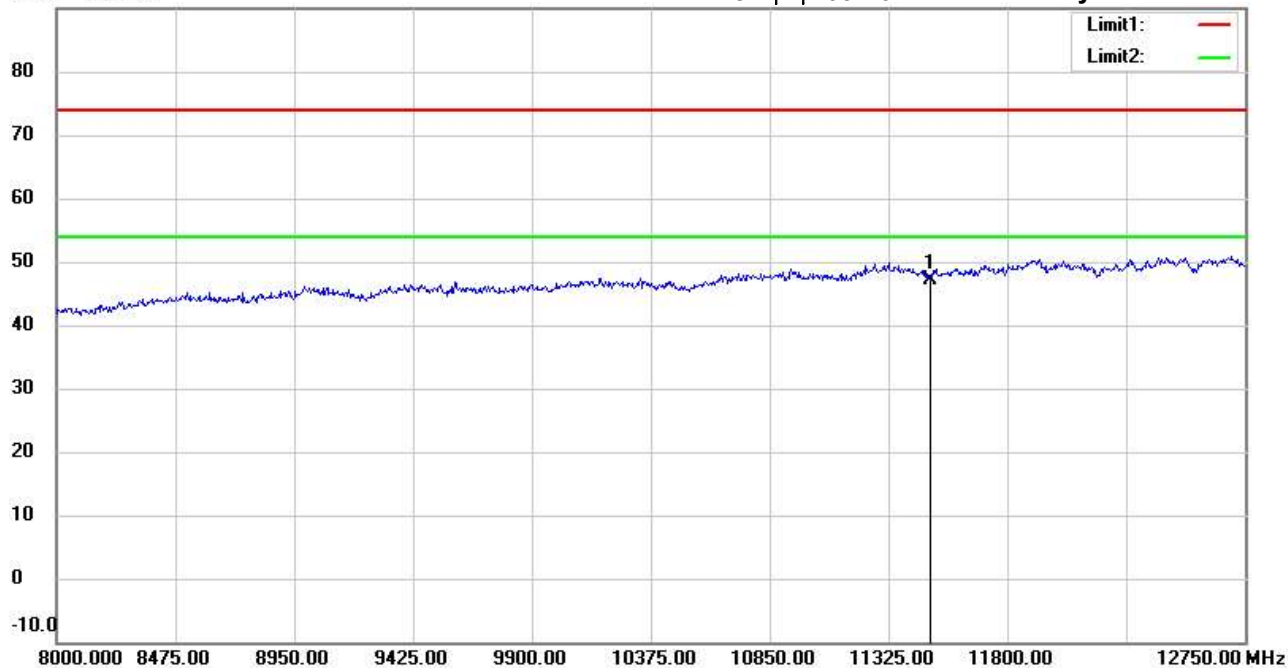
Polarization: **Horizontal**

| Mk. | Frequency (MHz) | Reading (dBuV) | Detector | Corr. factor (dB/m) | Result (dBuV/m) | Limit (dBuV/m) | Ant.Pos (cm) | Tab.Pos (deg.) | Margin (dB) | Comment |
|---|---|---|---|---|---|---|---|---|---|---|
| * | 11490.000 | 30.78 | peak | 16.42 | 47.20 | 74.00 | 150 | 317 | -26.80 | |

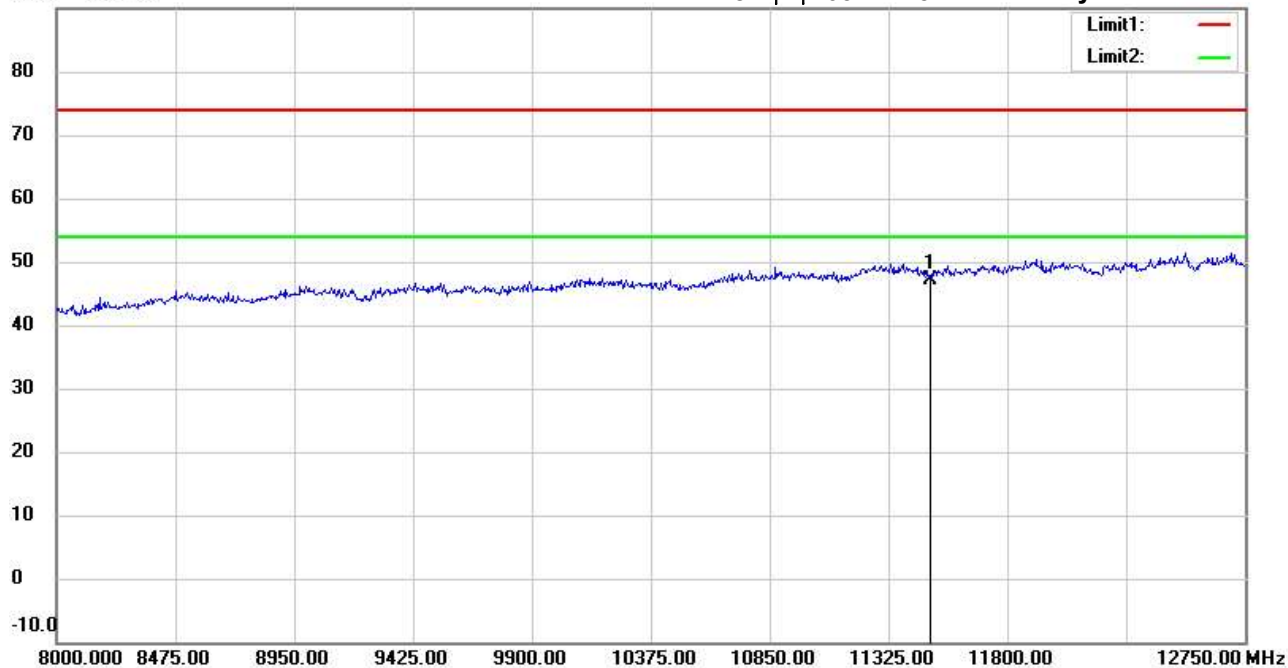
Test Mode : TX 802.11a CH149

Polarization: Vertical

| Mk. | Frequency (MHz) | Reading (dBuV) | Detector | Corr. factor (dB/m) | Result (dBuV/m) | Limit (dBuV/m) | Ant.Pos (cm) | Tab.Pos (deg.) | Margin (dB) | Comment |
|---|---|---|---|---|---|---|---|---|---|---|
| * | 11490.000 | 30.72 | peak | 16.42 | 47.14 | 74.00 | 150 | 187 | -26.86 | |

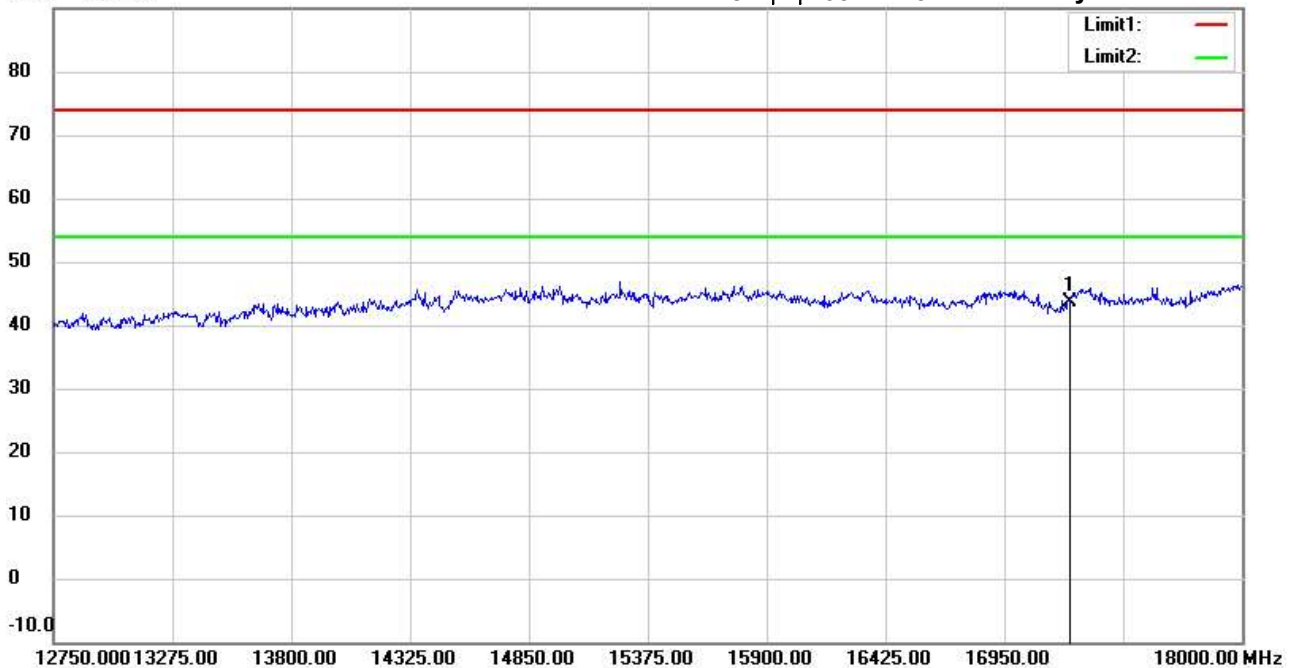
Test Mode : TX 802.11a CH149

Polarization: **Horizontal**

| Mk. | Frequency (MHz) | Reading (dBuV) | Detector | Corr. factor (dB/m) | Result (dBuV/m) | Limit (dBuV/m) | Ant.Pos (cm) | Tab.Pos (deg.) | Margin (dB) | Comment |
|---|---|---|---|---|---|---|---|---|---|---|
| * | 17235.000 | 19.85 | peak | 23.74 | 43.59 | 74.00 | 150 | 336 | -30.41 | |

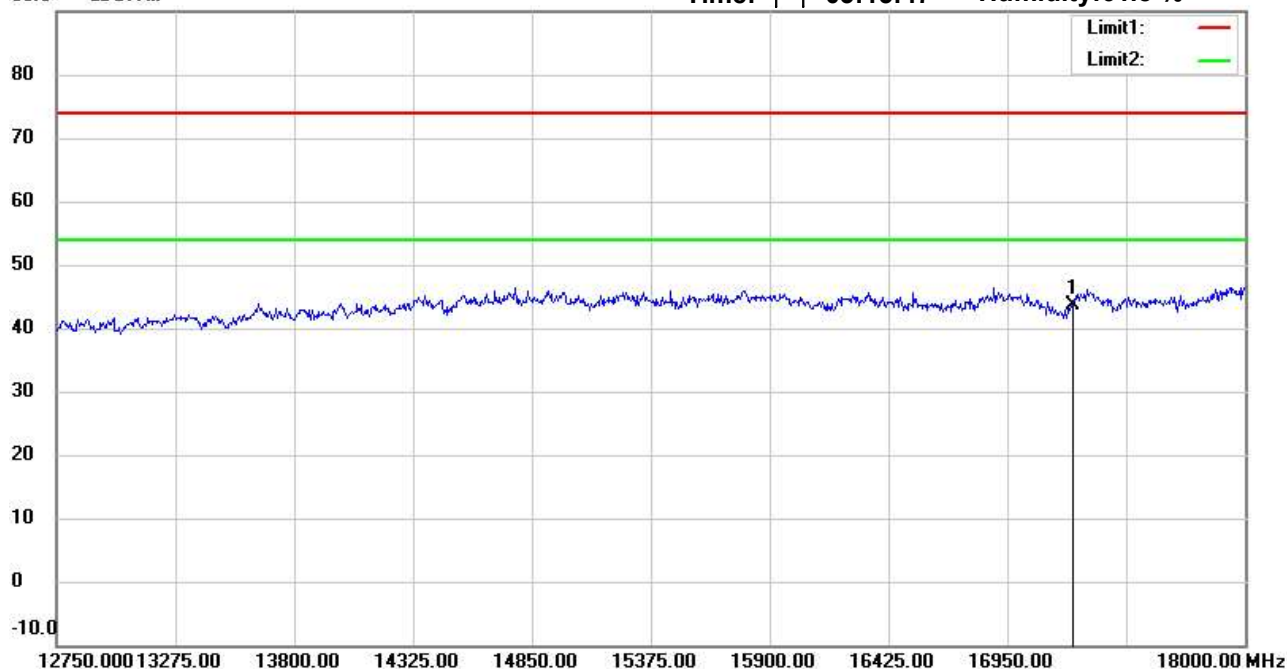
Test Mode : TX 802.11a CH149

Polarization: Vertical

| Mk. | Frequency (MHz) | Reading (dBuV) | Detector | Corr. factor (dB/m) | Result (dBuV/m) | Limit (dBuV/m) | Ant.Pos (cm) | Tab.Pos (deg.) | Margin (dB) | Comment |
|---|---|---|---|---|---|---|---|---|---|---|
| * | 17235.000 | 19.80 | peak | 23.74 | 43.54 | 74.00 | 150 | 28 | -30.46 | |

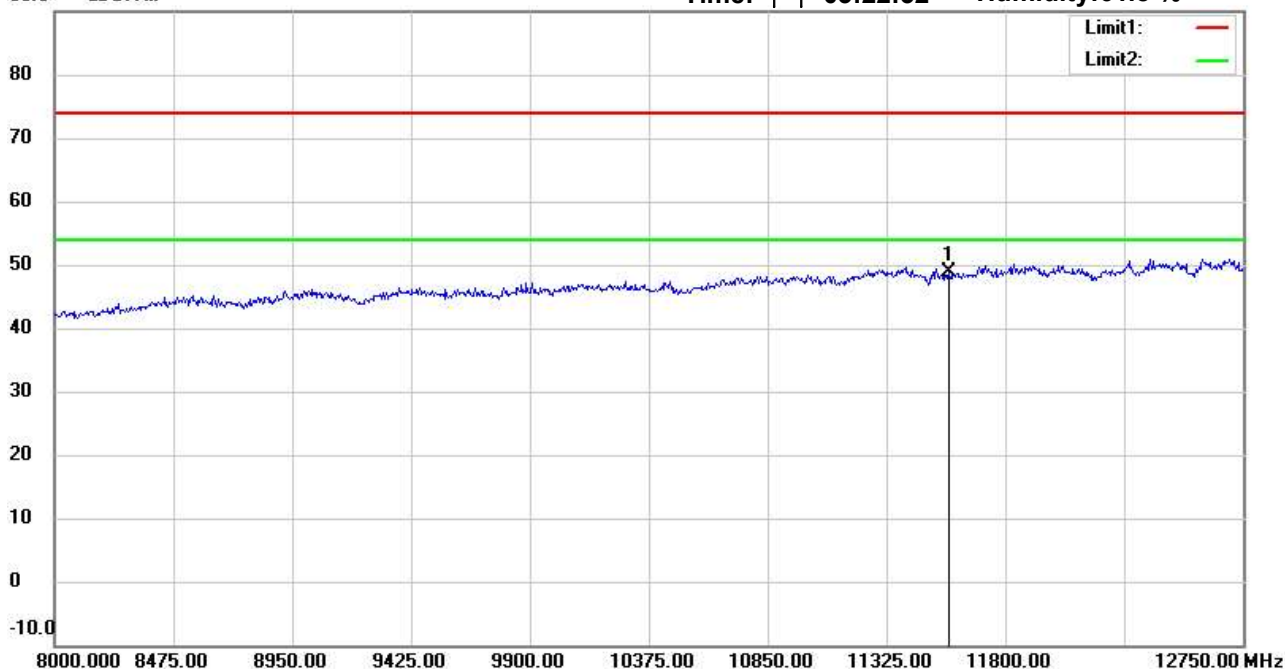
Test Mode : TX 802.11a CH157

Polarization: **Horizontal**

| Mk. | Frequency (MHz) | Reading (dBuV) | Detector | Corr. factor (dB/m) | Result (dBuV/m) | Limit (dBuV/m) | Ant.Pos (cm) | Tab.Pos (deg.) | Margin (dB) | Comment |
|---|---|---|---|---|---|---|---|---|---|---|
| * | 11570.000 | 32.30 | peak | 16.60 | 48.90 | 74.00 | 150 | 94 | -25.10 | |

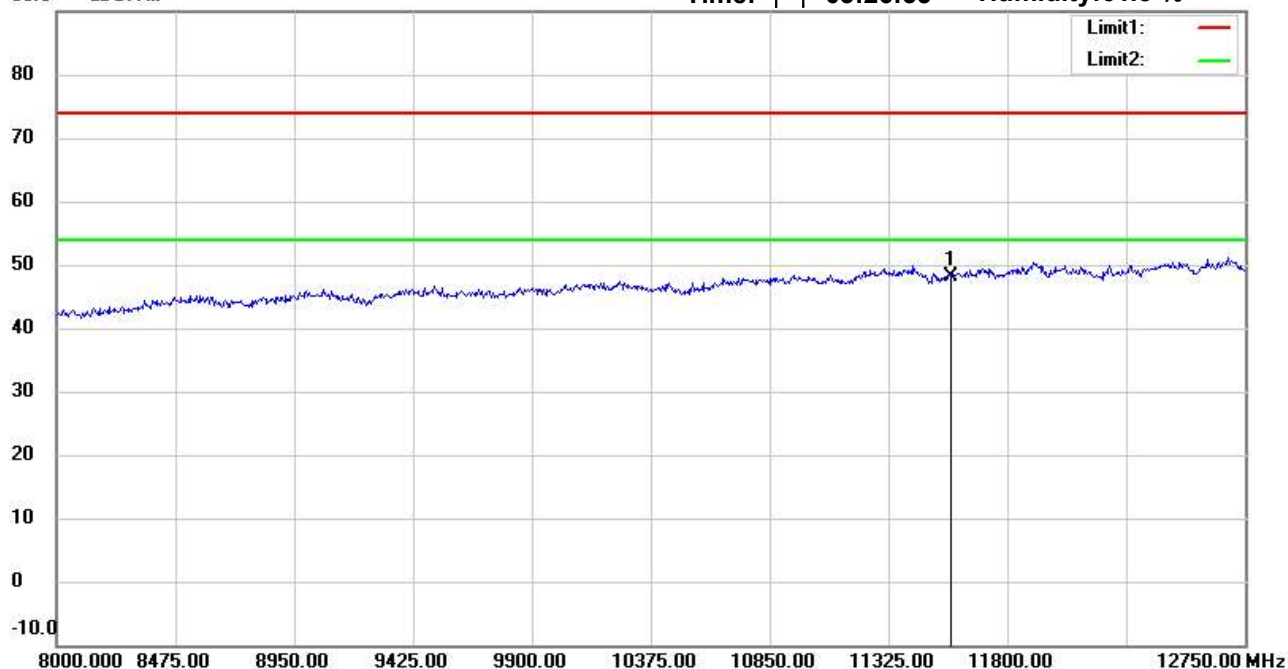
Test Mode : TX 802.11a CH157

Polarization: Vertical

| Mk. | Frequency (MHz) | Reading (dBuV) | Detector | Corr. factor (dB/m) | Result (dBuV/m) | Limit (dBuV/m) | Ant.Pos (cm) | Tab.Pos (deg.) | Margin (dB) | Comment |
|---|---|---|---|---|---|---|---|---|---|---|
| * | 11570.000 | 31.52 | peak | 16.60 | 48.12 | 74.00 | 150 | 11 | -25.88 | |

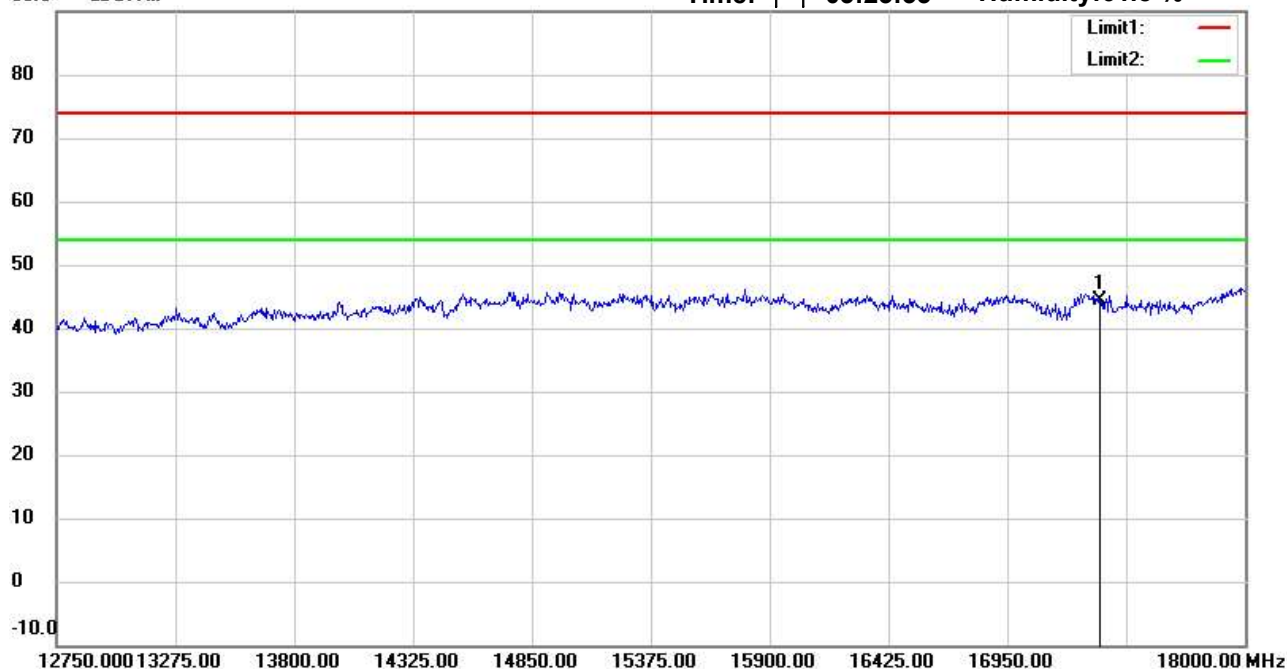
Test Mode : TX 802.11a CH157

Polarization: Horizontal

| Mk. | Frequency (MHz) | Reading (dBuV) | Detector | Corr. factor (dB/m) | Result (dBuV/m) | Limit (dBuV/m) | Ant.Pos (cm) | Tab.Pos (deg.) | Margin (dB) | Comment |
|---|---|---|---|---|---|---|---|---|---|---|
| * | 17355.000 | 20.36 | peak | 23.97 | 44.33 | 74.00 | 1520 | 84 | -29.67 | |

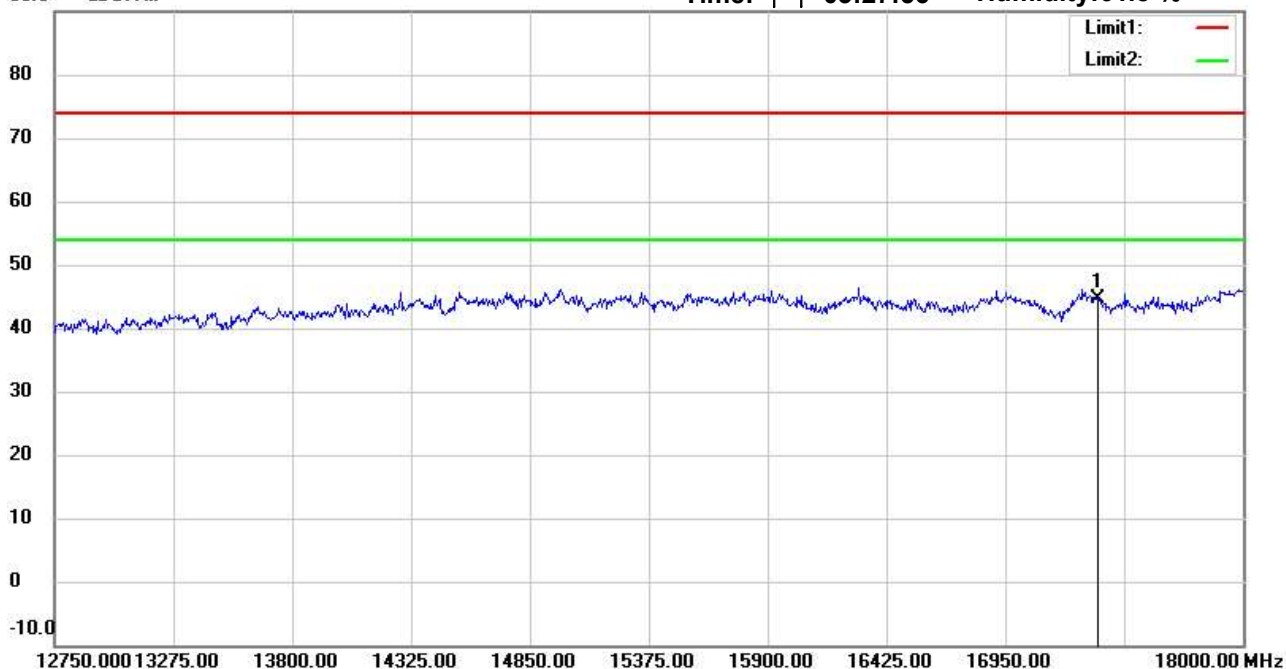
Test Mode : TX 802.11a CH157

Polarization: **Vertical**

| Mk. | Frequency (MHz) | Reading (dBuV) | Detector | Corr. factor (dB/m) | Result (dBuV/m) | Limit (dBuV/m) | Ant.Pos (cm) | Tab.Pos (deg.) | Margin (dB) | Comment |
|---|---|---|---|---|---|---|---|---|---|---|
| * | 17355.000 | 20.60 | peak | 23.97 | 44.57 | 74.00 | 150 | 37 | -29.43 | |

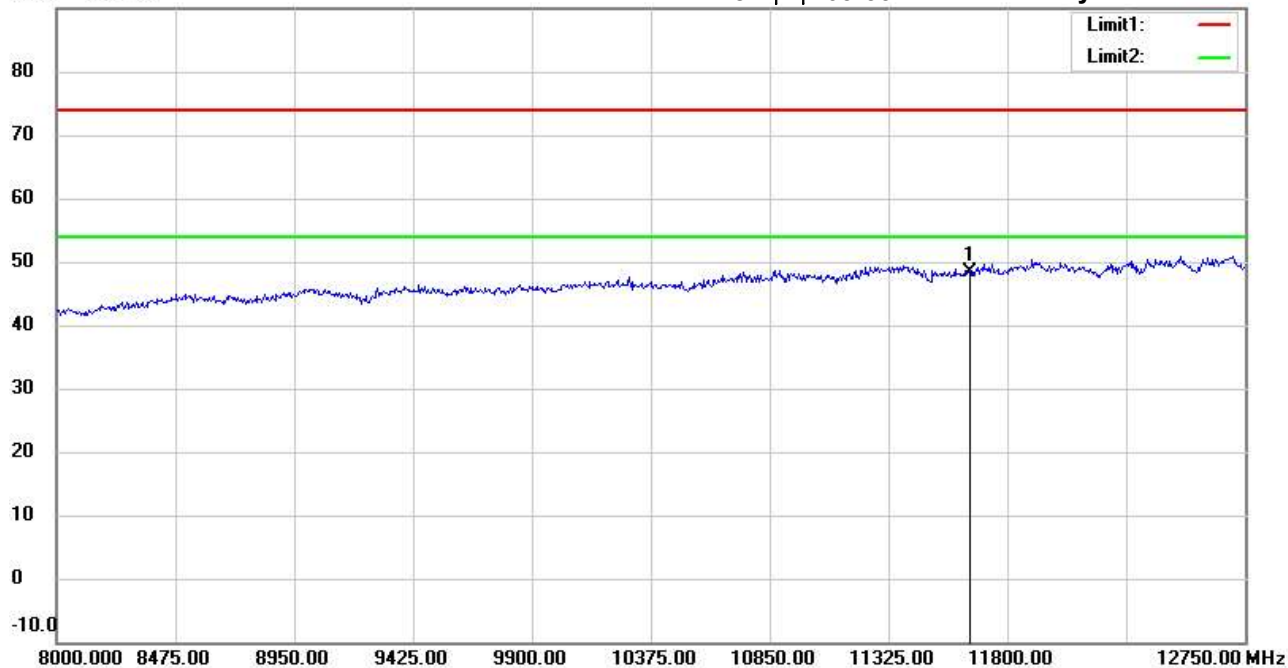
Test Mode : TX 802.11a CH165

Polarization: **Horizontal**

| Mk. | Frequency (MHz) | Reading (dBuV) | Detector | Corr. factor (dB/m) | Result (dBuV/m) | Limit (dBuV/m) | Ant.Pos (cm) | Tab.Pos (deg.) | Margin (dB) | Comment |
|---|---|---|---|---|---|---|---|---|---|---|
| * | 11650.000 | 31.79 | peak | 16.48 | 48.27 | 74.00 | 150 | 322 | -25.73 | |

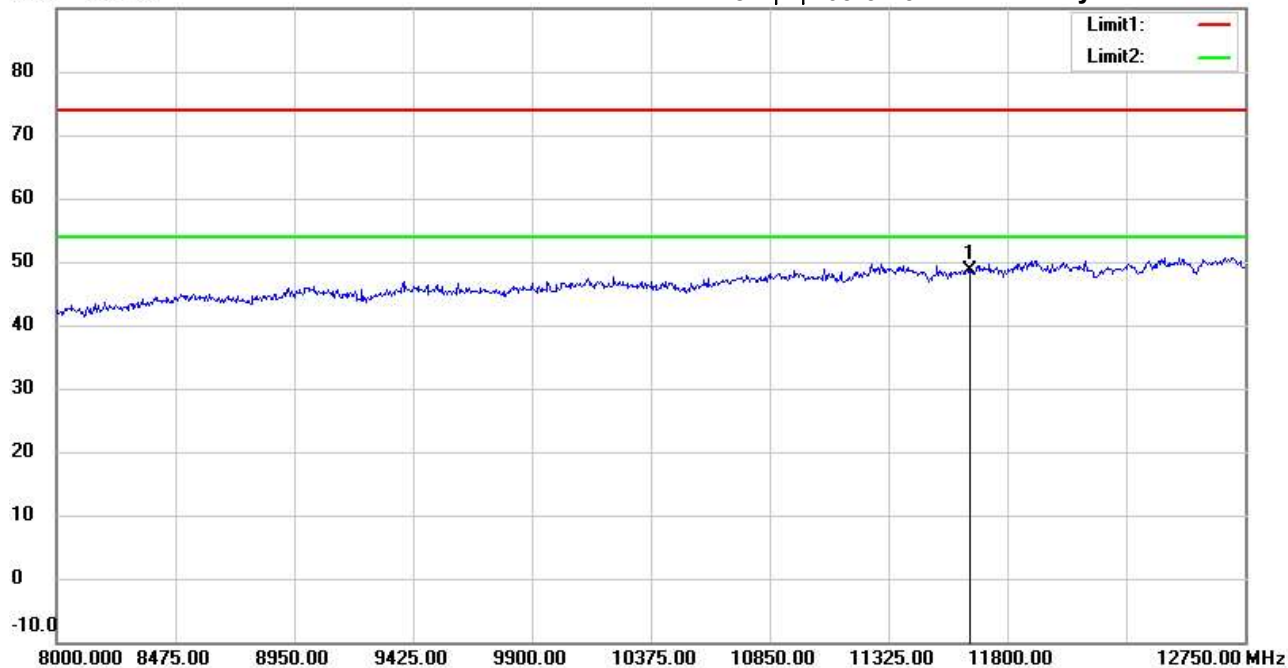
Test Mode : TX 802.11a CH165

Polarization: Vertical

| Mk. | Frequency (MHz) | Reading (dBuV) | Detector | Corr. factor (dB/m) | Result (dBuV/m) | Limit (dBuV/m) | Ant.Pos (cm) | Tab.Pos (deg.) | Margin (dB) | Comment |
|---|---|---|---|---|---|---|---|---|---|---|
| * | 11650.000 | 32.25 | peak | 16.48 | 48.73 | 74.00 | 150 | 248 | -25.27 | |

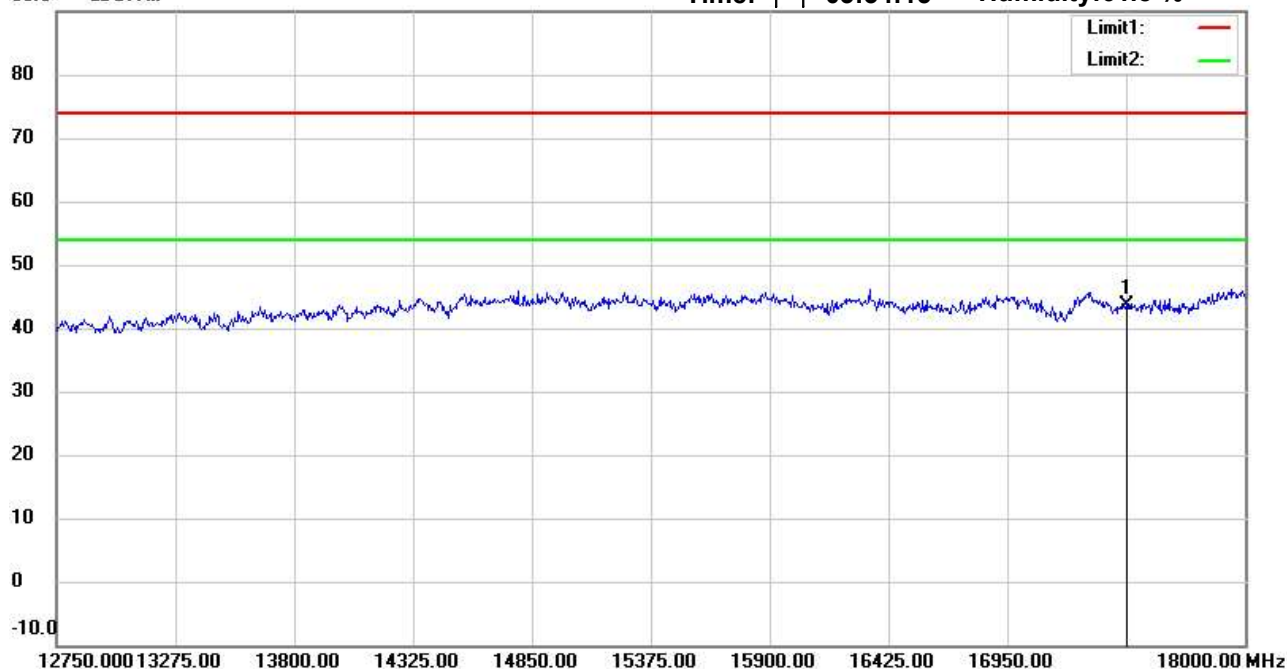
Test Mode : TX 802.11a CH165

Polarization: **Horizontal**

| Mk. | Frequency (MHz) | Reading (dBuV) | Detector | Corr. factor (dB/m) | Result (dBuV/m) | Limit (dBuV/m) | Ant.Pos (cm) | Tab.Pos (deg.) | Margin (dB) | Comment |
|---|---|---|---|---|---|---|---|---|---|---|
| * | 17475.000 | 20.54 | peak | 23.21 | 43.75 | 74.00 | 150 | 307 | -30.25 | |
