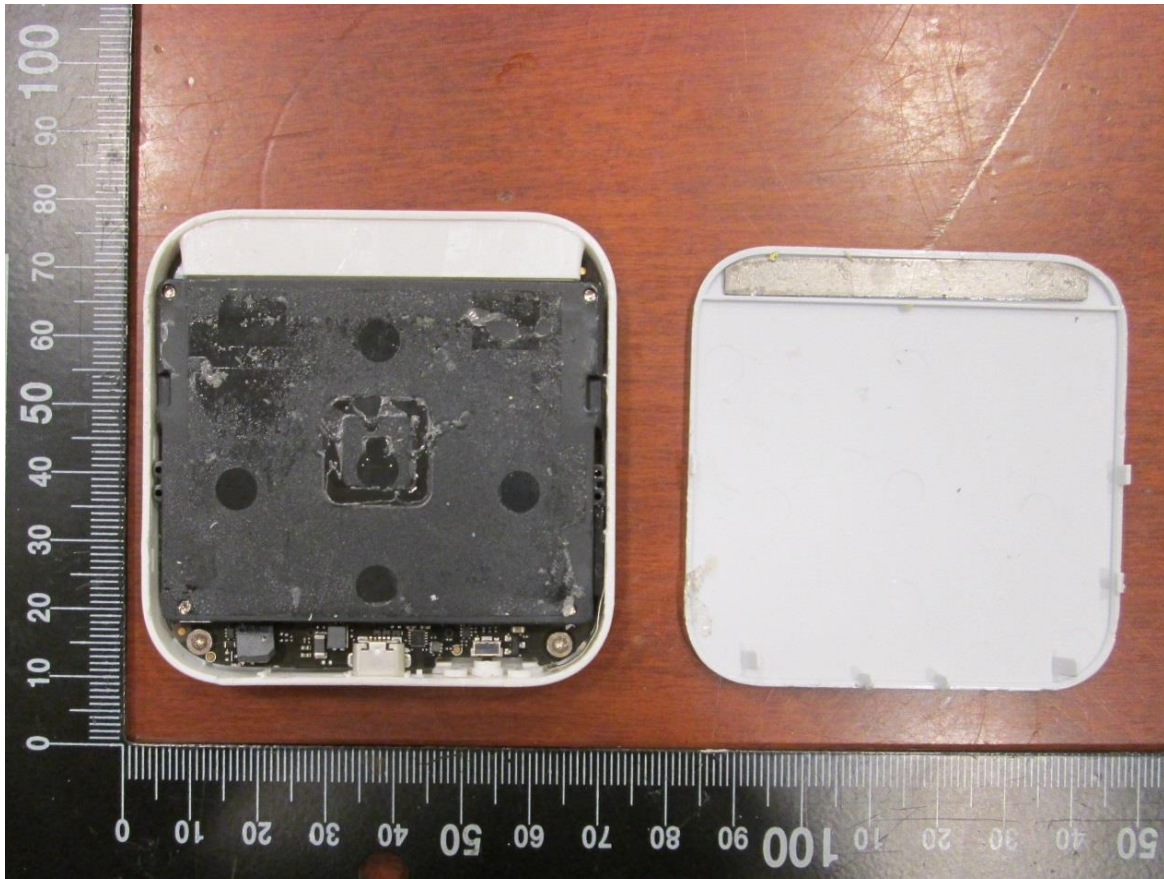
EUT – Internal view 1
Back cover removed.

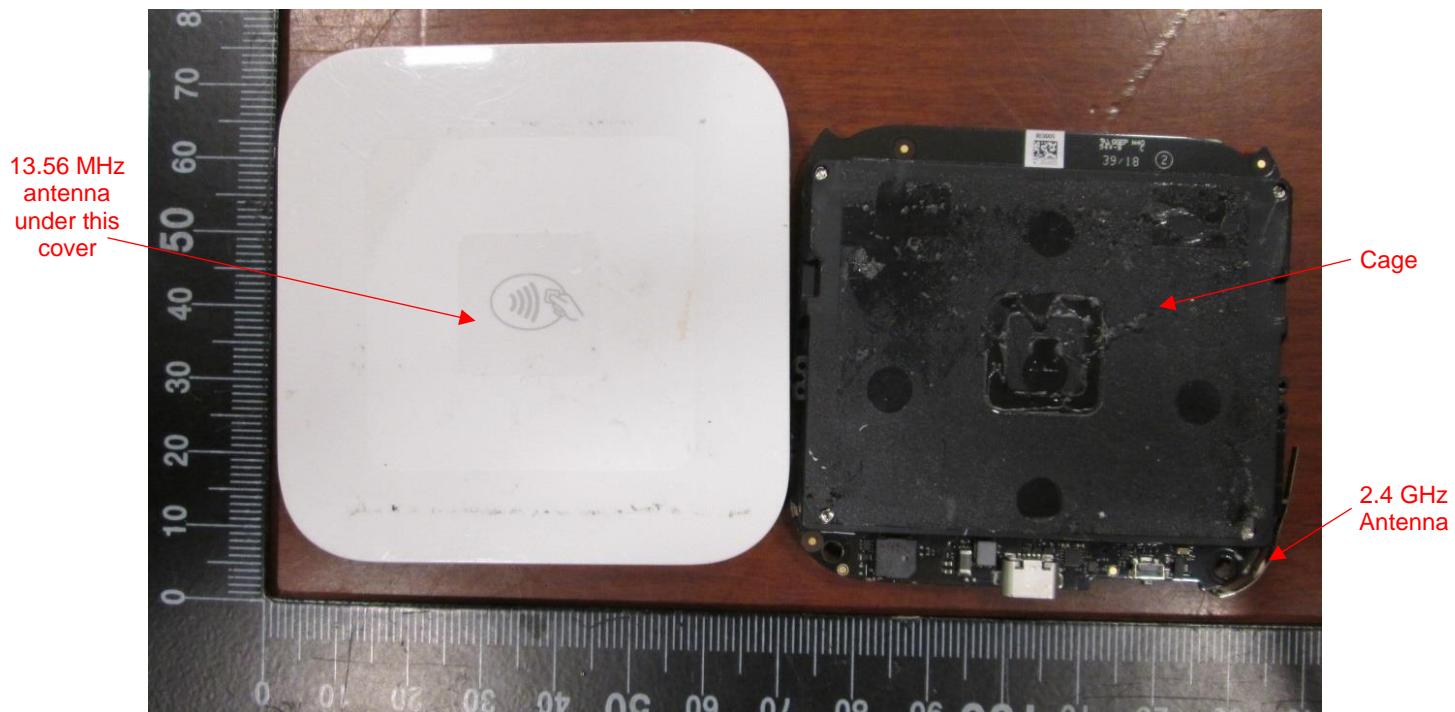
EUT – Internal view 2
PCB removed from enclosure

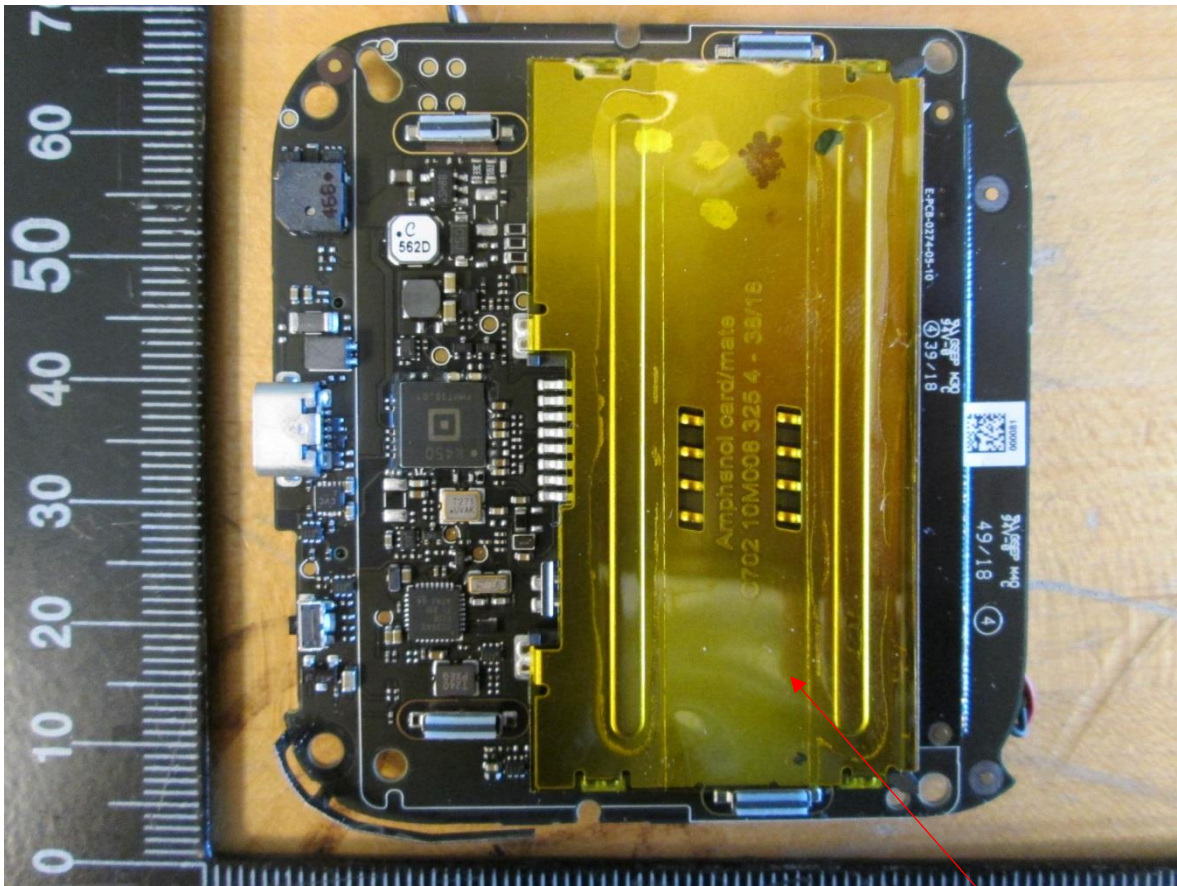
EUT – Internal view 5
Close-up of PCB side 1, alternate view

Contact card socket
soldered directly onto the
PCB. Not a shield. No
components under this part.
