## 6 Photographs of the Test Set-Up

**Prüfbericht - Nr.: CN223ZEA 001**  
Test report no.

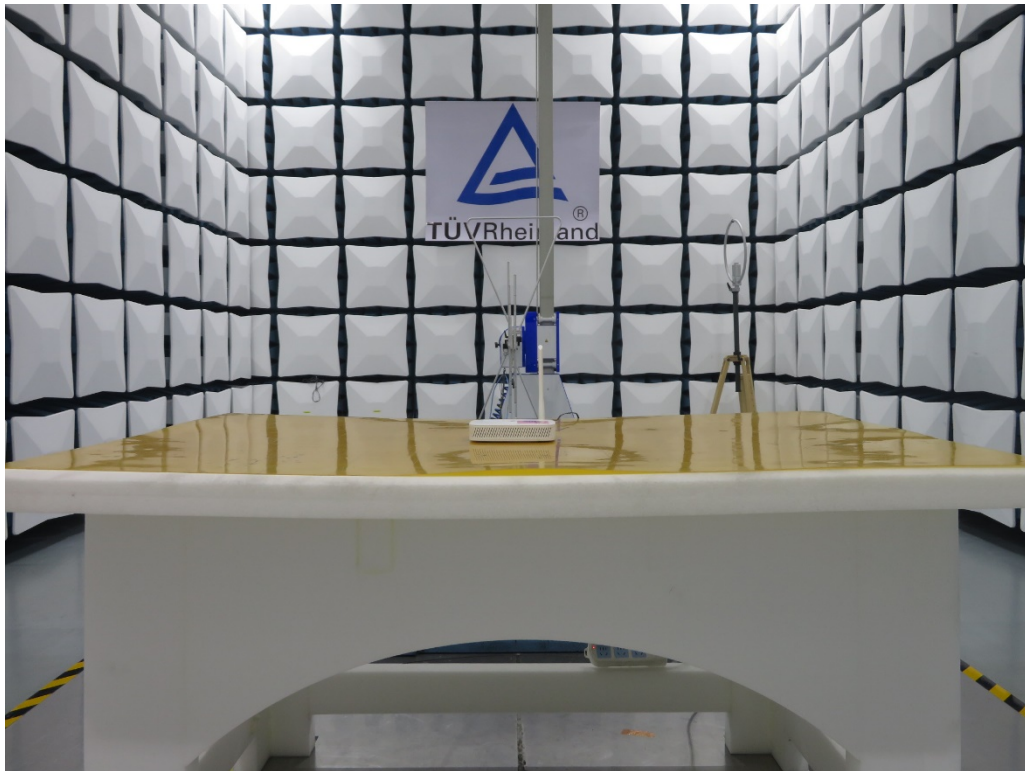
**Photograph 1: Set-up for Co-Located Radiated Spurious Emissions, below 1GHz**

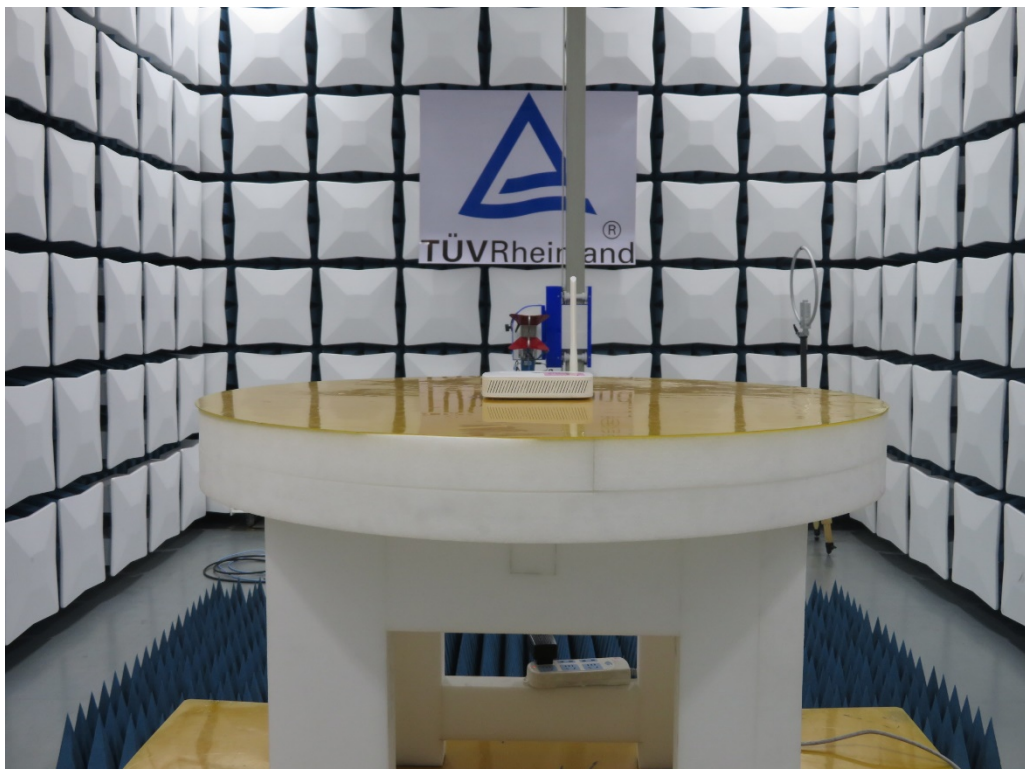
**Photograph 2: Set-up for Co-Located Radiated Spurious Emissions, above 1GHz**

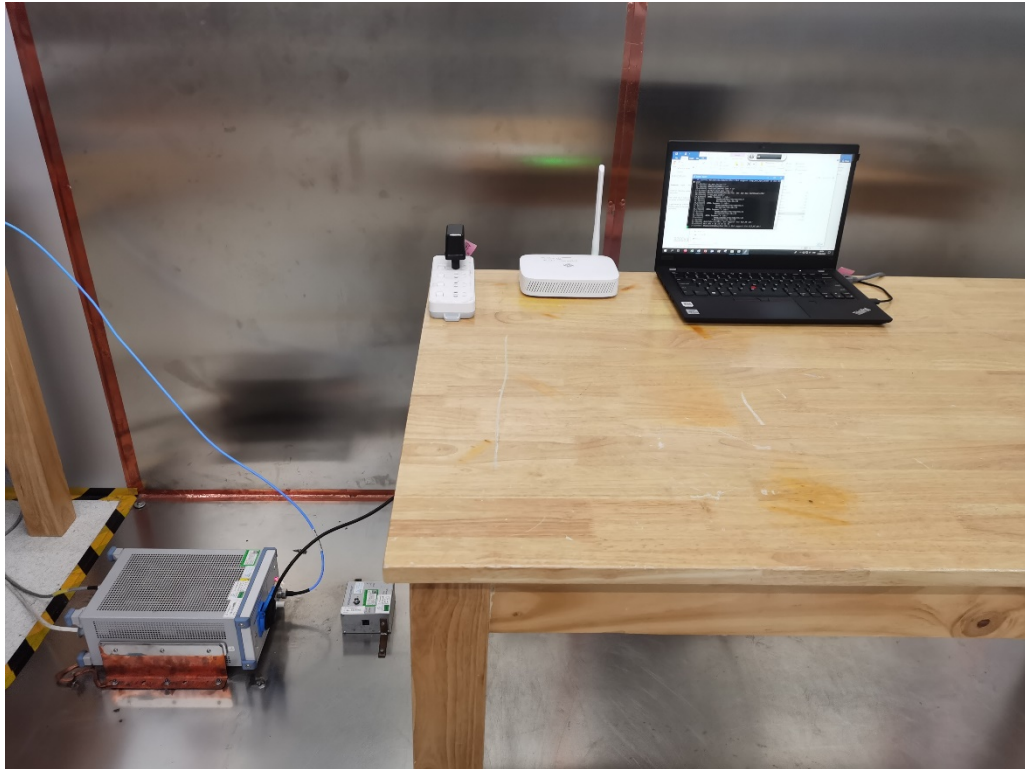
**Photograph 3: Set-up for Conducted Emissions, AC Mains**
