## Band Edge

## APPENDIX: PHOTOGRAPHS OF TEST CONFIGURATION

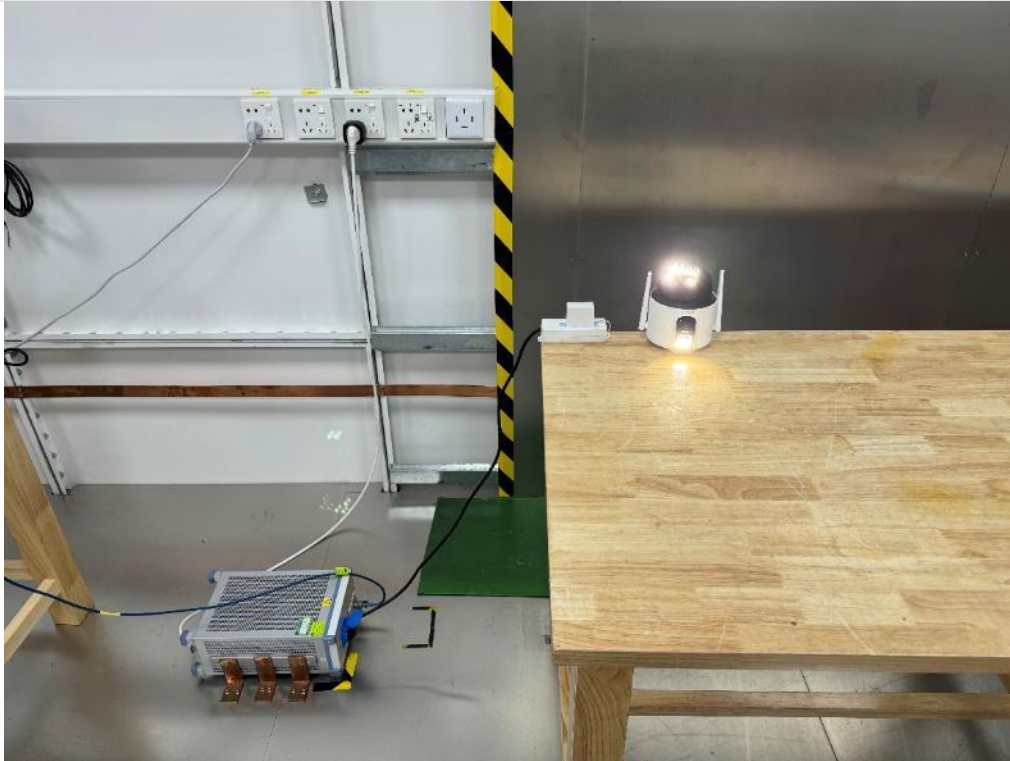
AC Power Line Conducted Emission

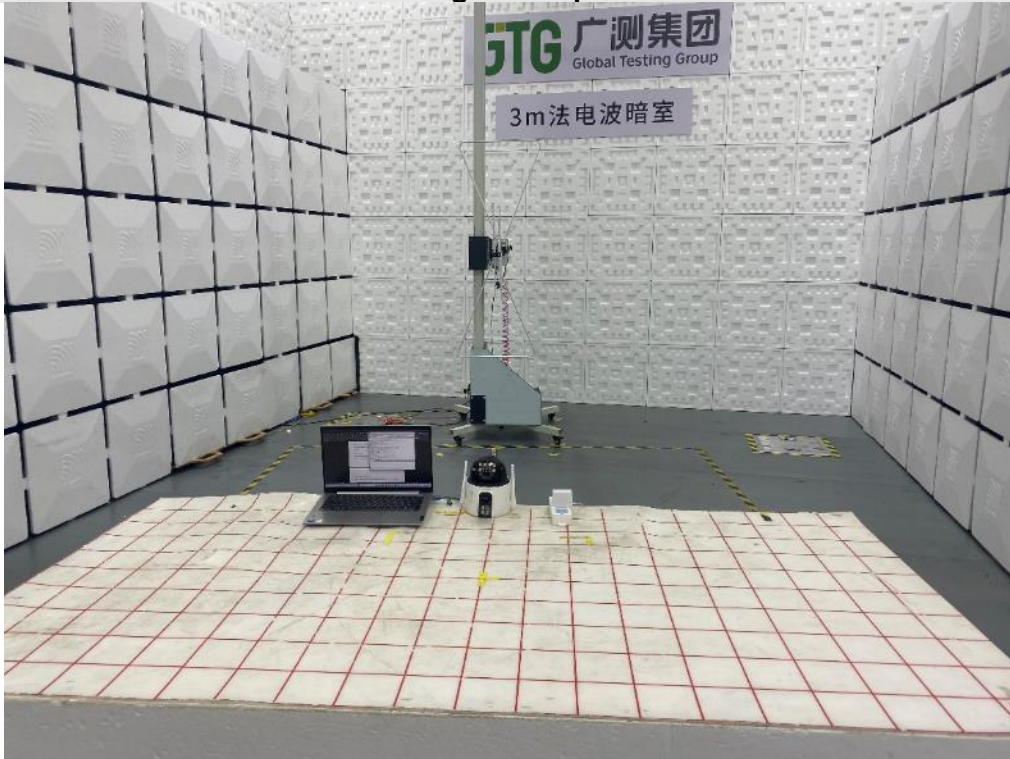
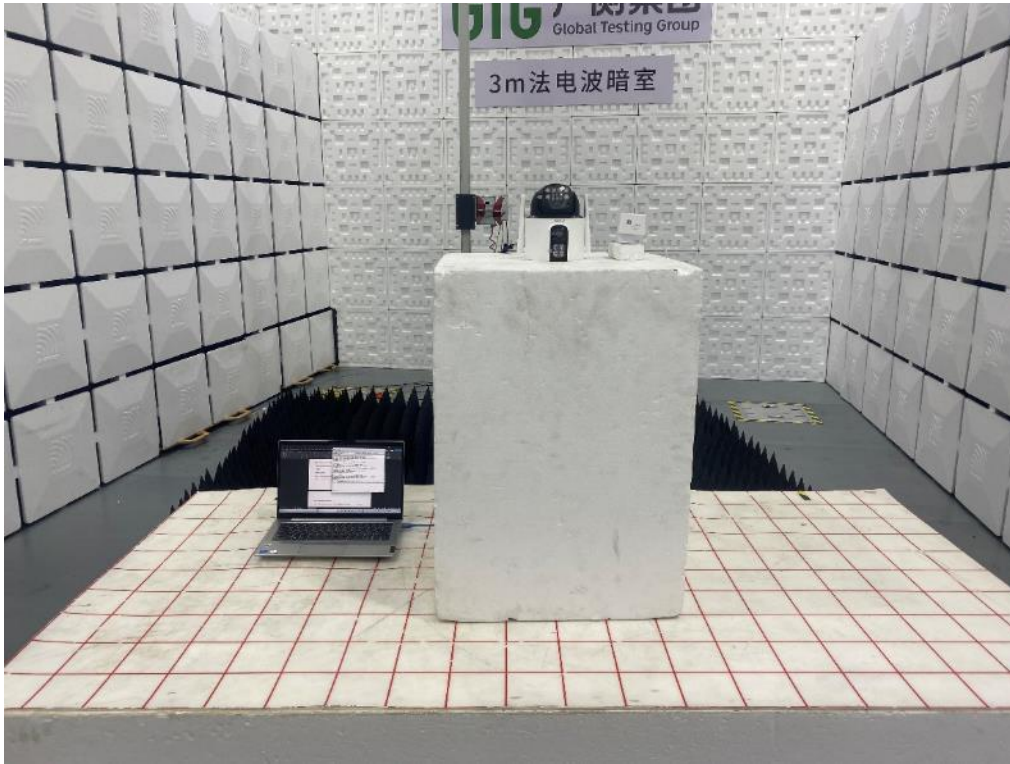
Radiated Band edge and Spurious Emission
