Setup photos for HAC RF Emissions and T-Coil Test Report

Test report no.:	HAC_Photo_RM-1085_03	Date of report:	2015-09-04
Template version:	4.0	Number of pages:	3
Testing laboratory:	TCC Microsoft Salo Laboratory P.O.Box 303 Joensuunkatu 7E FIN-24101 SALO, FINLAND Tel. +358 71 800 8000 Fax. +358 71 80 44122	Client:	Microsoft P.O.Box 303 Joensuunkatu 7 FIN-24101 SALO, FINLAND Tel. +358 71 800 8000 Fax. +358 71 80 44122
Responsible test engineer:	Janne Hirsimäki	Product contact person:	Tia Melava
Measurements made by:	Sami Savela		
Tested devices:	RM-1085		
FCC ID:	PYARM-1085	IC:	661X-RM1085
Supplement reports:	RF_RM-1085_01, T-Coil_RM-1085_02		
Testing has been carried out in accordance with:	<p>ANSI C63.19-2011 American National Standard for Methods of Measurement of Compatibility between Wireless Communications Devices and Hearing Aids</p> <p>CTIA Test Plan for Hearing Aid Compatibility, Revision 3.0, November 2013</p>		
Documentation:	The documentation of the testing performed on the tested devices is archived for 15 years at TCC Microsoft.

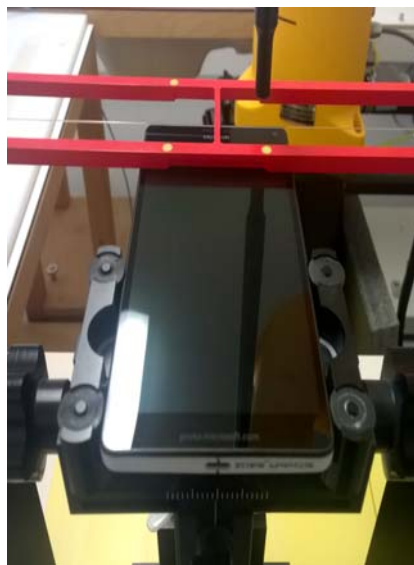
1.2.1 Scan area centered at the acoustic output

The device was positioned such that Device Reference plane was touching the bottom of the Test Arch. The scan is centered at the acoustic output by aligning the acoustic output with the intersection of the Test Arch's middle bar and dielectric wire.

Photo of the device positioned under Test Arch
