PHOTOGRAPHS OF TEST SETUP

Test model No.: GWP-SLCR2-BT-V2

Report No.: EED32N81130401 Page 39 of 55

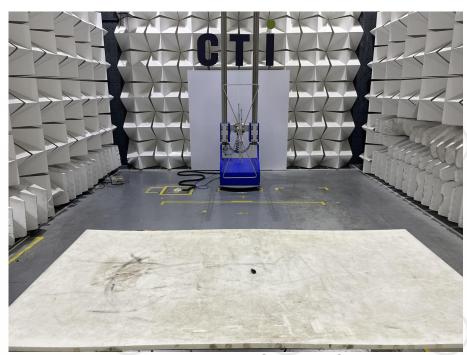
Radiated spurious emission Test Setup-1 left ears(Below 1GHz)

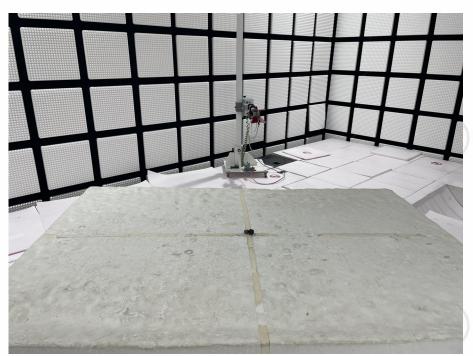
Radiated spurious emission Test Setup-2 left ears(Above 1GHz)

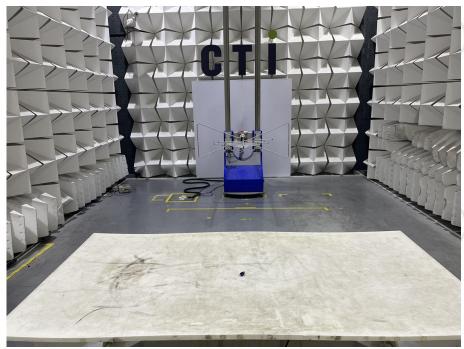
Radiated spurious emission Test Setup-1 right ears(Below 1GHz)

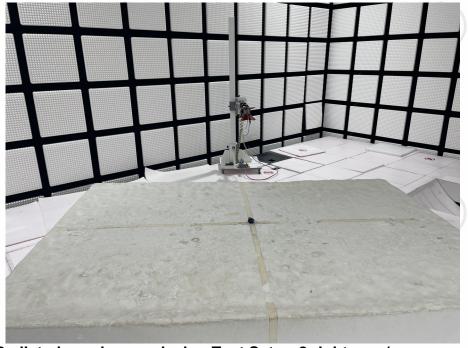
Radiated spurious emission Test Setup-2 right ears(Above 1GHz)

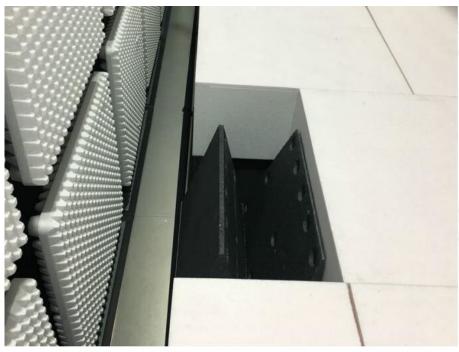
Radiated spurious emission Test Setup-3(Above 1GHz) There are absorbing materials under the ground.
