Report No. : EED32L00320701 Page 200 of 207

PHOTOGRAPHS OF TEST SETUP

Test model No.: W5LM2001

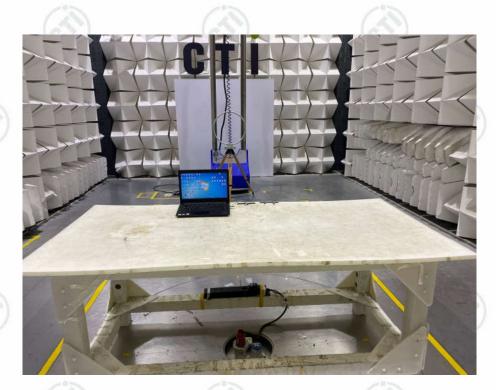
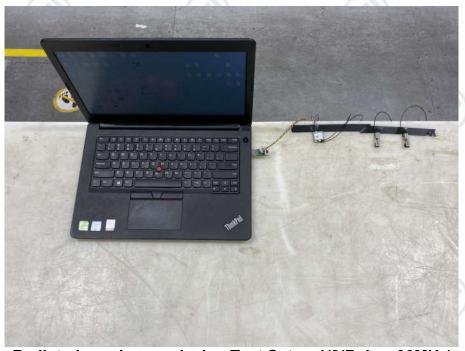
Radiated spurious emission Test Setup-1/2(Below 30MHz)

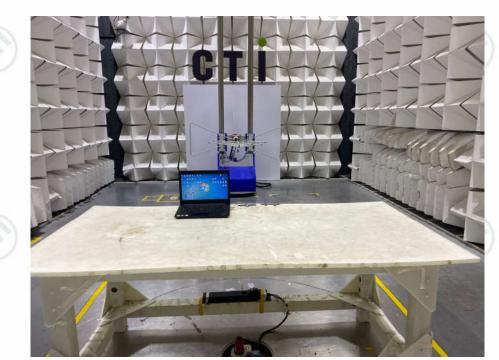
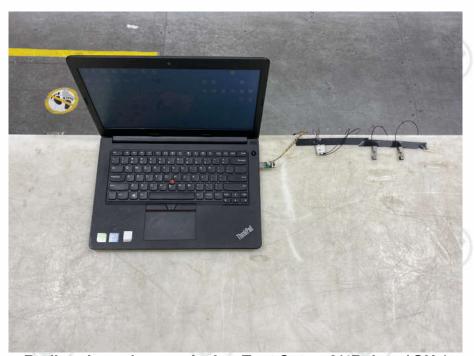
Radiated spurious emission Test Setup-3/4Below 1GHz)

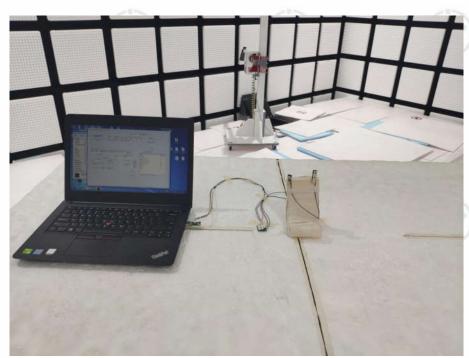
Radiated spurious emission Test Setup-5(Above 1GHz)

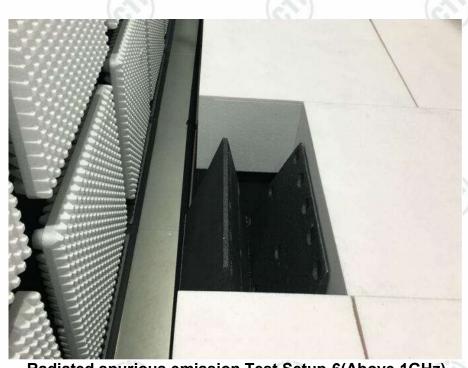
Radiated spurious emission Test Setup-6(Above 1GHz)
There are absorbing materials under the ground.
