## APPENDIX 1 PHOTOS OF TEST SETUP

## APPENDIX 2 PHOTOS OF EUT CONSTRUCTIONAL DETAILS

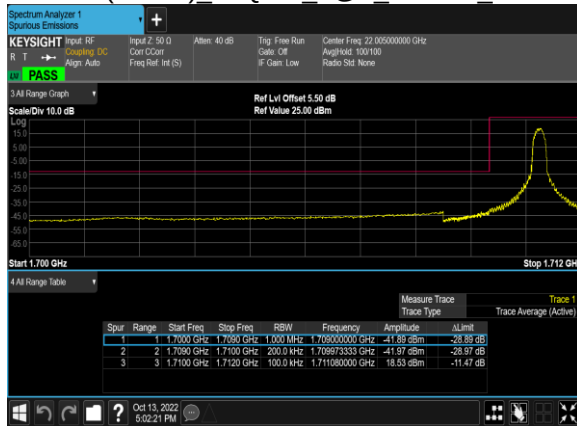
B66(20.0M) 64QAM 1@0 132072 CH

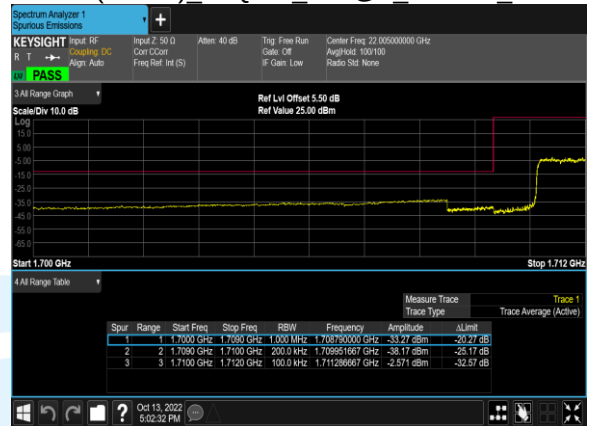
B66(20.0M) 64QAM 100@0 132072 CH

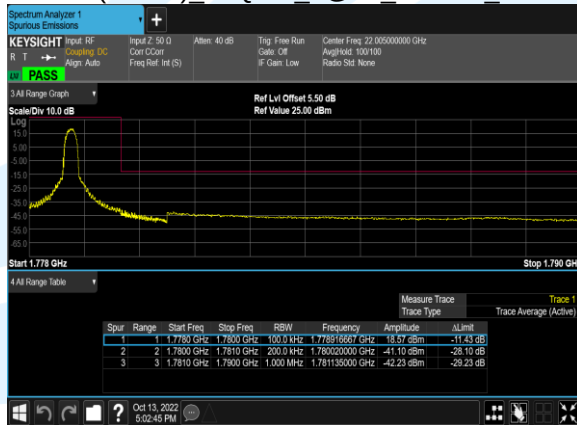
B66(20.0M) 64QAM 1@99 132572 CH

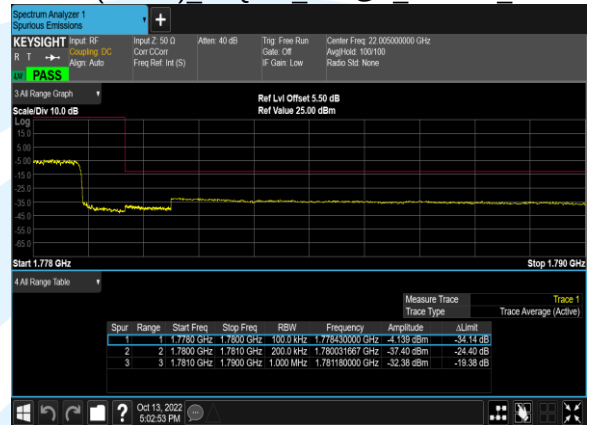
B66(20.0M) 64QAM 100@0 132572 CH

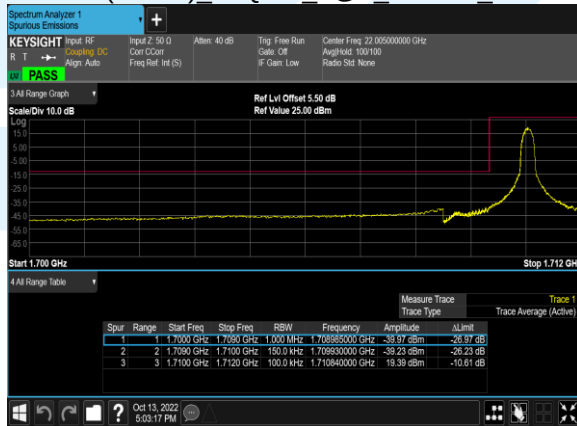
B66(15.0M) 64QAM 1@0 132047 CH

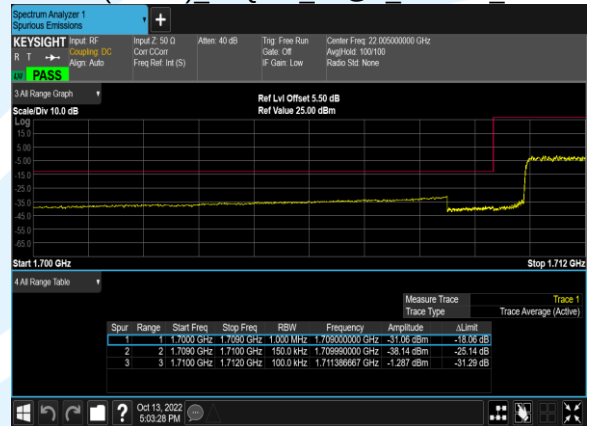
B66(15.0M) 64QAM 75@0 132047 CH

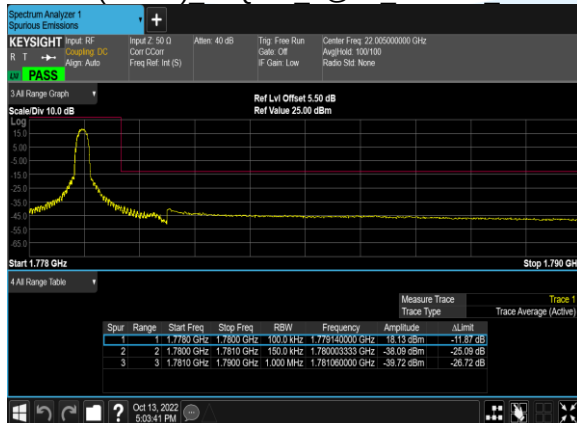
B66(15.0M) 64QAM 1@74 132597 CH

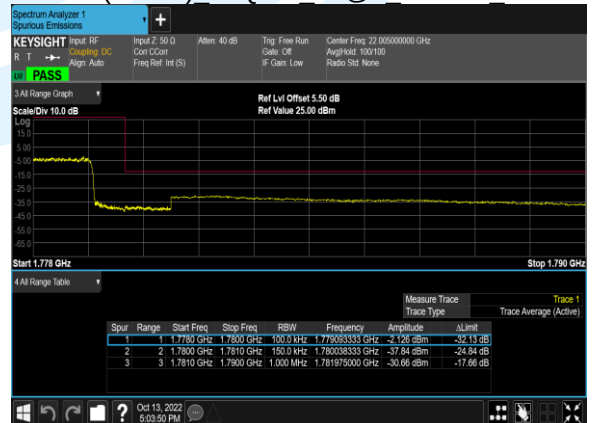
B66(15.0M) 64QAM 75@0 132597 CH

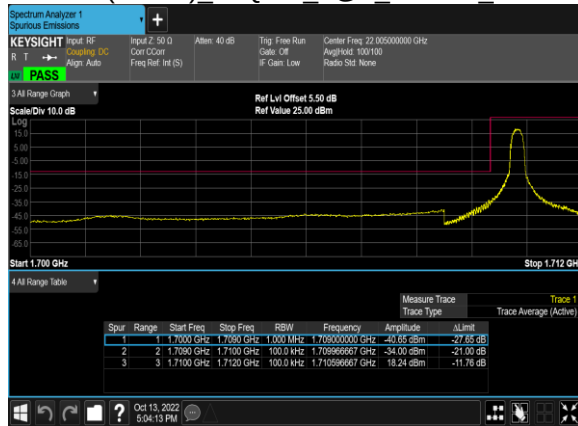
B66(10.0M) 64QAM 1@0 132022 CH

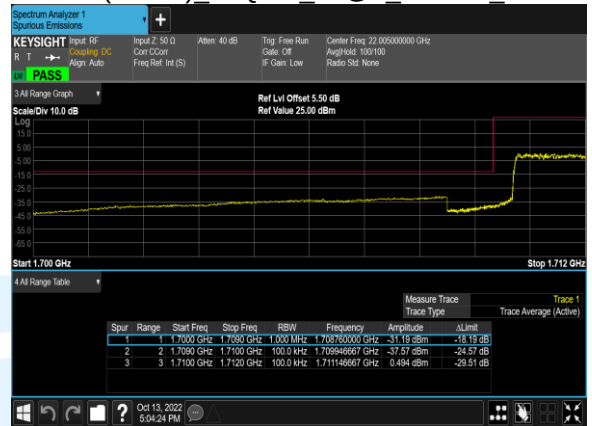
B66(10.0M) 64QAM 50@0 132022 CH

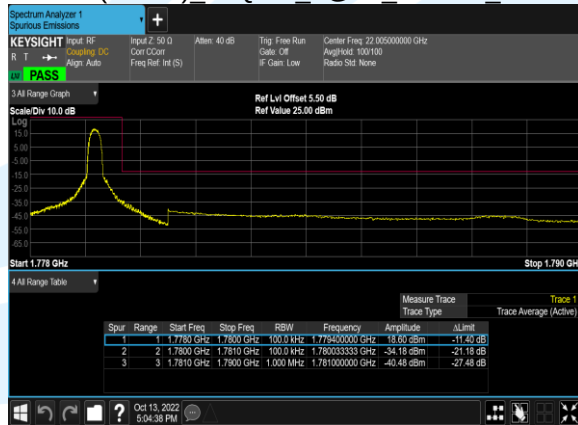
B66(10.0M) 64QAM 1@49 132622 CH

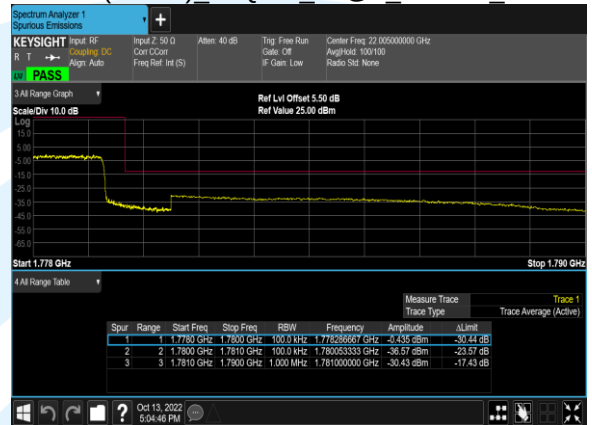
B66(10.0M) 64QAM 50@0 132622 CH

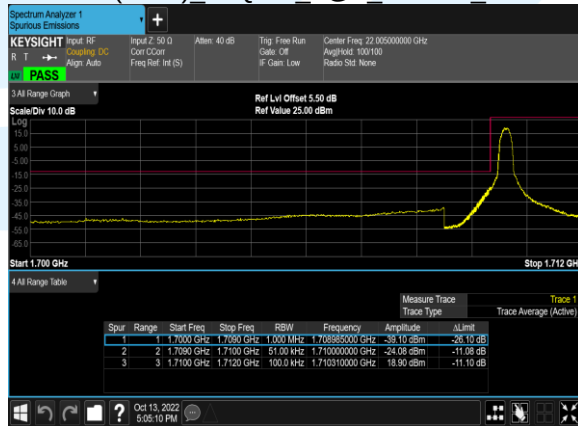
B66(5.0M) 64QAM 1@0 131997 CH

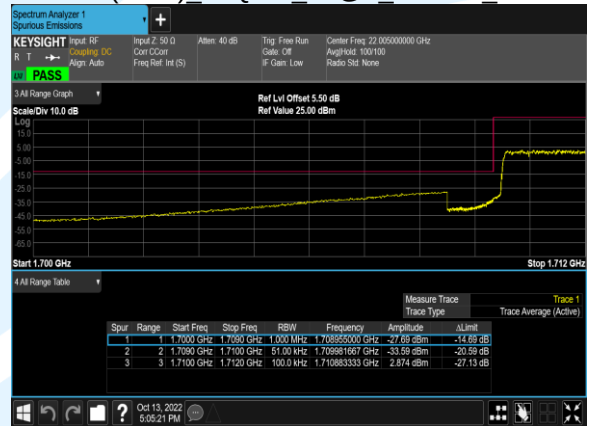
B66(5.0M) 64QAM 25@0 131997 CH

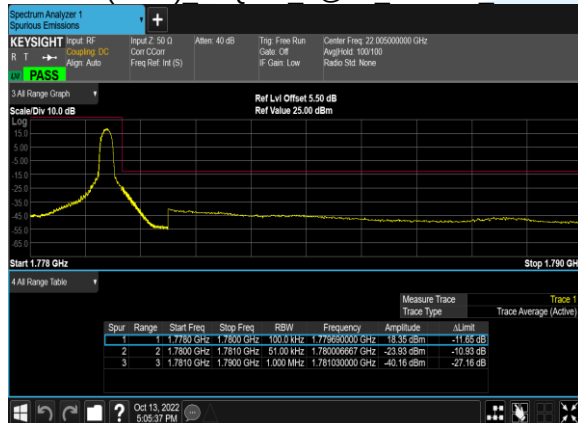
B66(5.0M) 64QAM 1@24 132647 CH

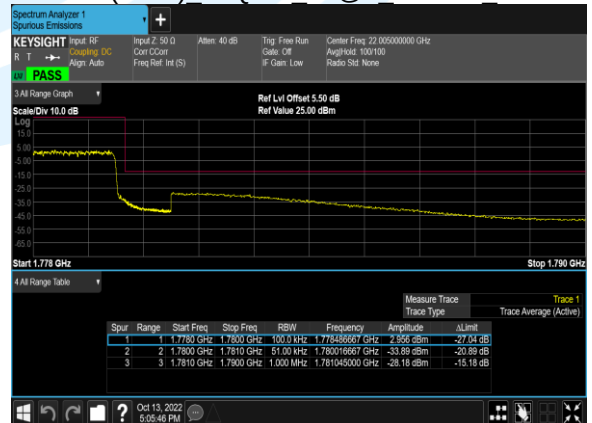
B66(5.0M) 64QAM 25@0 132647 CH

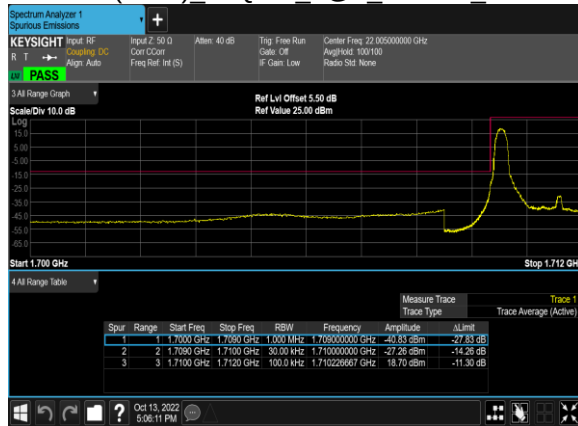
B66(3.0M) 64QAM 1@0 131987 CH

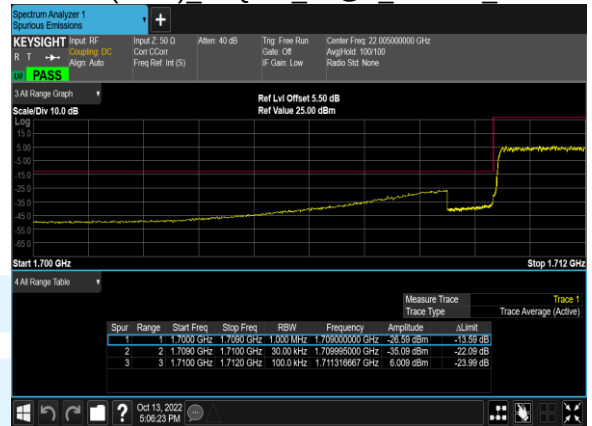
B66(3.0M) 64QAM 15@0 131987 CH

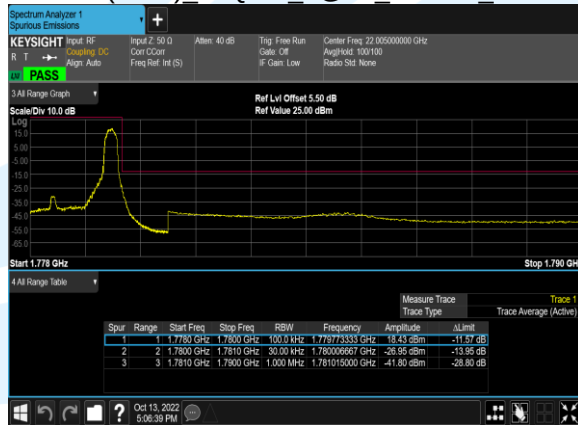
B66(3.0M) 64QAM 1@14 132657 CH

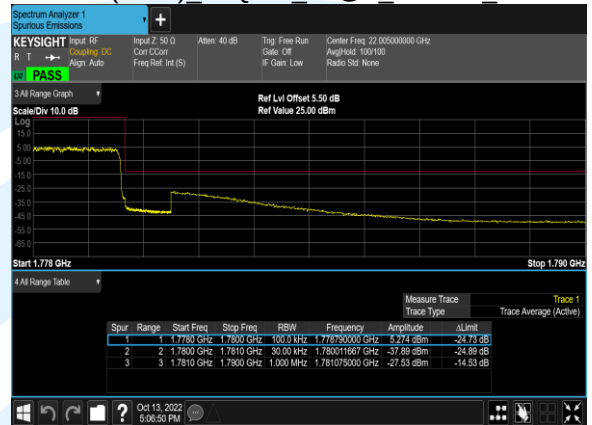
B66(3.0M) 64QAM 15@0 132657 CH

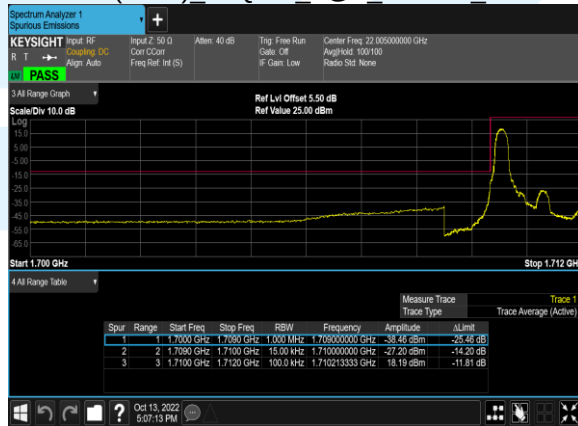
B66(1.4M) 64QAM 1@0 131979 CH

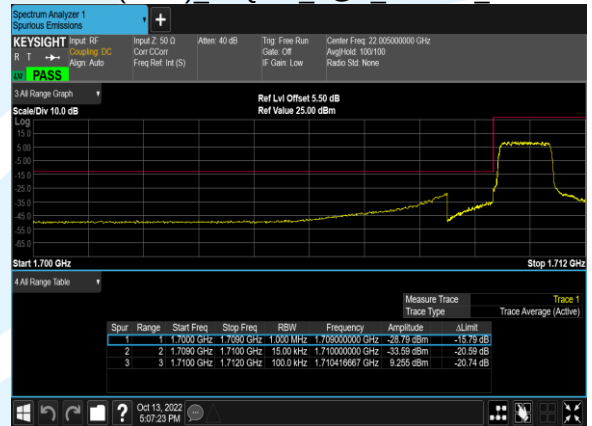
B66(1.4M) 64QAM 6@0 131979 CH

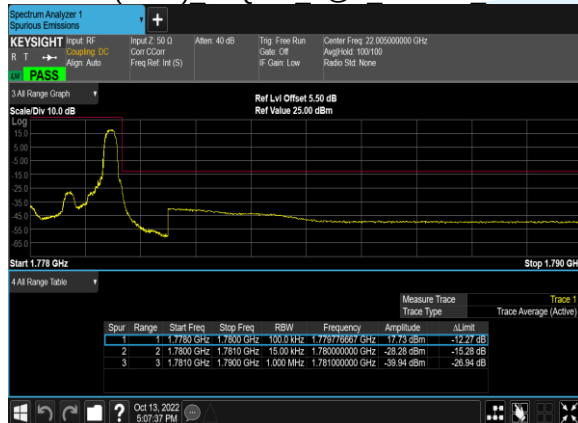
B66(1.4M) 64QAM 1@5 132665 CH

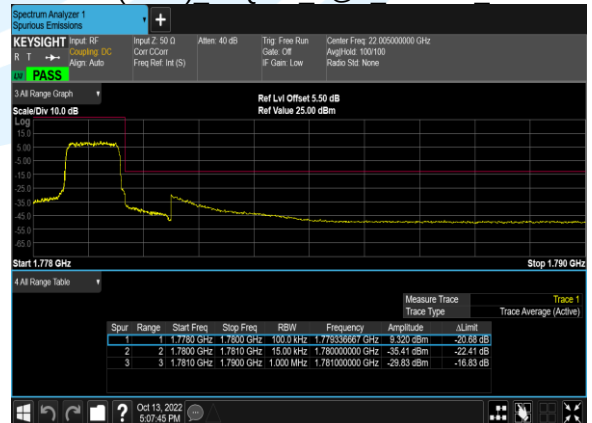
B66(1.4M) 64QAM 6@0 132665 CH
