# Radiated Emission Measurement

Condition : FCC\_part 15E RE\_Above 1GHz\_PK

EUT : W6M22311-23090

Test Mode : TX 802.11ac80 CH42

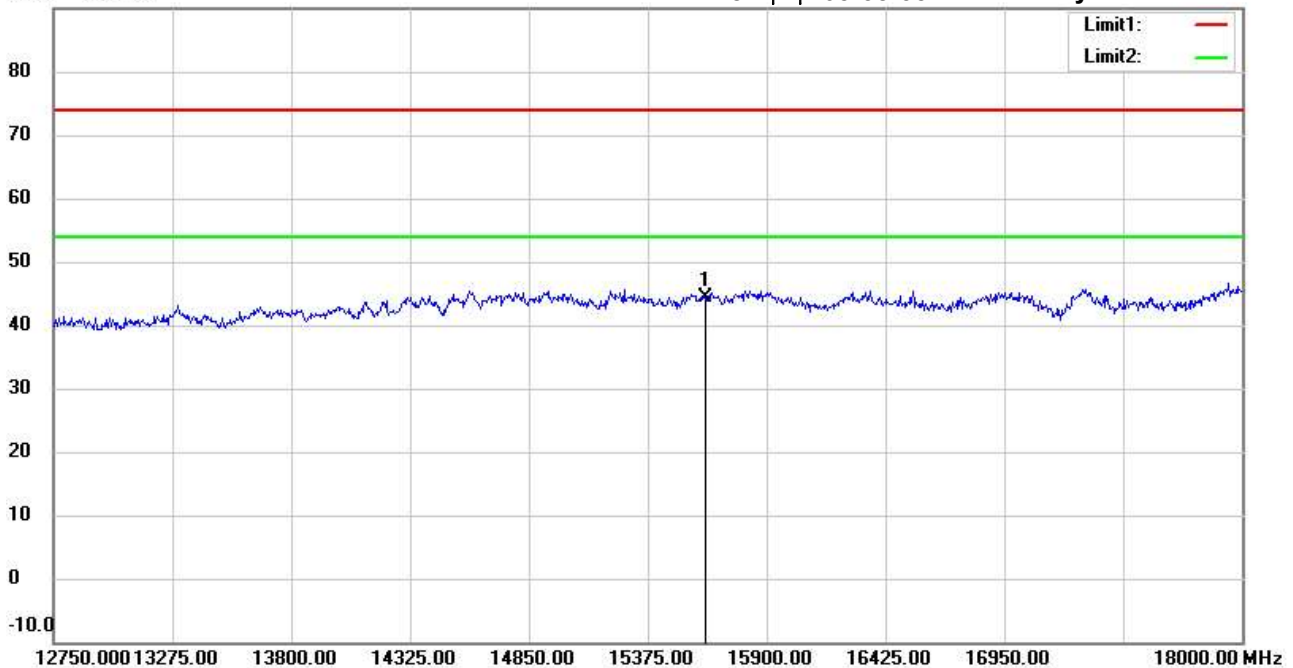
Data :#4

Polarization: **Horizontal**

| Mk. | Frequency (MHz) | Reading (dBuV) | Detector | Corr. factor (dB/m) | Result (dBuV/m) | Limit (dBuV/m) | Ant.Pos (cm) | Tab.Pos (deg.) | Margin (dB) | Comment |
|---|---|---|---|---|---|---|---|---|---|---|
| * | 15630.000 | 21.01 | peak | 23.39 | 44.40 | 74.00 | 150 | 270 | -29.60 | |

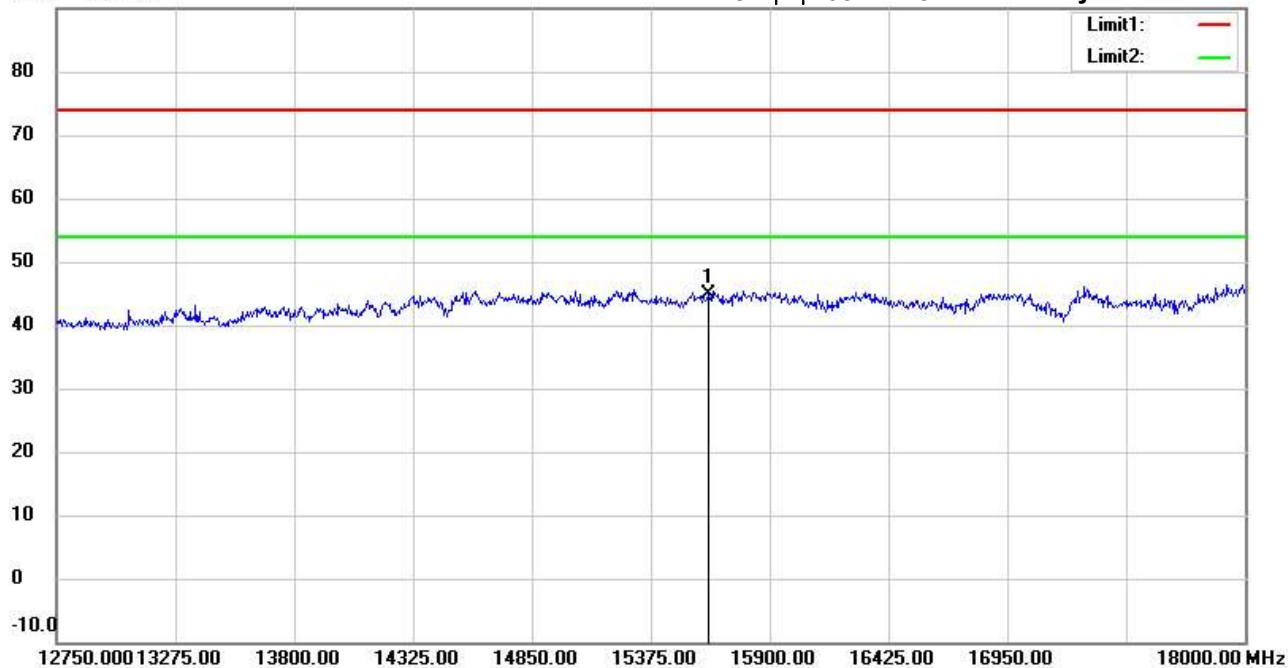
Data :#10

Condition : FCC\_part 15E RE\_Above 1GHz\_PK

Test Mode : TX 802.11ac80 CH42

Polarization: Vertical

| Mk. | Frequency (MHz) | Reading (dBuV) | Detector | Corr. factor (dB/m) | Result (dBuV/m) | Limit (dBuV/m) | Ant.Pos (cm) | Tab.Pos (deg.) | Margin (dB) | Comment |
|---|---|---|---|---|---|---|---|---|---|---|
| * | 15630.000 | 21.60 | peak | 23.39 | 44.99 | 74.00 | 150 | 336 | -29.01 | |

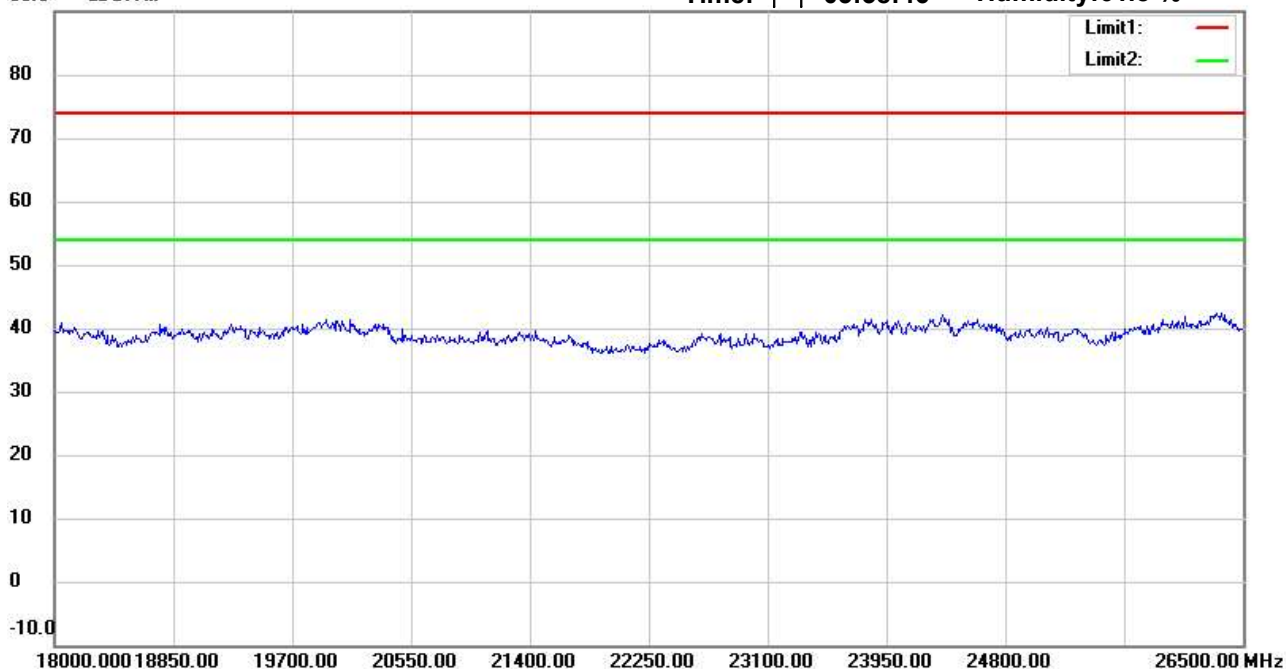
Data :#5

Condition : FCC\_part 15E RE\_Above 1GHz\_PK

Test Mode : TX 802.11ac80 CH42

Polarization: Horizontal

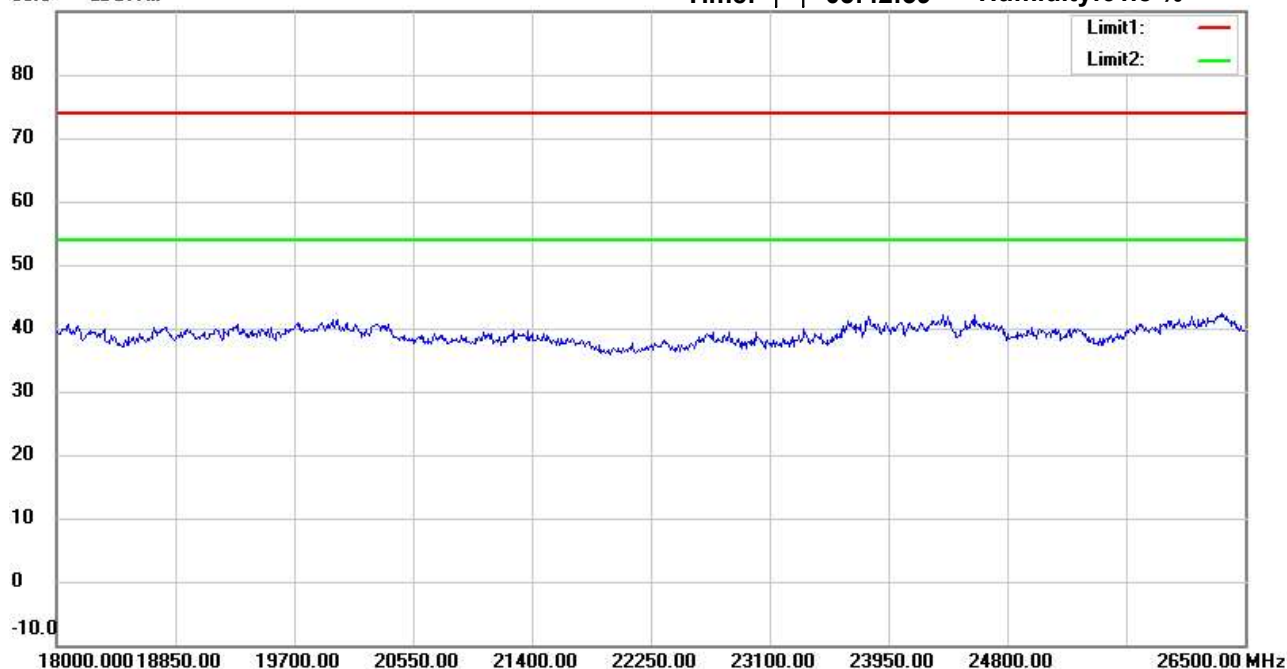
Data :#11

Condition : FCC\_part 15E RE\_Above 1GHz\_PK

Test Mode : TX 802.11ac80 CH42

Polarization: Vertical

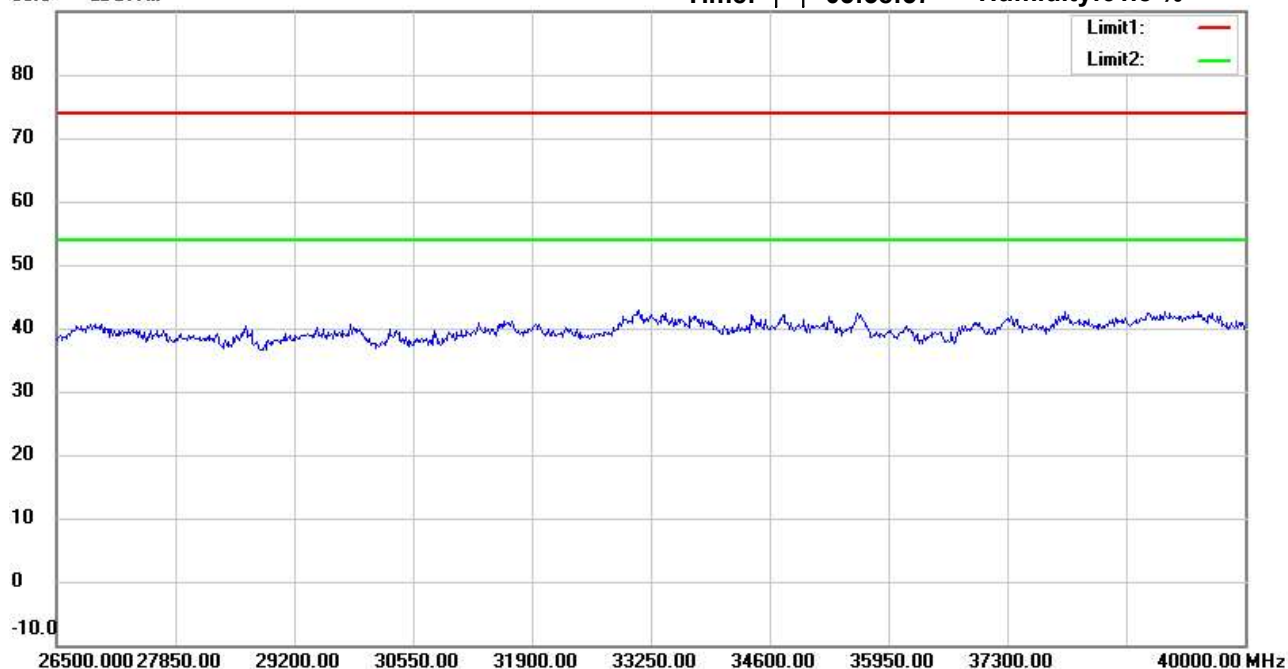
Data :#6

Condition : FCC\_part 15E RE\_Above 1GHz\_PK

Test Mode : TX 802.11ac80 CH42

Polarization: **Horizontal**

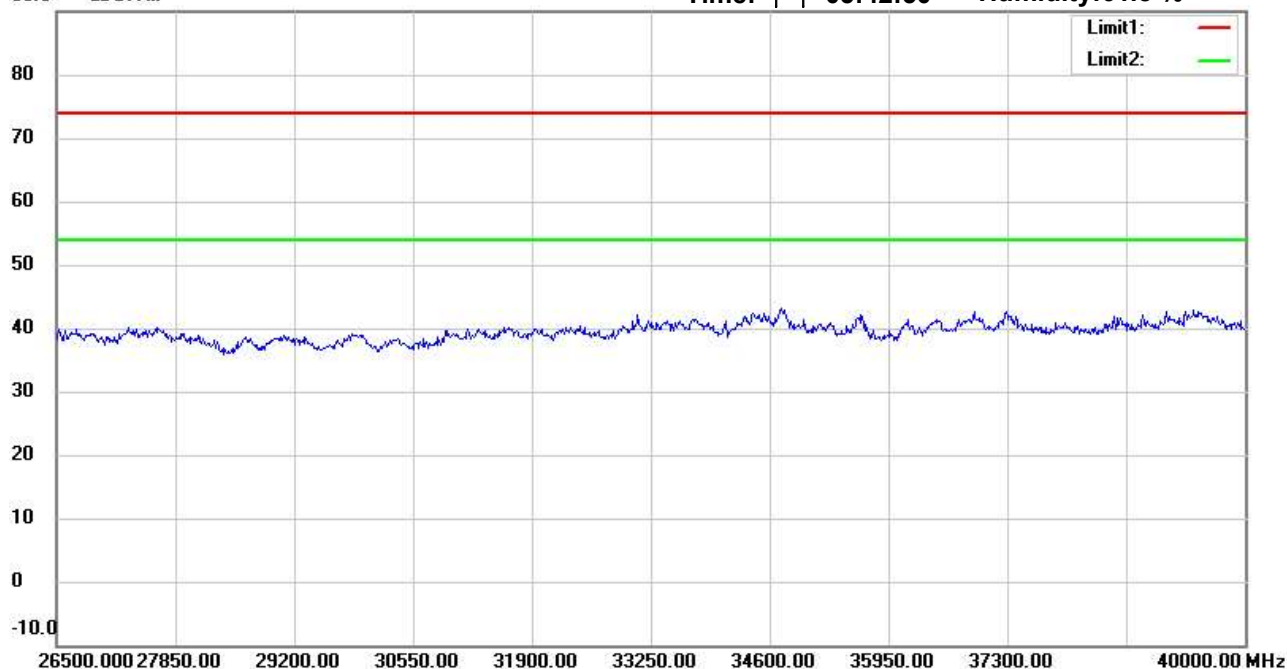
Data :#12

Condition : FCC\_part 15E RE\_Above 1GHz\_PK

Test Mode : TX 802.11ac80 CH42

Polarization: Vertical

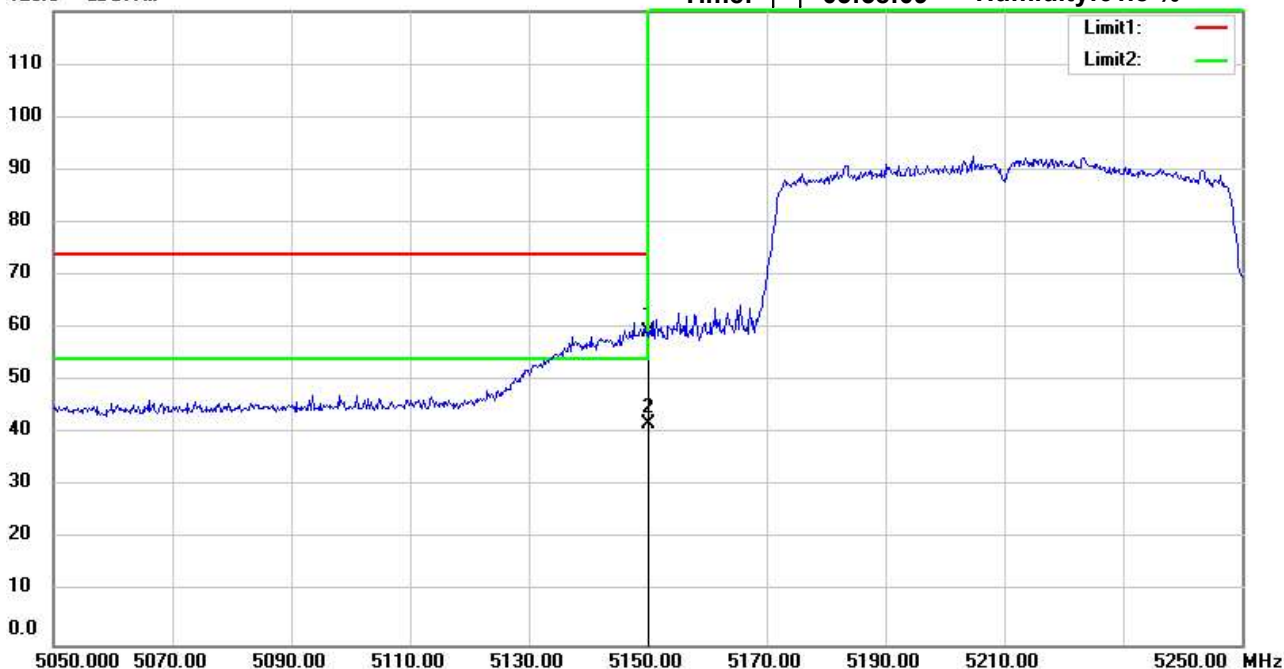
Data : #1

Condition : FCC 15.407 PK (Bandedge)(B1\_5150\_5250)

Polarization: **Horizontal**

| Mk. | Frequency (MHz) | Reading (dBuV) | Detector | Corr. factor (dB/m) | Result (dBuV/m) | Limit (dBuV/m) | Ant.Pos (cm) | Tab.Pos (deg.) | Margin (dB) | Comment |
|---|---|---|---|---|---|---|---|---|---|---|
| | 5150.000 | 53.83 | peak | 5.31 | 59.14 | 74.00 | 150 | 320 | -14.86 | |
| * | 5150.000 | 36.68 | AVG | 5.31 | 41.99 | 54.00 | 150 | 320 | -12.01 | |

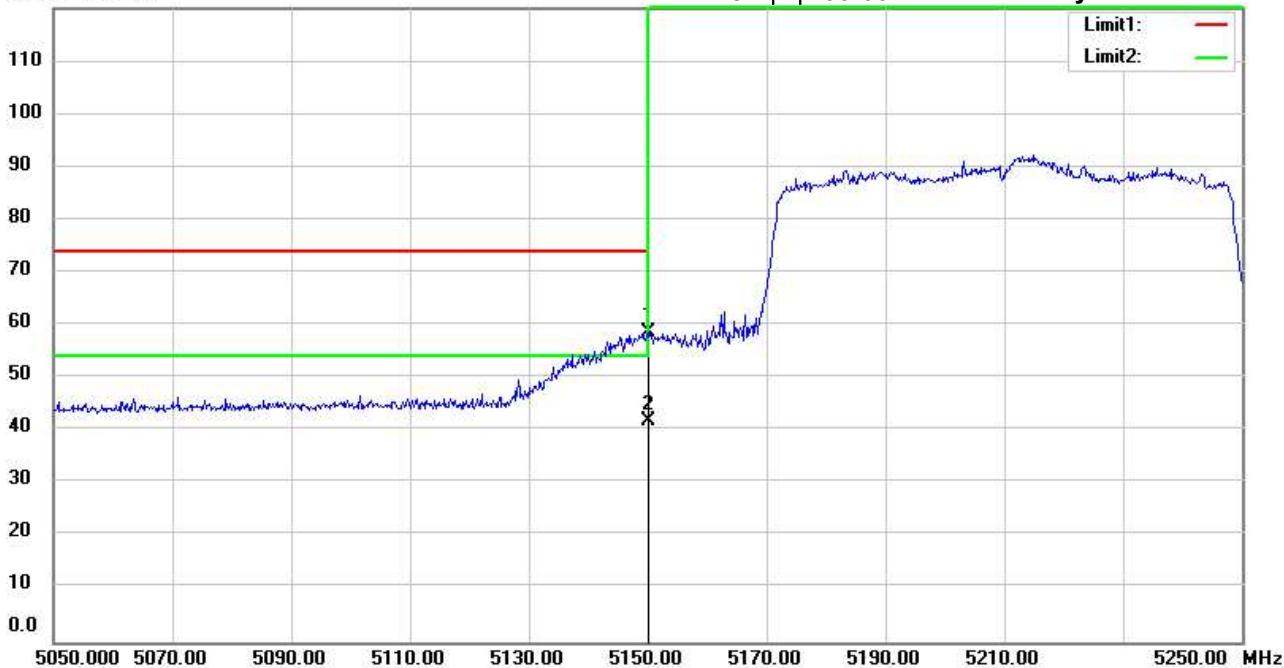
Data :#2

Condition : FCC 15.407 PK (Bandedge)(B1\_5150\_5250)

Polarization: Vertical

| Mk. | Frequency (MHz) | Reading (dBuV) | Detector | Corr. factor (dB/m) | Result (dBuV/m) | Limit (dBuV/m) | Ant.Pos (cm) | Tab.Pos (deg.) | Margin (dB) | Comment |
|---|---|---|---|---|---|---|---|---|---|---|
| | 5150.000 | 53.22 | peak | 5.31 | 58.53 | 74.00 | 150 | 88 | -15.47 | |
| * | 5150.000 | 36.45 | AVG | 5.31 | 41.76 | 54.00 | 150 | 88 | -12.24 | |

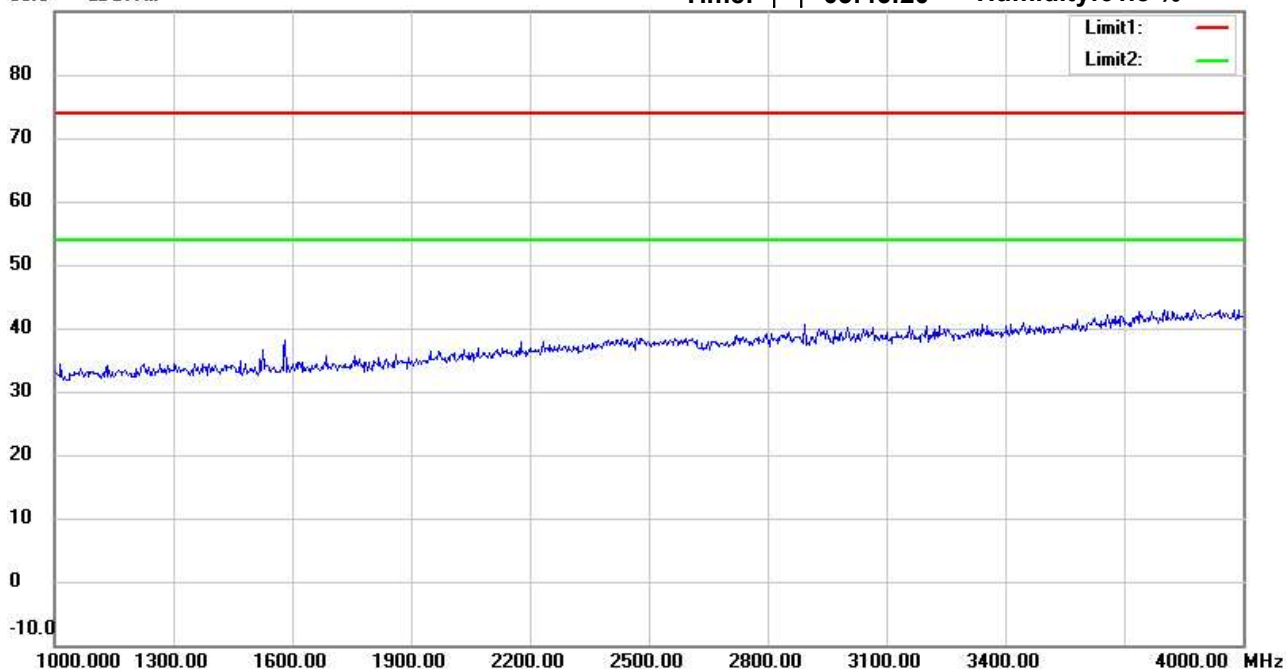
Data :#1

Condition : FCC\_part 15E RE\_Above 1GHz\_PK

Test Mode : TX 802.11ac80 CH155

Polarization: **Horizontal**

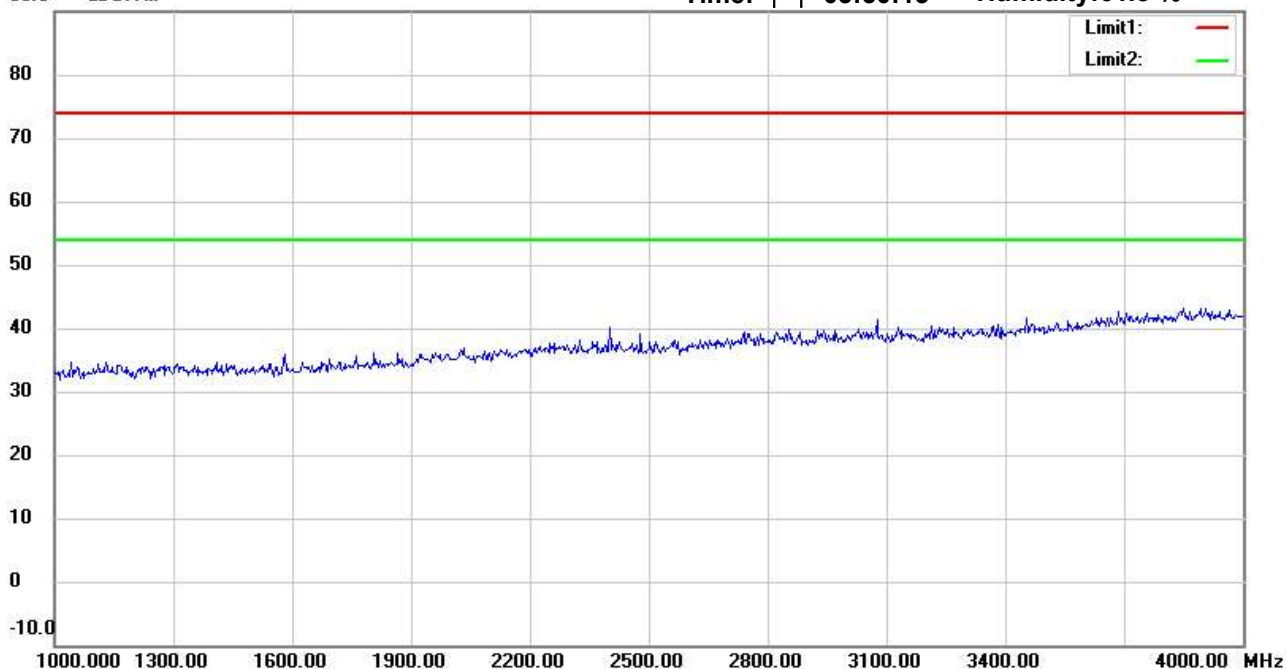
Data :#7

Condition : FCC\_part 15E RE\_Above 1GHz\_PK

Test Mode : TX 802.11ac80 CH155

Polarization: **Vertical**

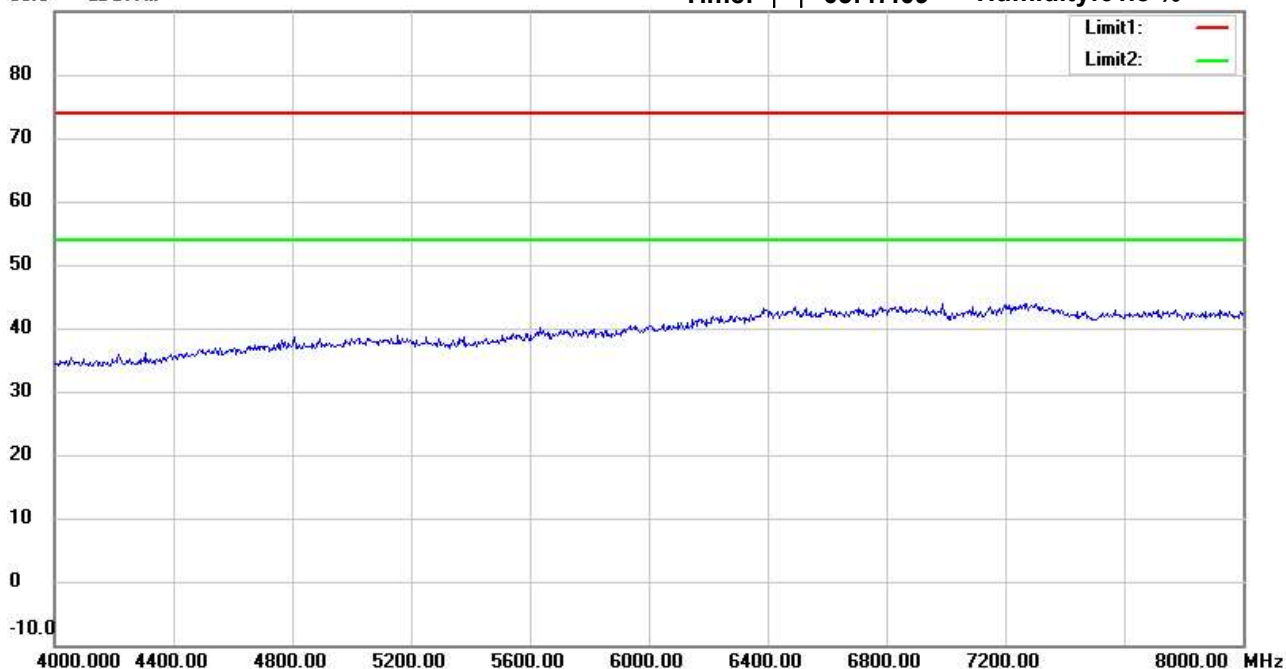
Data :#2

Condition : FCC\_part 15E RE\_Above 1GHz\_PK

Test Mode : TX 802.11ac80 CH155

Polarization: **Horizontal**

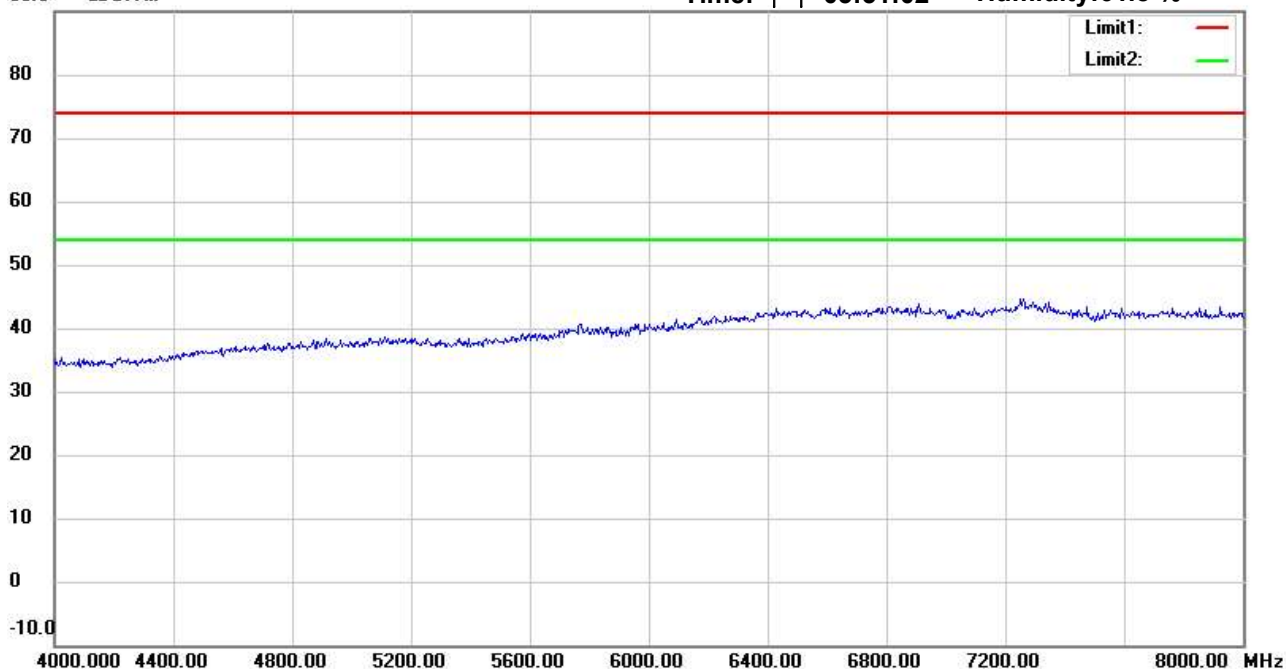
Data :#8

Condition : FCC\_part 15E RE\_Above 1GHz\_PK

Test Mode : TX 802.11ac80 CH155

Polarization: **Vertical**

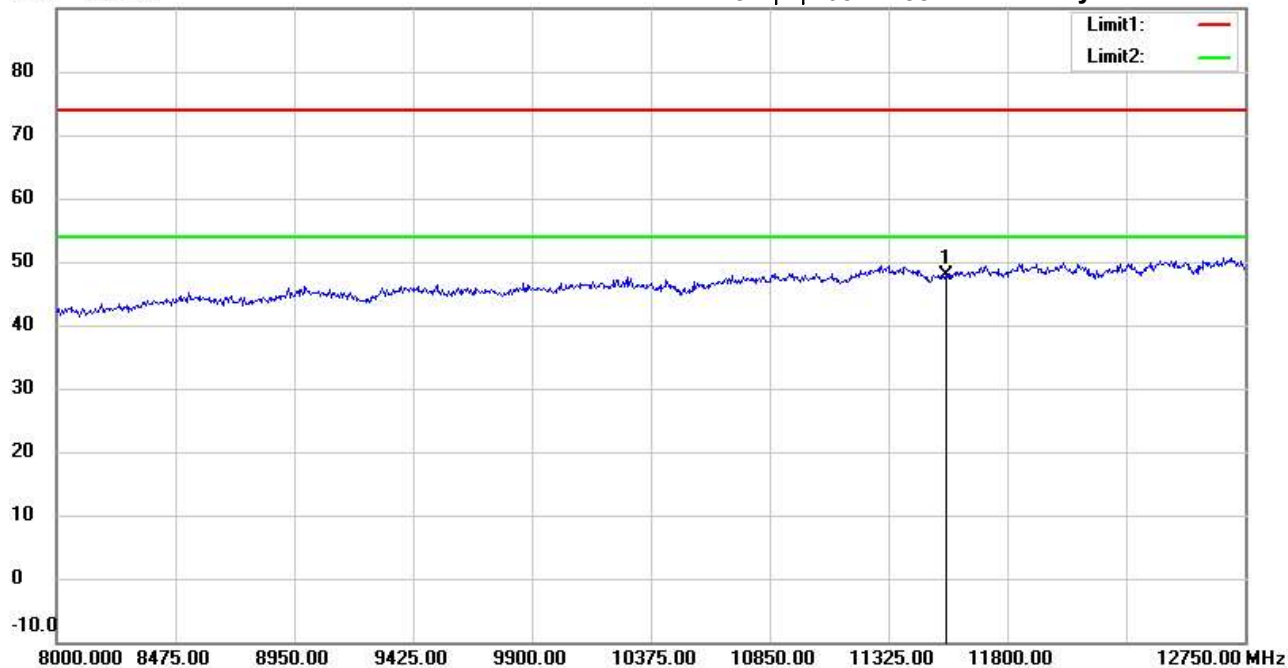
Data : #3

Condition : FCC\_part 15E RE\_Above 1GHz\_PK

Test Mode : TX 802.11ac80 CH155

Polarization: **Horizontal**

| Mk. | Frequency (MHz) | Reading (dBuV) | Detector | Corr. factor (dB/m) | Result (dBuV/m) | Limit (dBuV/m) | Ant.Pos (cm) | Tab.Pos (deg.) | Margin (dB) | Comment |
|---|---|---|---|---|---|---|---|---|---|---|
| * | 11550.000 | 31.26 | peak | 16.55 | 47.81 | 74.00 | 150 | 14 | -26.19 | |

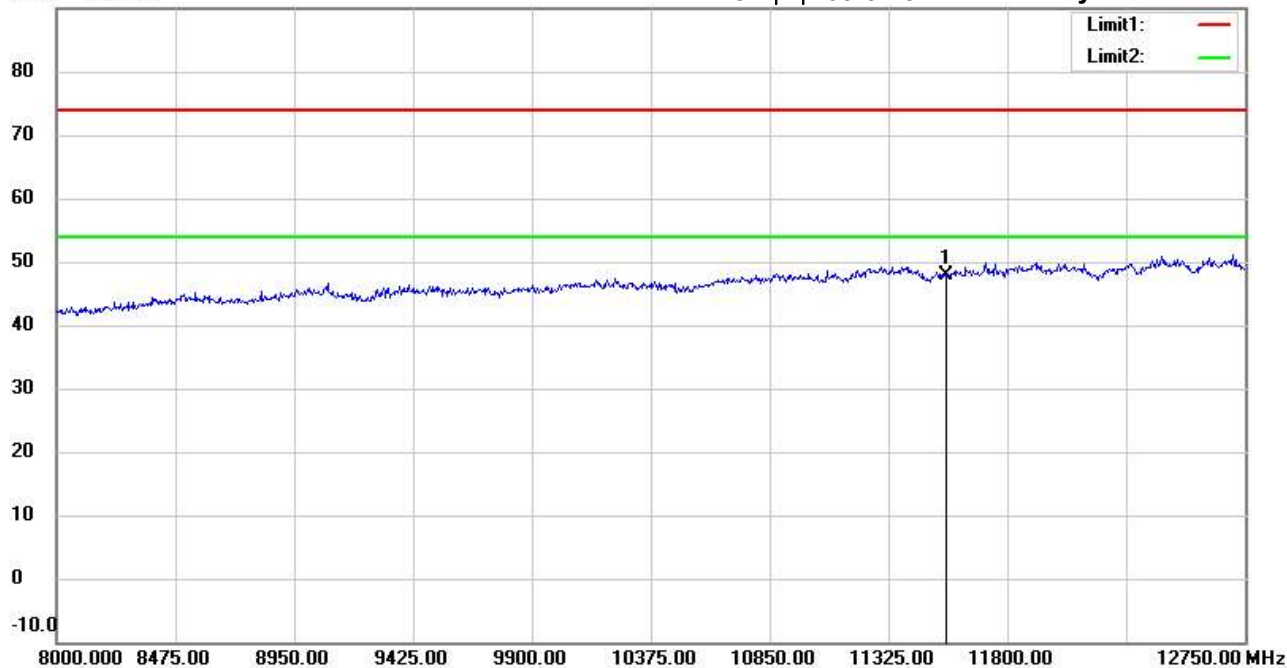
Data : #9

Condition : FCC\_part 15E RE\_Above 1GHz\_PK

Test Mode : TX 802.11ac80 CH155

Polarization: Vertical

| Mk. | Frequency (MHz) | Reading (dBuV) | Detector | Corr. factor (dB/m) | Result (dBuV/m) | Limit (dBuV/m) | Ant.Pos (cm) | Tab.Pos (deg.) | Margin (dB) | Comment |
|---|---|---|---|---|---|---|---|---|---|---|
| * | 11550.000 | 31.39 | peak | 16.55 | 47.94 | 74.00 | 150 | 27 | -26.06 | |

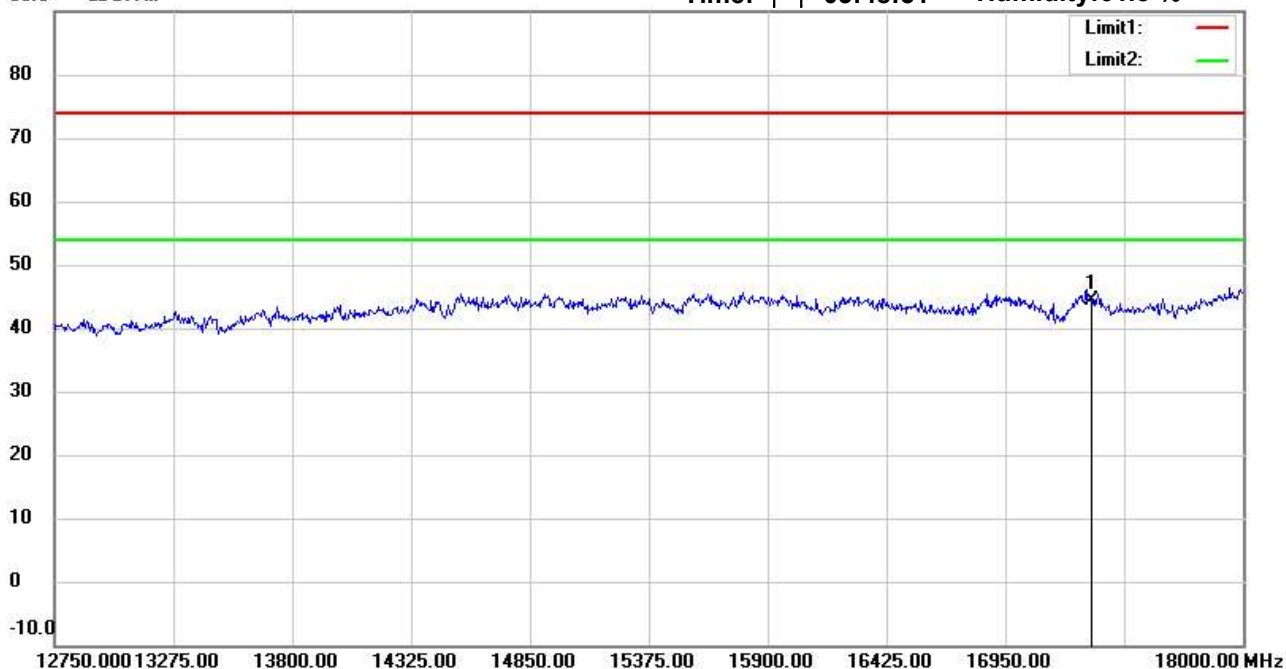
Data : #4

Condition : FCC\_part 15E RE\_Above 1GHz\_PK

Test Mode : TX 802.11ac80 CH155

Polarization: Horizontal

| Mk. | Frequency (MHz) | Reading (dBuV) | Detector | Corr. factor (dB/m) | Result (dBuV/m) | Limit (dBuV/m) | Ant.Pos (cm) | Tab.Pos (deg.) | Margin (dB) | Comment |
|---|---|---|---|---|---|---|---|---|---|---|
| * | 17325.000 | 20.20 | peak | 24.11 | 44.31 | 74.00 | 150 | 120 | -29.69 | |

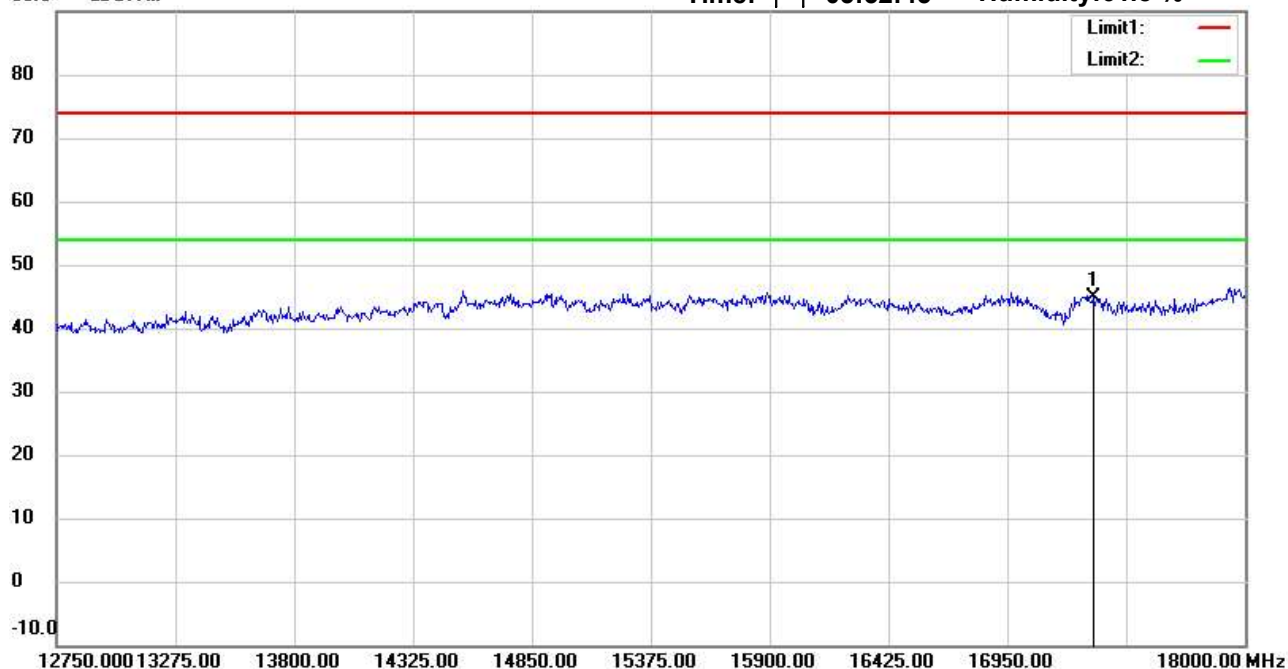
Data : #10

Condition : FCC\_part 15E RE\_Above 1GHz\_PK

Test Mode : TX 802.11ac80 CH155

Polarization: Vertical

| Mk. | Frequency (MHz) | Reading (dBuV) | Detector | Corr. factor (dB/m) | Result (dBuV/m) | Limit (dBuV/m) | Ant.Pos (cm) | Tab.Pos (deg.) | Margin (dB) | Comment |
|---|---|---|---|---|---|---|---|---|---|---|
| * | 17325.000 | 20.78 | peak | 24.11 | 44.89 | 74.00 | 150 | 16 | -29.11 | |

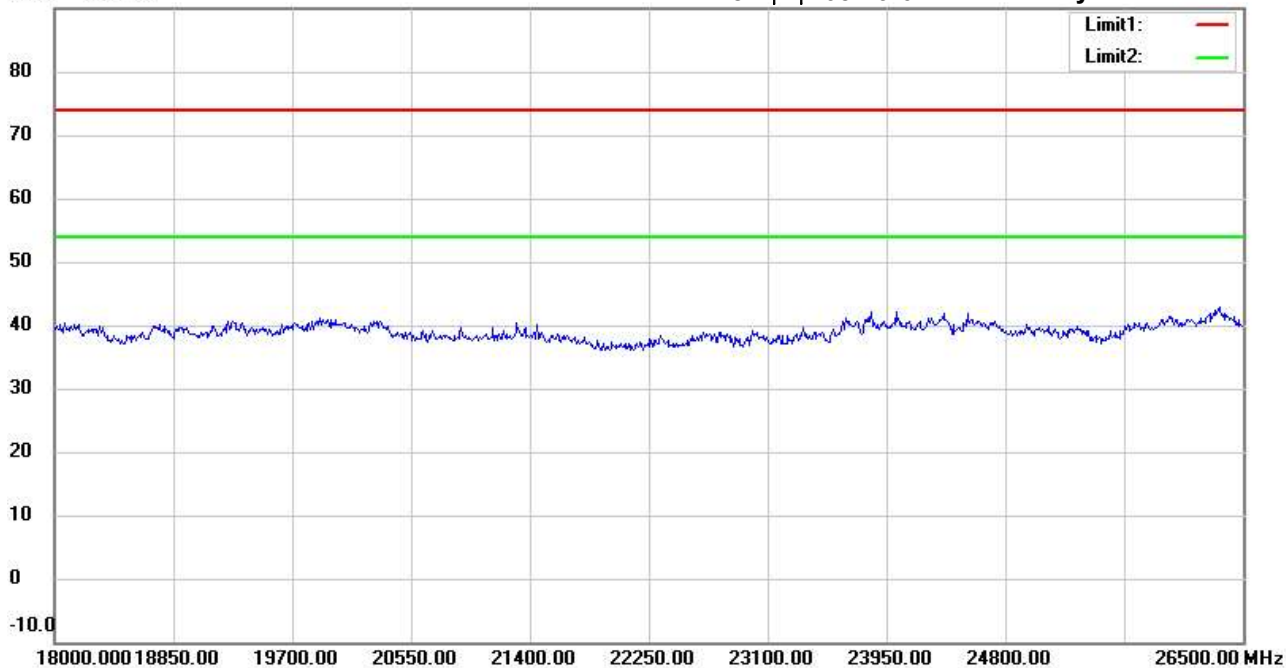
Data :#5

Condition : FCC\_part 15E RE\_Above 1GHz\_PK

Test Mode : TX 802.11ac80 CH155

Polarization: Horizontal

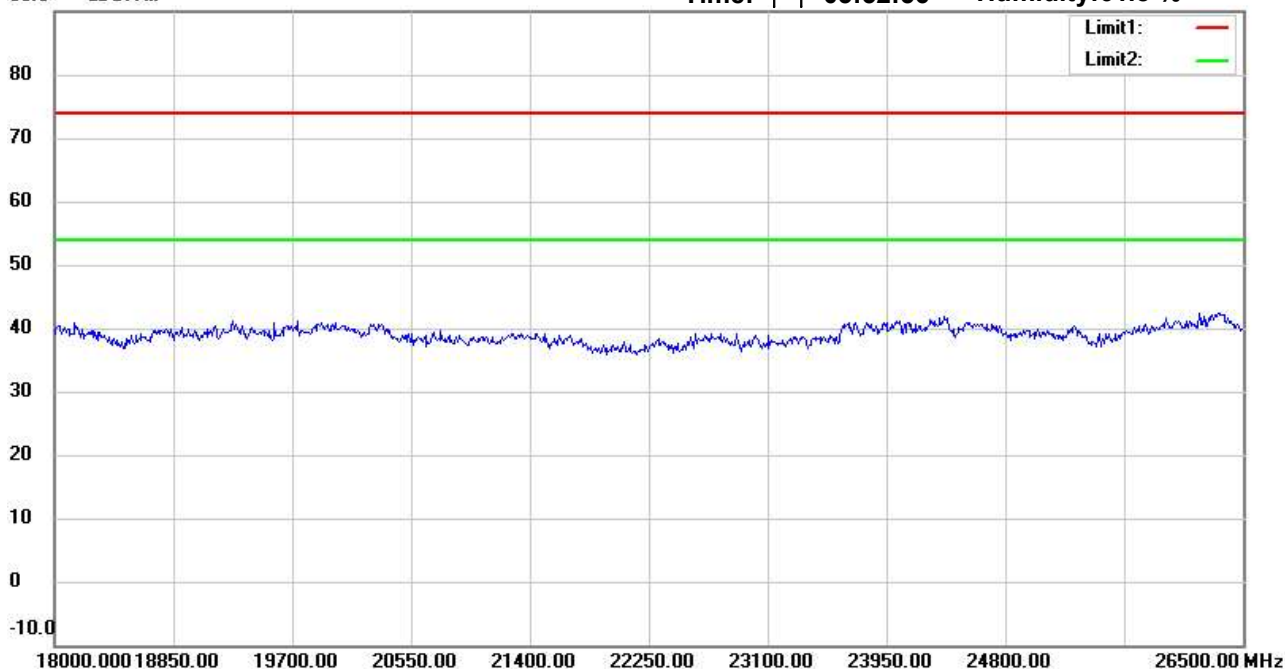
Data :#11

Condition : FCC\_part 15E RE\_Above 1GHz\_PK

Test Mode : TX 802.11ac80 CH155

Polarization: Vertical

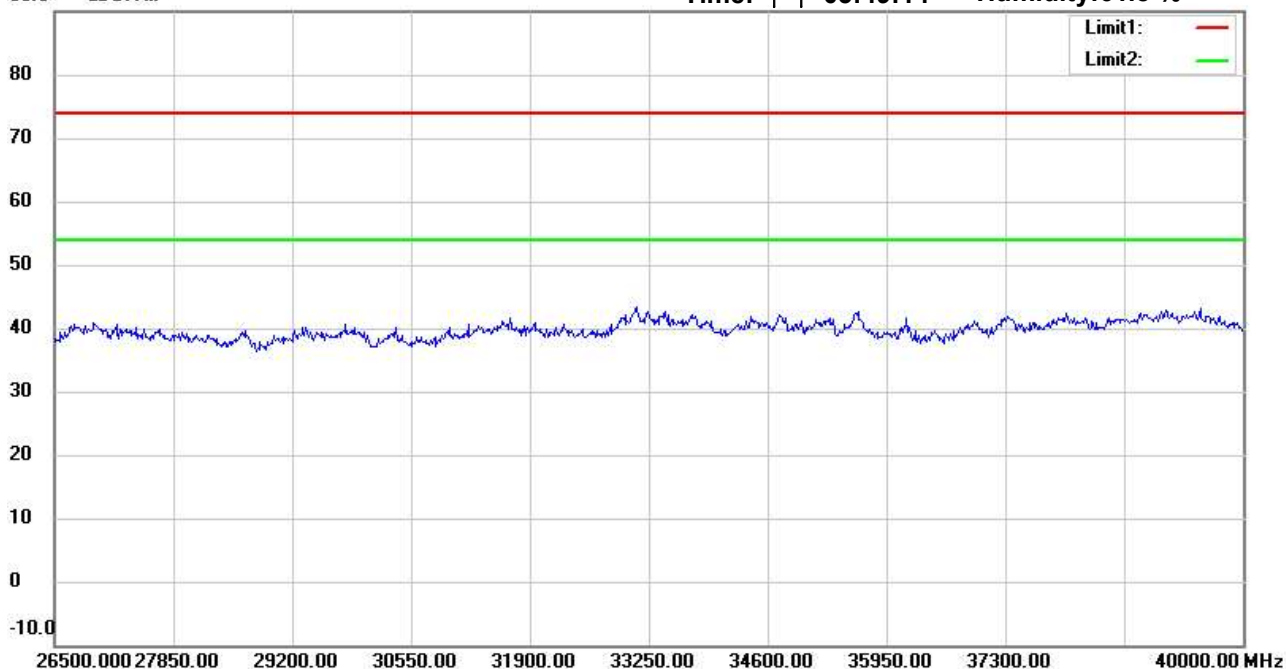
Data :#6

Condition : FCC\_part 15E RE\_Above 1GHz\_PK

Test Mode : TX 802.11ac80 CH155

Polarization: Horizontal

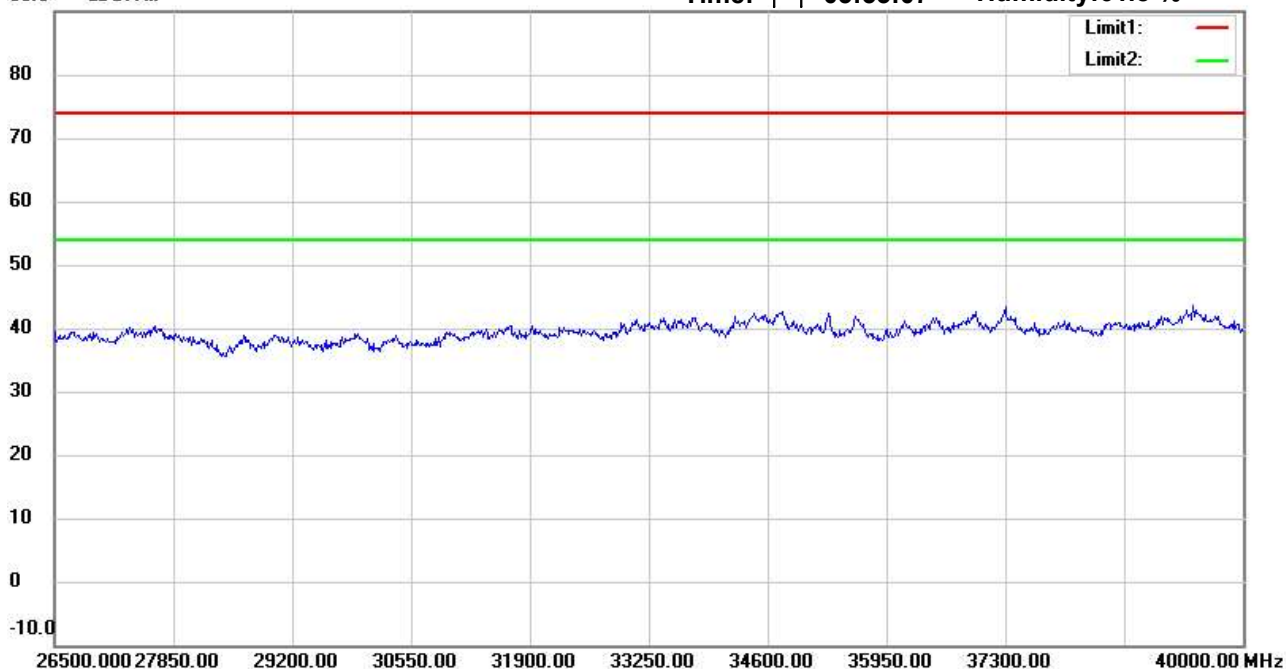
Data :#12

Condition : FCC\_part 15E RE\_Above 1GHz\_PK

Test Mode : TX 802.11ac80 CH155

Polarization: **Vertical**
