Conformance test report of an

AIS system

Equipment under test: **McMurdo**

Test Report No.: 734.2/0066/2003/S3220

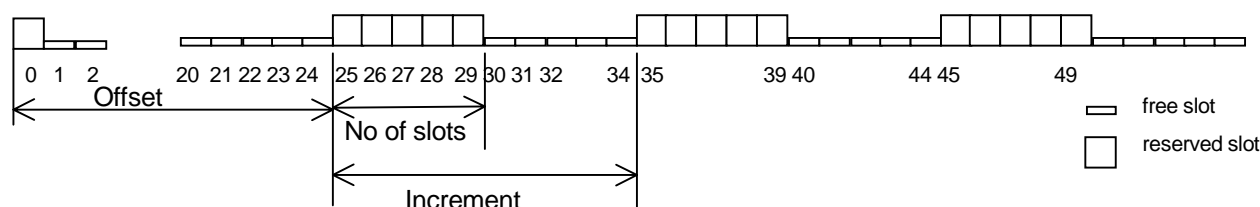
FATDMA reservation

- Msg 20 is transmitted in slot 0 in each frame
- Offset number 1: 25
- Number of slots: 5
- Time out 1: 3
- Increment: 10

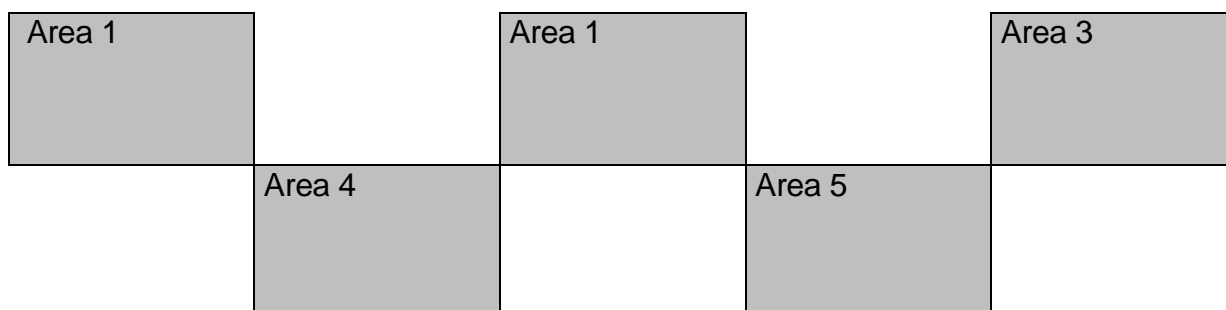
Note) accepted areas

25.10.04 Wa	Area handling	<p>After the message "channel managment parameter change" the msg "all transmissions enable" and "own reports disable" pop up .</p> <p>Why "own reports disable"</p> <p><u>Remark 29.10.04 Ba:</u></p> <p>These TXT message are output because the Tx is disabled for some time to build up a slot map on the new channels and then the Tx are enabled again</p>	Ok
