FCC ID: 2BAH6-SU601

SU6 Change from Rev 2 to Rev 3

PCB changes (from PCB4465-2 to PCB4465-3):

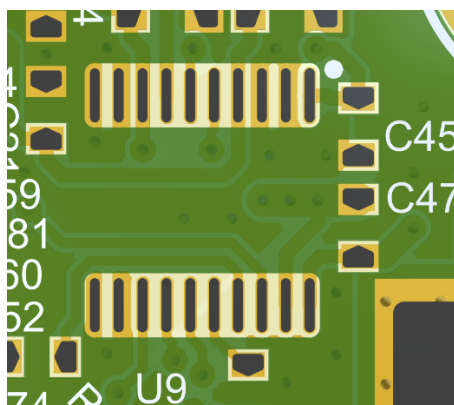
PCB4465-2

- 1) Footprint change (U9) – change in polygon pour for better SMT placement and inspection.
(U9) is an Analog to Digital converter.
No change in Radio parameters has occurred.

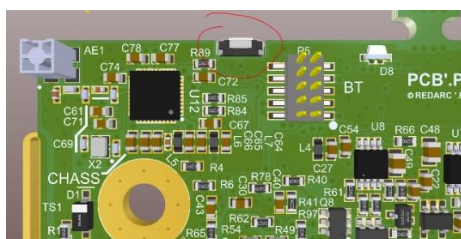
PCB4465-2

- 2) (SW1) moved to top side of PCB - for better SMT placement and soldering
No change in Radio parameters has occurred.

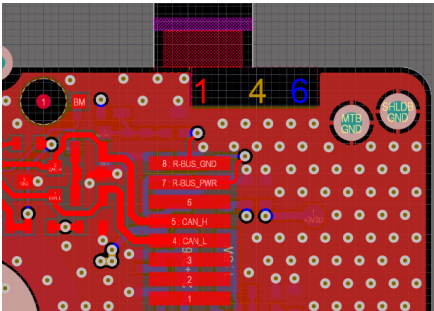
PCB4465-2

- 3) Tracks added to allow array testing, breaks out 2 interface lines to communicate to array testing and programming of multiple PCB's.
No change in Radio parameters has occurred.

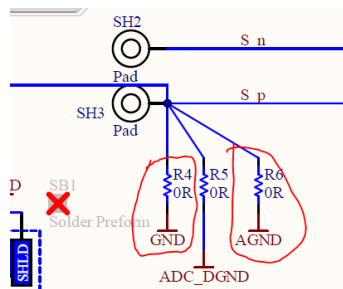
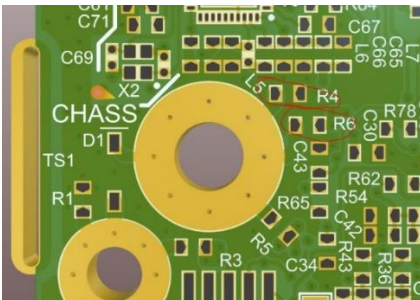
PCB4465-2

- 4) OR resistor jumpers (R4) and (R6) were moved from TOP layer to BOT layer
(R4) and (R6) connect the PCB power GND and the PCB Analog GND to the power GND terminal (SH3 pad). No change in Radio parameters has occurred.
