# **Troubleshooting-Installing an RF link**

**Issue : 5.3.x**

**Authors : Matt Olson/Dave Sida**

**Date : 30<sup>th</sup> July 2004**

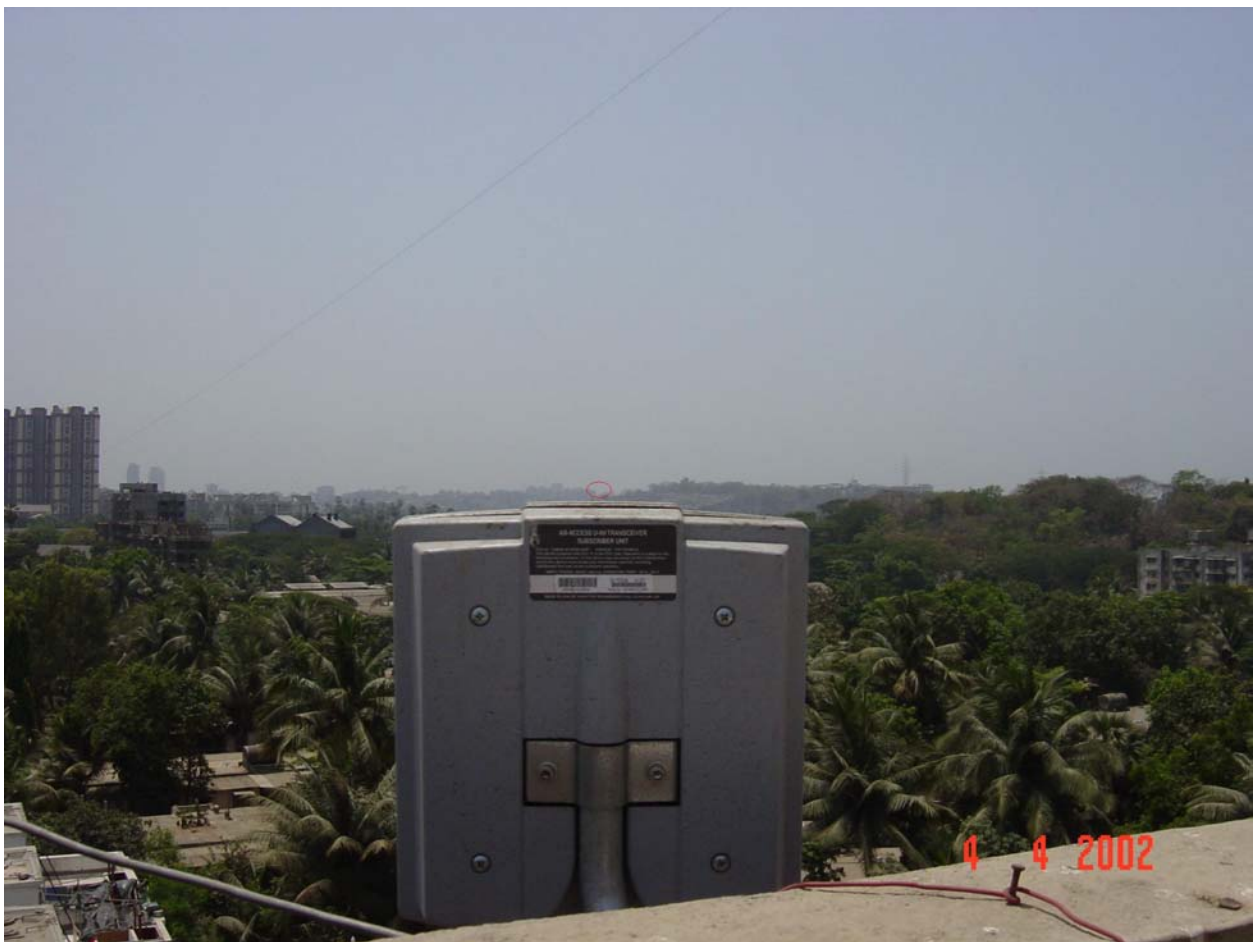
The regular SU has a 20x20 (azimuth x elevation) so it usually very easy to eyeball the alignment. The extender SU has a 10x10 (azimuth x elevation) so it may be a little more difficult to align. This can be done by standing behind the unit while looking just over the top of the unit and adjusting the radio to point directly at the AP. As you can see in this picture the SU has been aligned by just eyeballing the tower. On the day this picture was taken there was a little bit of haze in the air so the tower is harder to see so it has been identified by a red circle. With the 20x20 antenna this is generally good enough to get a quality RSSI.
