### 3.7 Antenna Installation & Alignment

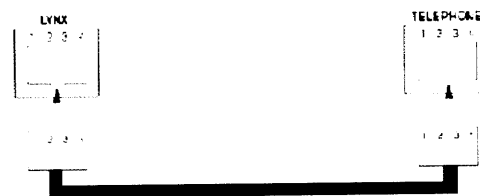
**Figure 3-8: Orderwire & VF Port Connection**

Orderwire Connection

VF Port Connection

1. Using a standard RJ-11 telephone cable, connect a standard electronic telephone (a touch tone phone, complete with dialer; a handset by itself will not work) to the Orderwire connector on the *Lynx* front panel. This connector is wired identically to a standard two-wire telephone jack, see Figure 3-8 for details.
2. With a telephone connected to each *Lynx* terminal on opposite ends of the link, either telephone can be used to "dial-up" the far-end location. The far-end terminal's internal ringer and the connected telephone will ring, and if answered, two-way full-duplex voice communication is established.
