Appendix A – Test Photos

Company: Model Tested: Report Number: DLS Project: Cambium Networks C036045A004A 19784 6383

Photo Information and Test Setup:

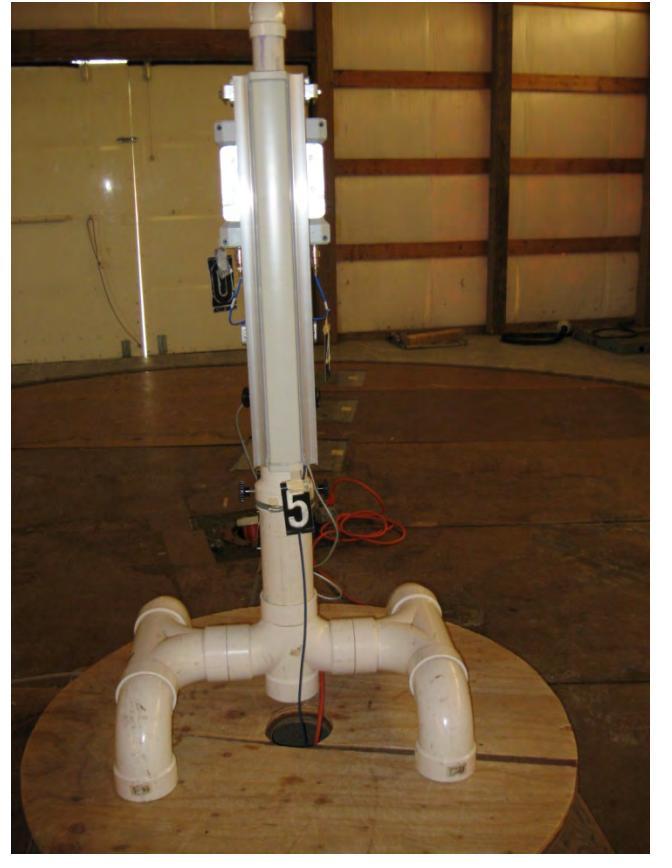
Radiated Below 1 GHz - Front

- Item 0: PMP450AP 3.65GHz OFDM Radio, Model C036045A004A
- Item 1: Phihong Power Supply, Model PSA15M-300 (AP)
- Item 2: Unshielded Power Over Ethernet cable, 1.5m long
- Item 3: Unshielded CAT 5e Ethernet cable to remote PC, 10m long
- Item 4: 2 x Shielded RF cables, each with 1dB loss at 3.65GHz, 0.3m long
- Item 5: Laird 17dBi Sector Antenna, Model C030045D901A revAA
