10.5. TEST RESULT OF LINE CONDUCTED EMISSION TEST

APPENDIX A: PHOTOGRAPHS OF TEST SETUP

APPENDIX B: PHOTOGRAPH OF EUT

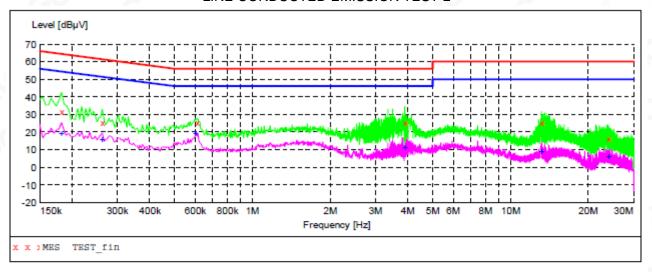
LINE CONDUCTED EMISSION TEST-L

MEASUREMENT RESULT: "TEST fin"

6/12/2019 10:22AM									
	Frequency	Level	Transd	Limit	Margin	Detector	Line	PE	
	MHz	dΒμV	dB	dΒμV	dB				
	0.182000	31.50	10.9	64	32.9	QP	L1	FLO	
	0.262000	25.60	10.9	61	35.8	QP	L1	FLO	
	0.610000	25.40	10.7	56	30.6	QP	L1	FLO	
	3.898000	25.70	11.6	56	30.3	QP	L1	FLO	
	13.198000	25.40	12.1	60	34.6	QP	L1	FLO	
	23.938000	16.20	12.6	60	43.8	QP	L1	FLO

MEASUREMENT RESULT: "TEST fin2"

6/	12/2019 10: Frequency MHz	22 AM Level dBμV	Transd dB	Limit dBµV	Margin dB	Detector	Line	PE
	0.182000	19.50	10.9	54	34.9	AV	L1	FLO
	0.262000	15.90	10.9	51	35.5	AV	L1	FLO
	0.602000	19.40	10.7	46	26.6	AV	L1	FLO
	3.898000	11.40	11.6	46	34.6	AV	L1	FLO
	13.198000	8.90	12.1	50	41.1	AV	L1	FLO
	23.942000	6.10	12.6	50	43.9	AV	L1	FLO

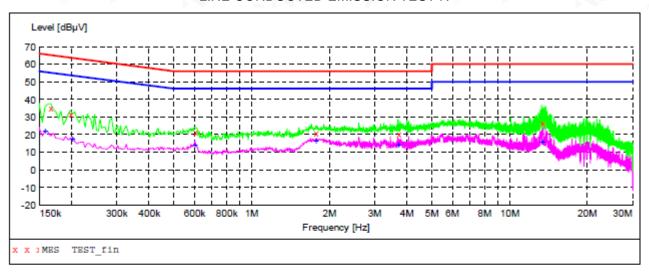
LINE CONDUCTED EMISSION TEST-N

MEASUREMENT RESULT: "TEST_fin"

6/12/2019 11:10AM									
Frequency	Level	Transd	Limit	Margin	Detector	Line	PE		
MHz	dBuV	dB	dBuV	dB					
0.166000	35.30	10.8	65	29.9	QP	N	FLO		
0.198000	31.90	10.9	64	31.8	QP	N	FLO		
0.602000	21.60	10.7	56	34.4	OP	N	FLO		
1.774000	21.30	11.5	56	34.7	QP	N	FLO		
3.698000	20.60	11.6	56	35.4	QP	N	FLO		
13.398000	26.70	12.1	60	33.3	QP	N	FLO

MEASUREMENT RESULT: "TEST_fin2"

6/12/2019 1 Frequency MHz		Transd dB	Limit dBµV	Margin dB	Detector	Line	PE
0.158000 0.202000 0.602000 1.774000 3.698000 13.398000	17.40 14.00 16.40 14.40	10.8 10.9 10.7 11.5 11.6 12.1	56 54 46 46 46 50	33.6 36.1 32.0 29.6 31.6 33.9	AV AV AV AV AV	N N N N N	FLO FLO FLO FLO FLO

RESULT: PASS

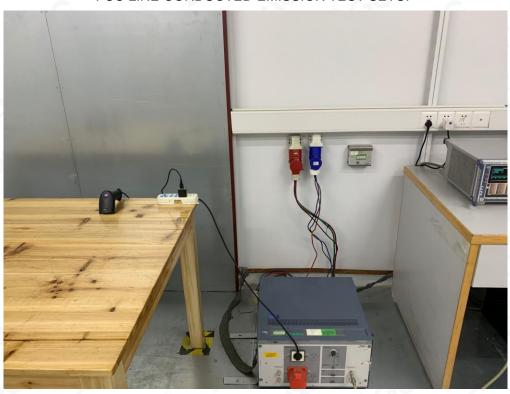
FCC LINE CONDUCTED EMISSION TEST SETUP

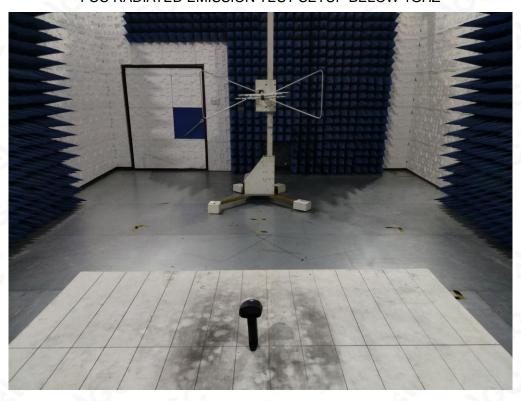
FCC RADIATED EMISSION TEST SETUP BELOW 1GHZ

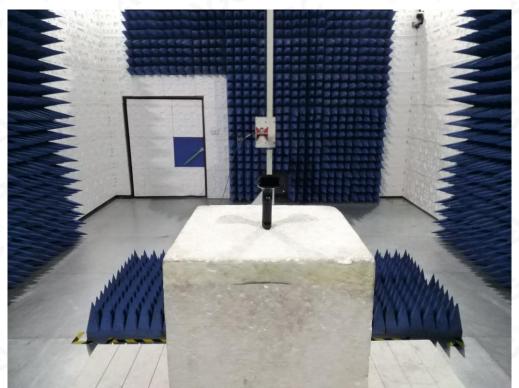
FCC RADIATED EMISSION TEST SETUP ABOVE 1GHZ
