### <Justification of the extended calibration>

If dipoles are verified in return loss ( $< -20\text{dB}$ , within 20% of prior calibration for below 3GHz, and  $< -8\text{dB}$ , within 20% of prior calibration for 5GHz to 6GHz), and in impedance (within 5 ohm of prior calibration), the annual calibration is not necessary and the calibration interval can be extended.

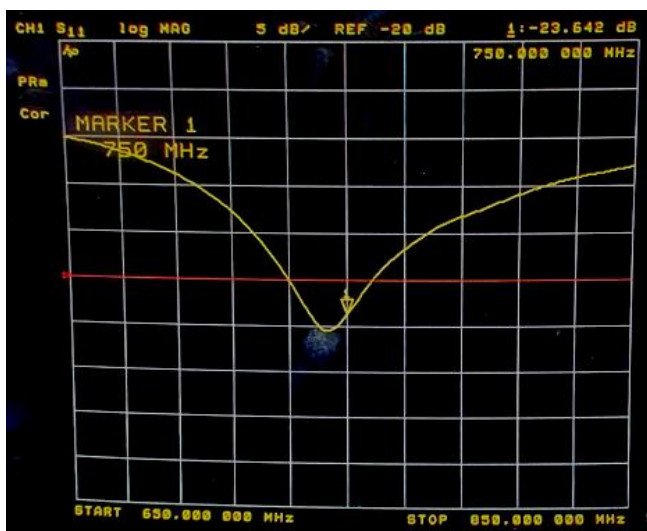
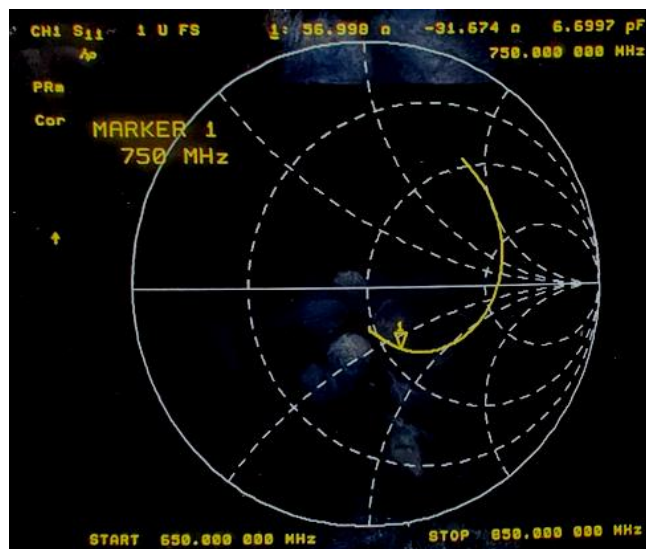
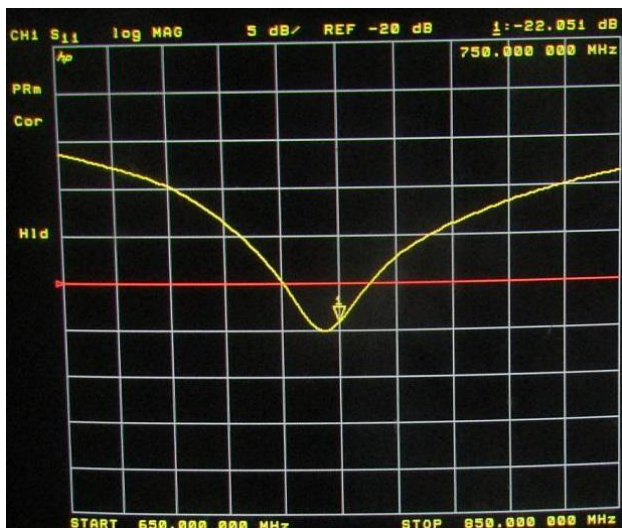
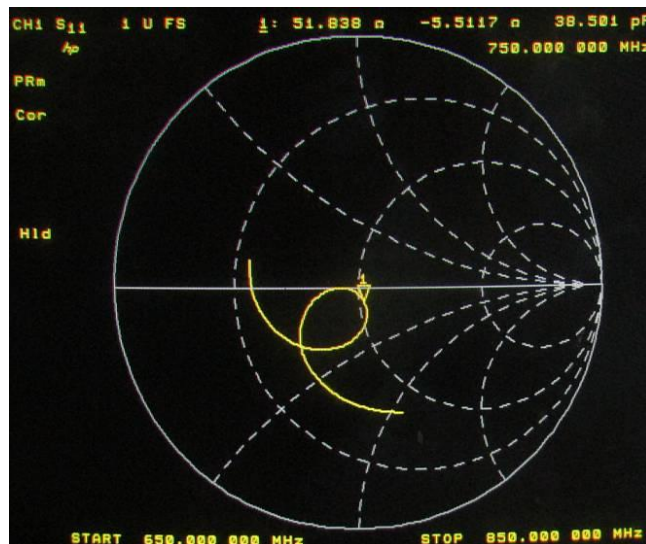
Dipole Verification Data

The return loss is  $< -20\text{dB}$ , within 20% of prior calibration; the impedance is within 5 ohm of prior calibration. Therefore the verification result should support extended calibration.

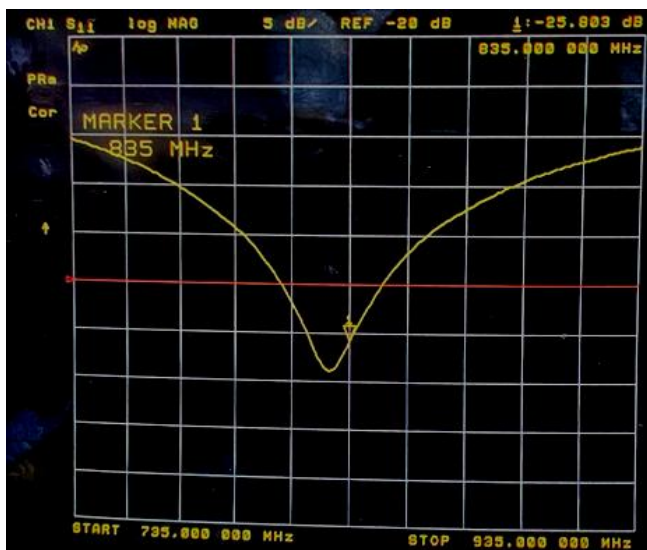
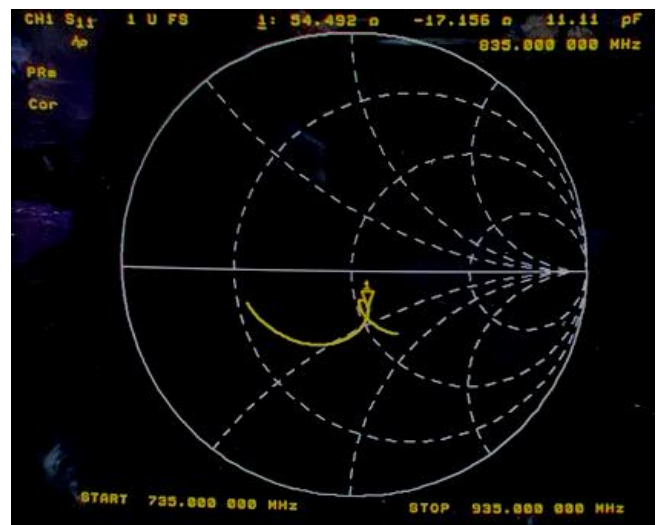
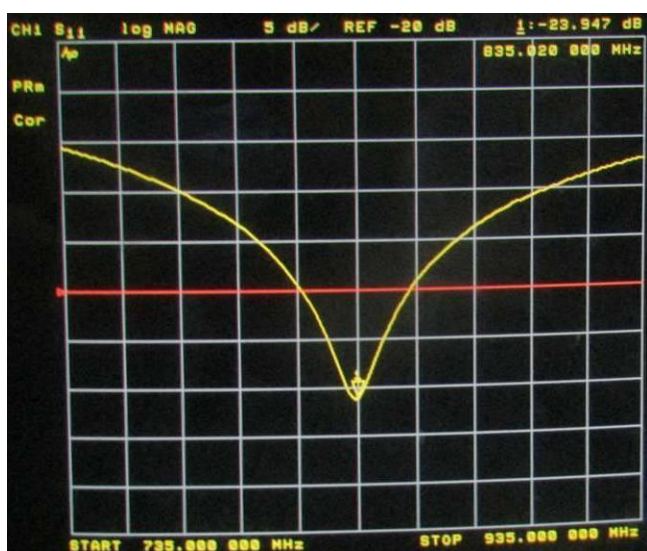
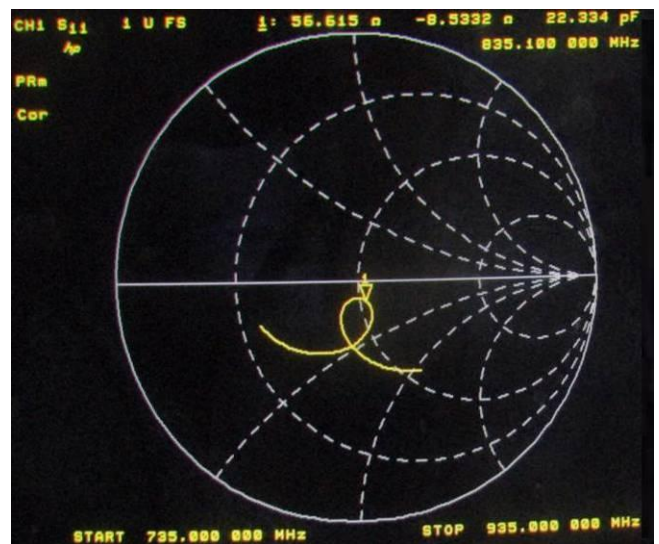
Dipole Verification Data

The return loss is <-20dB, within 20% of prior calibration; the impedance is within 5 ohm of prior calibration. Therefore the verification result should support extended calibration.

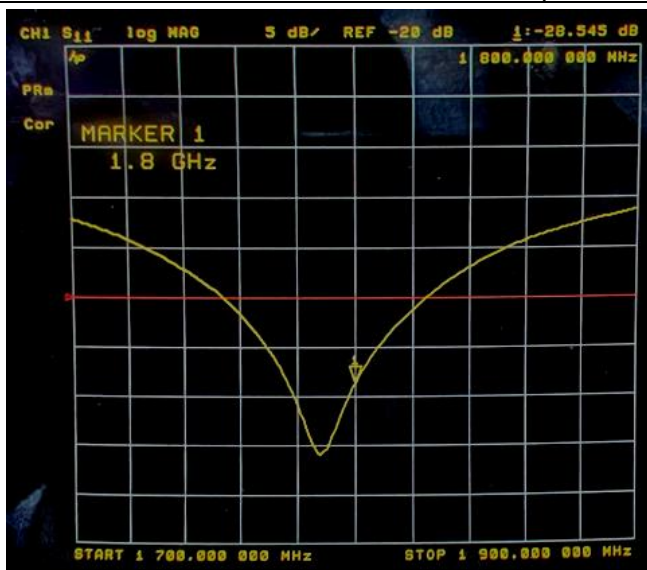
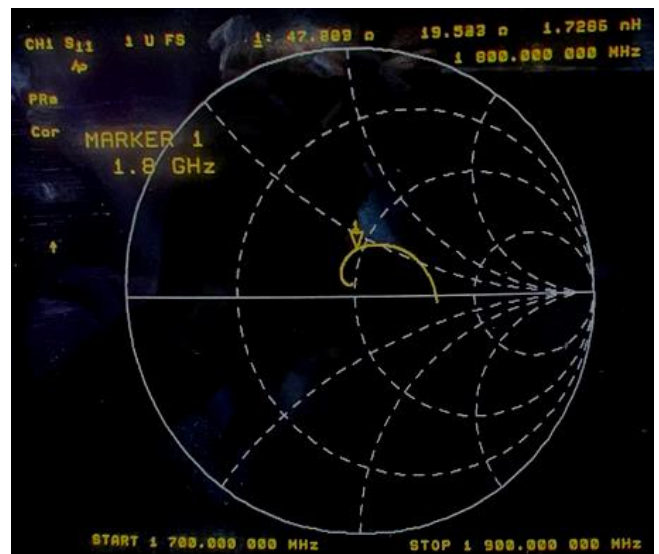
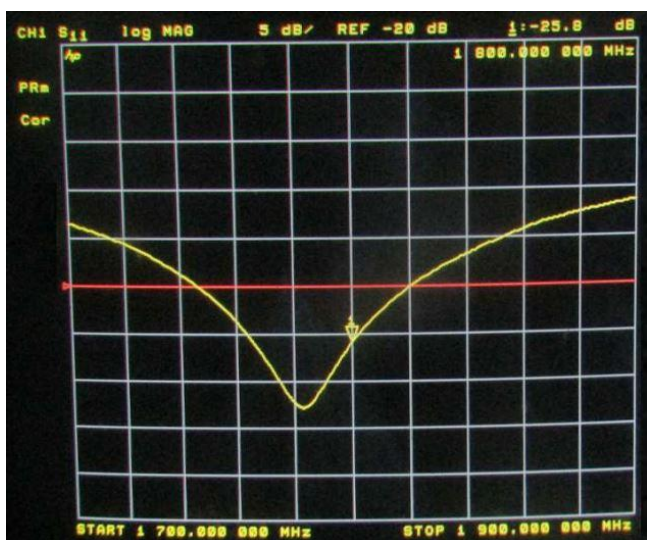
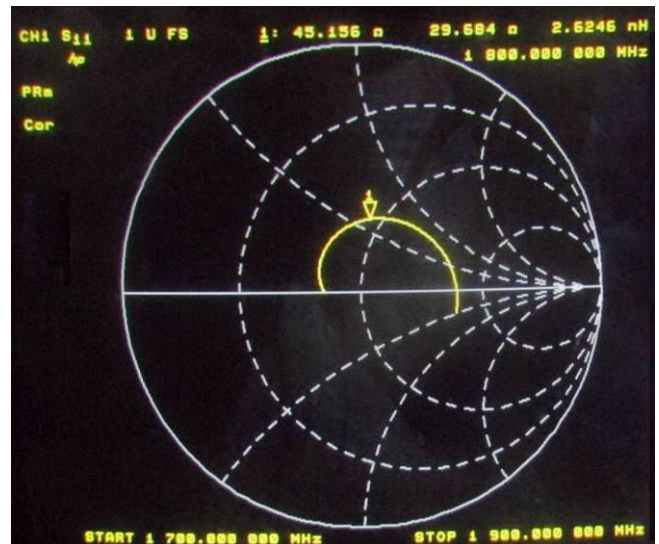
Dipole Verification Data

The return loss is <-20dB, within 20% of prior calibration; the impedance is within 5 ohm of prior calibration. Therefore the verification result should support extended calibration.

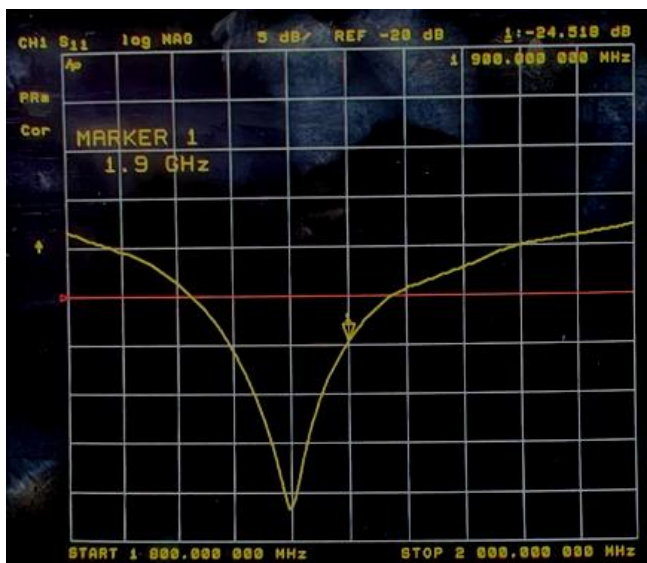
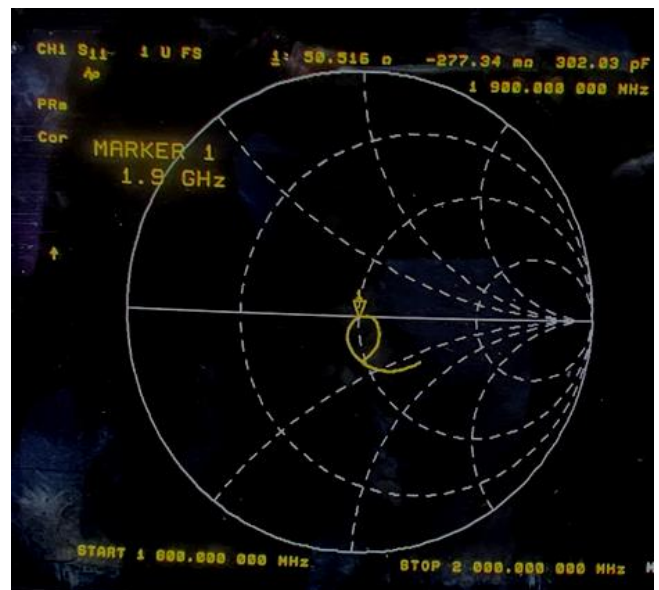
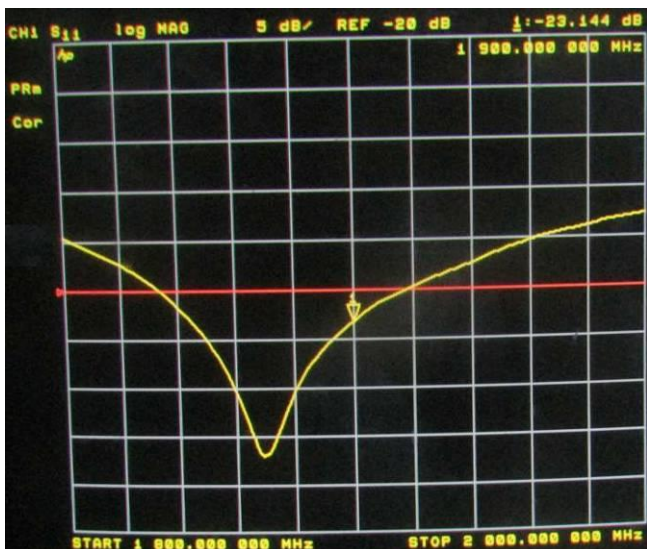
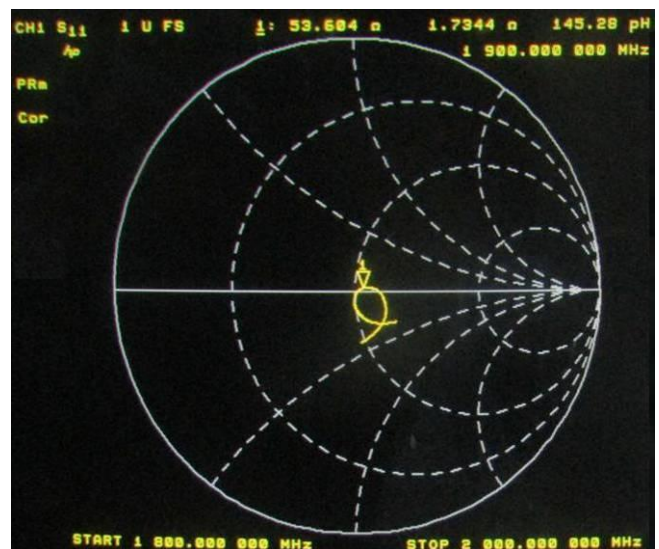
Dipole Verification Data

The return loss is <-20dB, within 20% of prior calibration; the impedance is within 5 ohm of prior calibration. Therefore the verification result should support extended calibration.

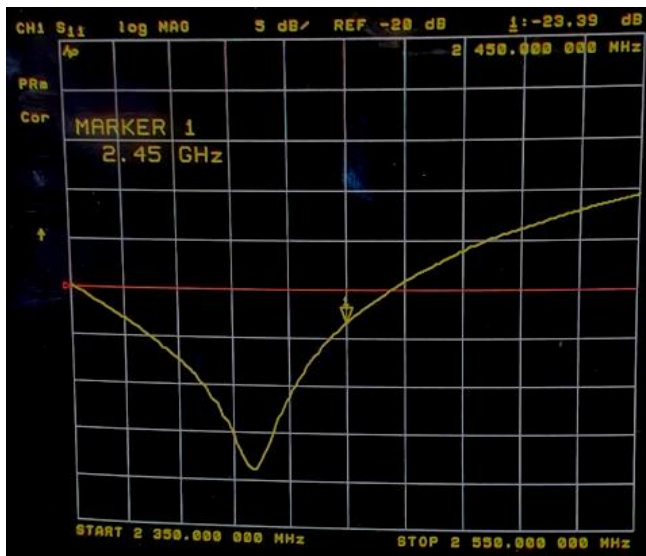
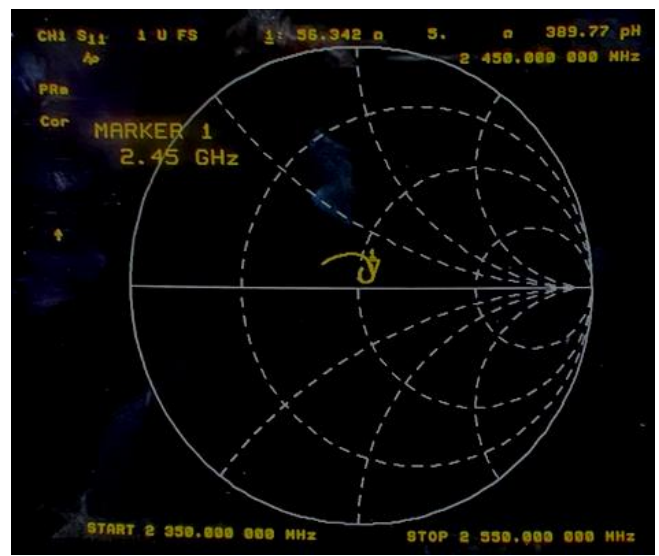
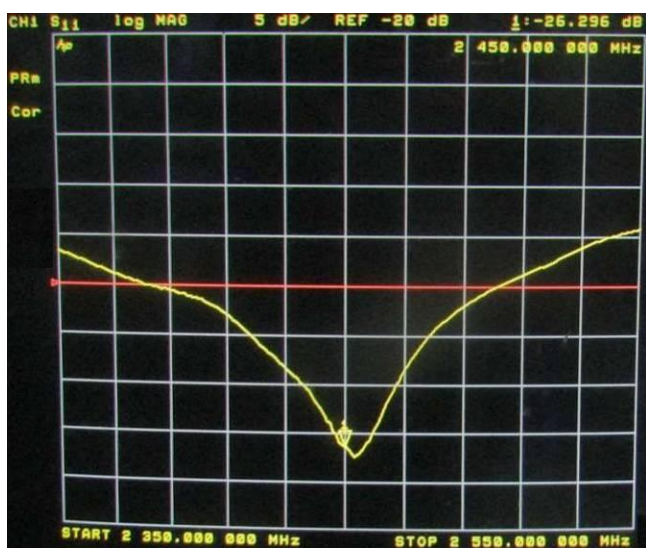
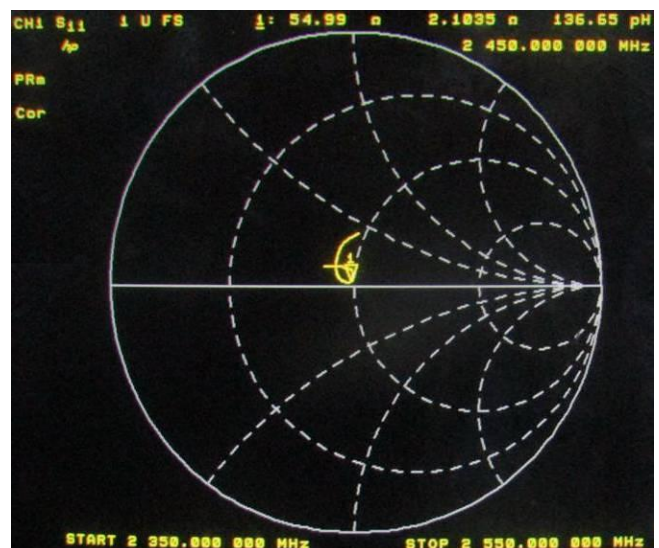
Dipole Verification Data

The return loss is <-20dB, within 20% of prior calibration; the impedance is within 5 ohm of prior calibration. Therefore the verification result should support extended calibration.

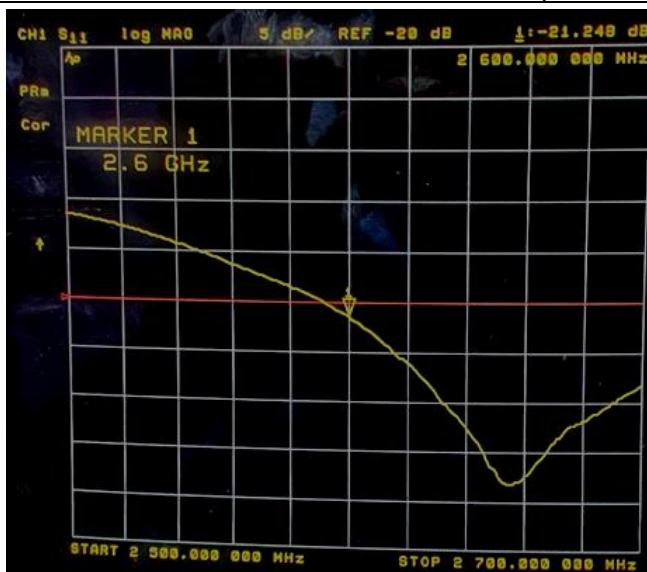
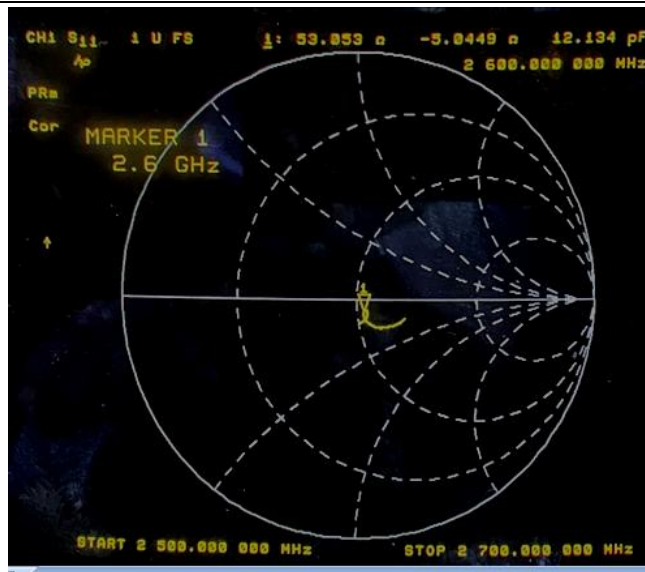
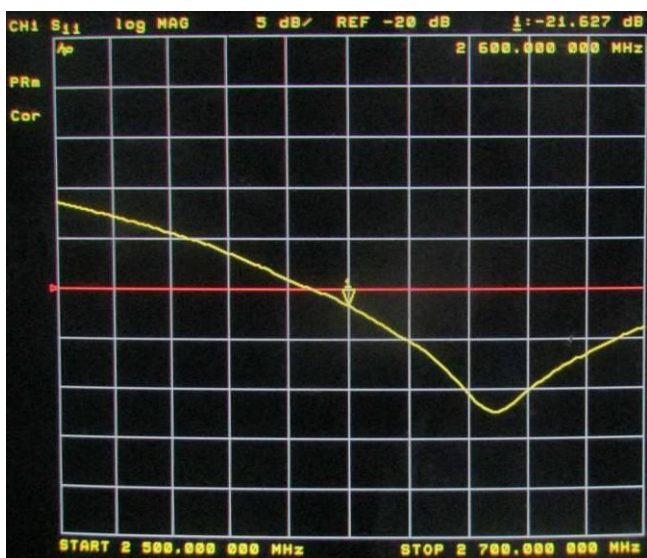
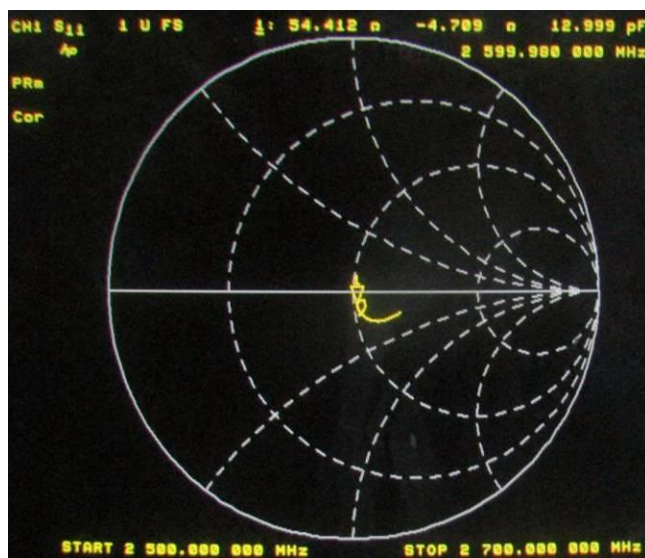
Dipole Verification Data

The return loss is <-20dB, within 20% of prior calibration; the impedance is within 5 ohm of prior calibration. Therefore the verification result should support extended calibration.

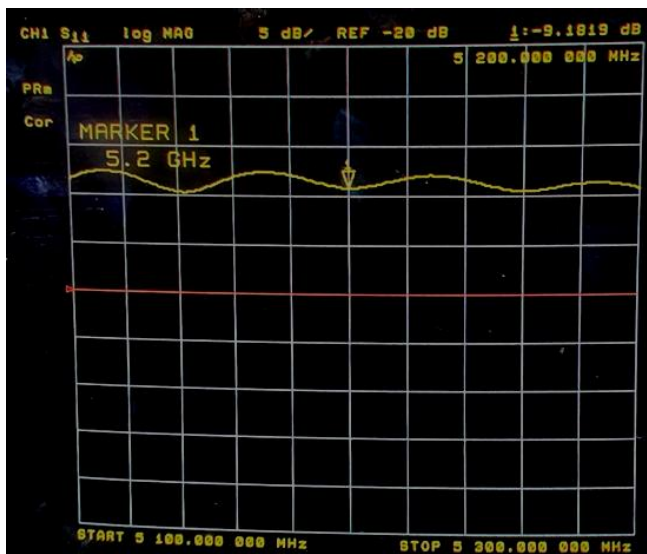
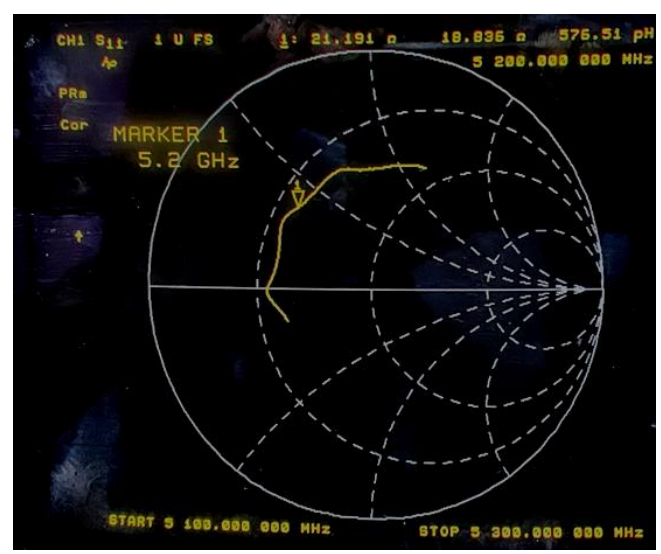
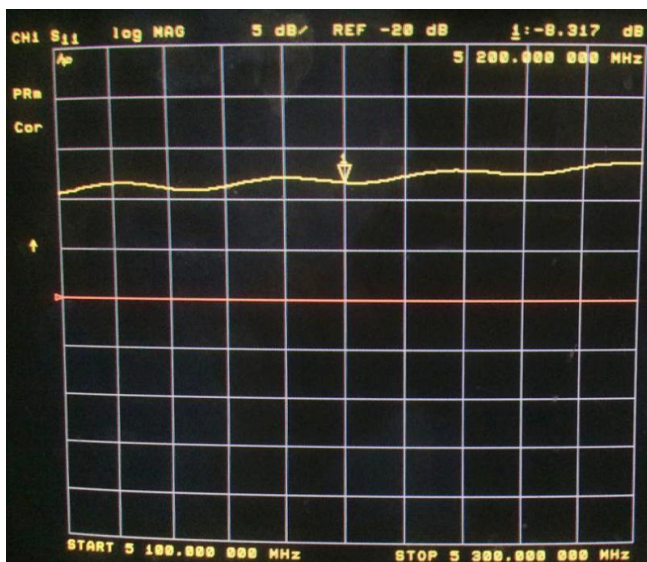
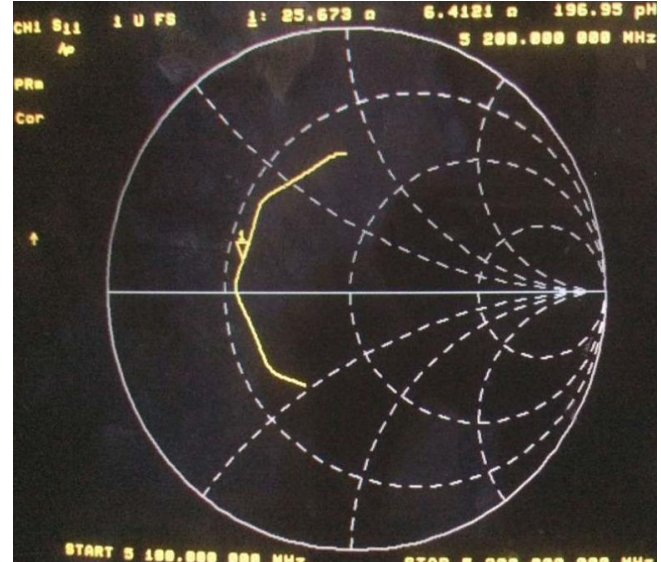
Dipole Verification Data

The return loss is <-8dB, within 20% of prior calibration; the impedance is within 5 ohm of prior calibration. Therefore the verification result should support extended calibration.

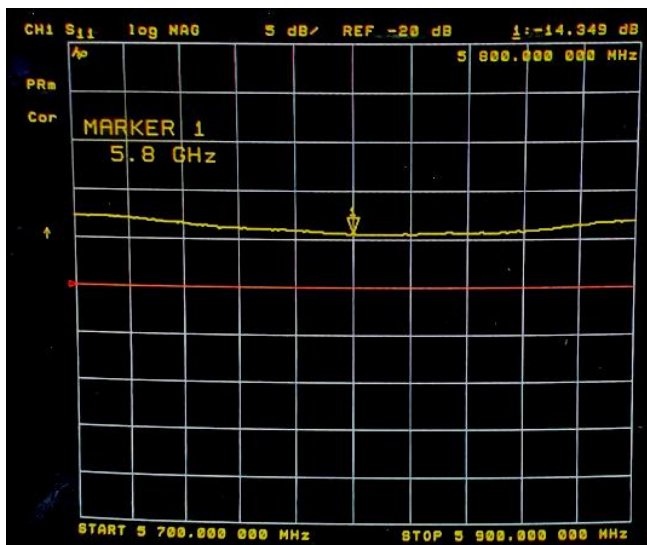
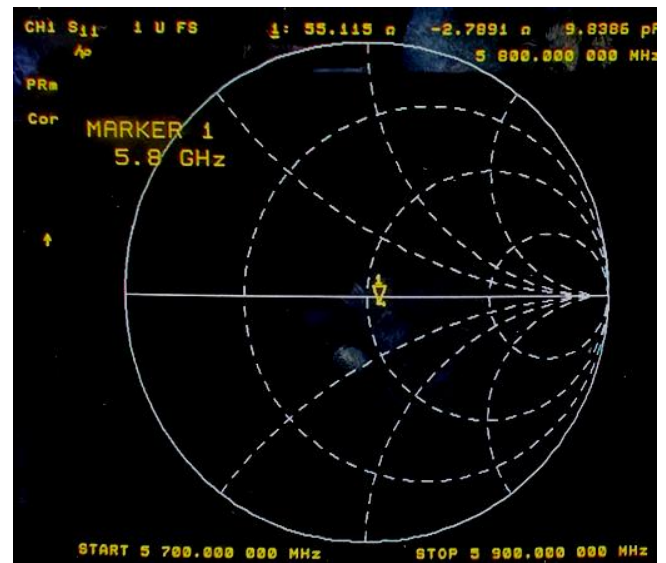
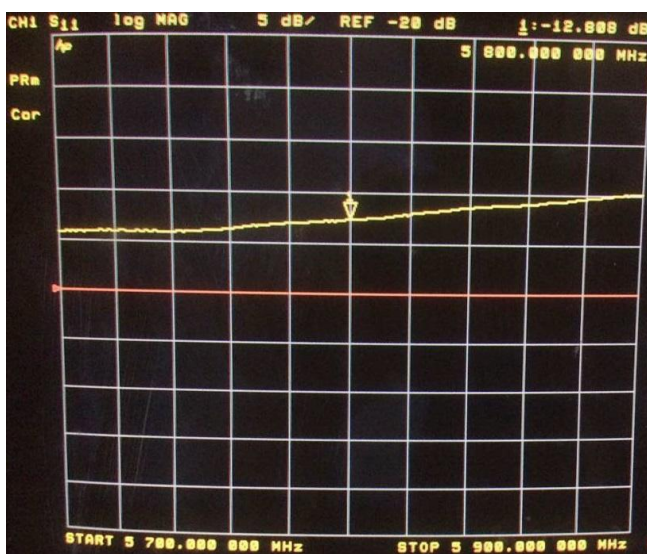
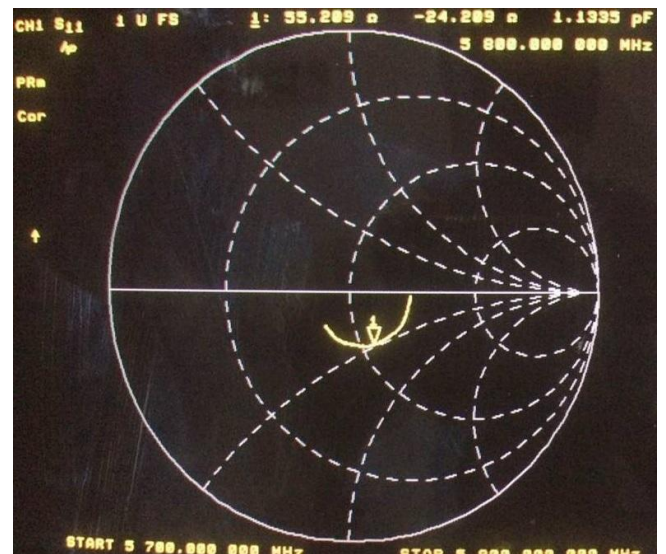
Dipole Verification Data

The return loss is <-8dB, within 20% of prior calibration; the impedance is within 5 ohm of prior calibration. Therefore the verification result should support extended calibration.
