## Appendix B: photographs of test setup

Reference to the test report no. BLA-EMC-202504-A3501

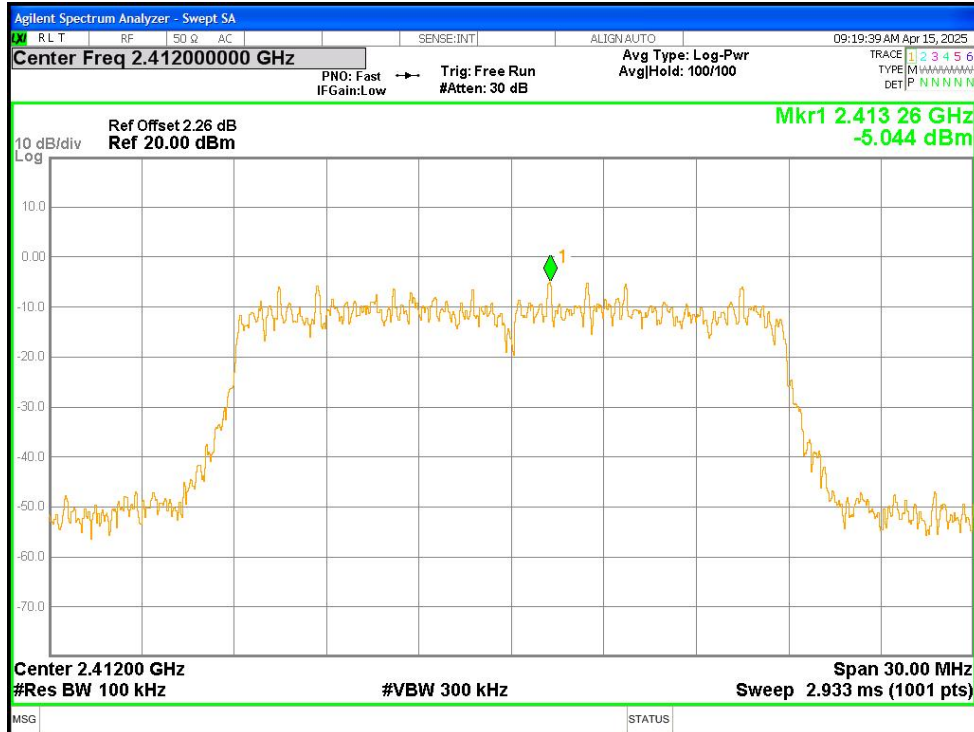
Tx. Spurious NVNT n20 2412MHz Ant1 Ref

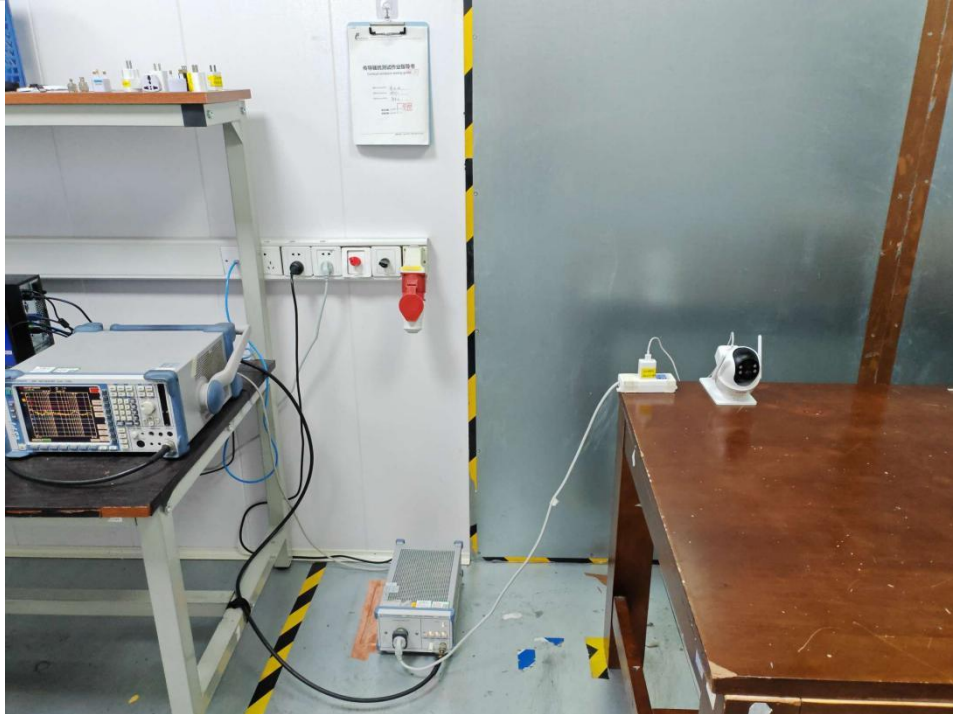
Conducted emissions at AC power line (150kHz-30MHz)
