Report No.: AGC09525191101FE03

APPENDIX A: PHOTOGRAPHS OF TEST SETUP

APPENDIX B: PHOTOGRAPHS OF EUT

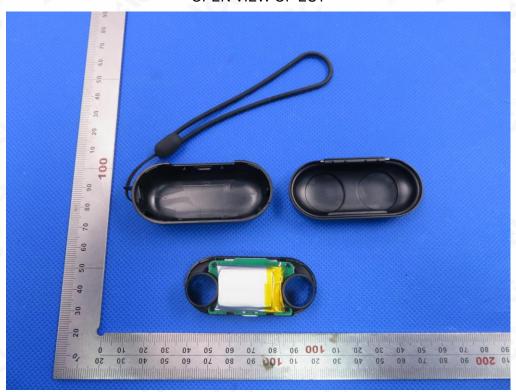
OPEN VIEW OF EUT
