# Radiated Emission Measurement

Condition : FCC\_part 15E RE\_Above 1GHz\_PK

EUT : W6M22311-23090

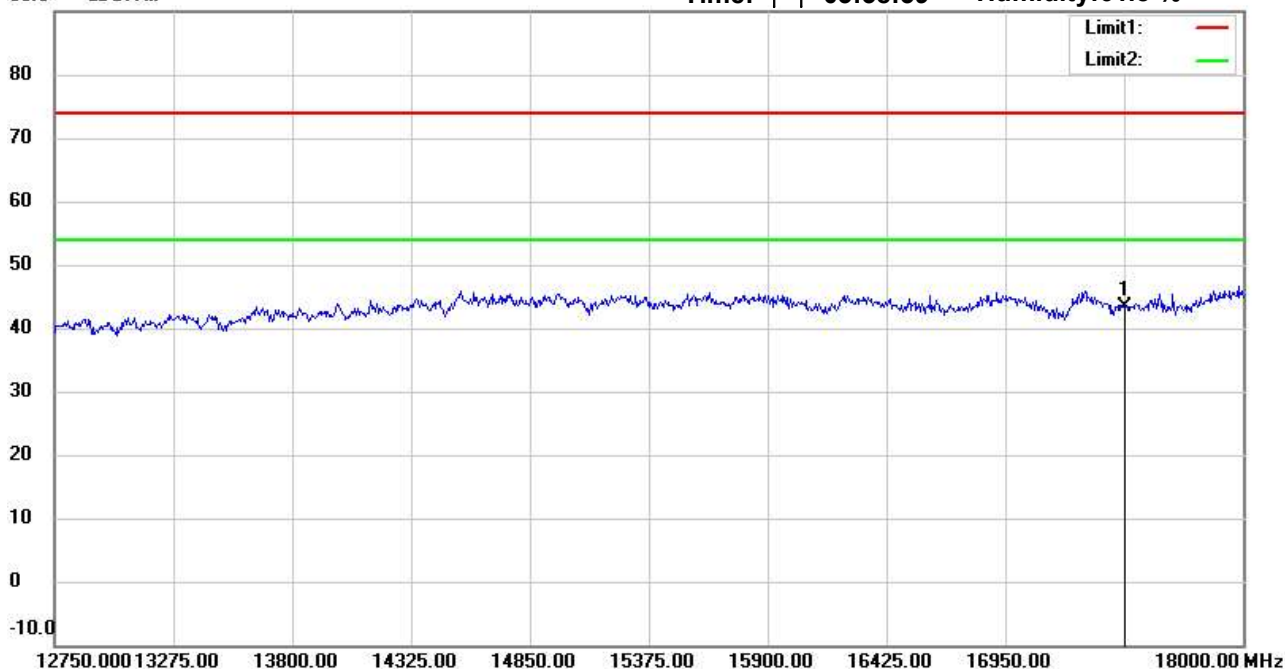
Test Mode : TX 802.11a CH165

Polarization: Vertical

| Mk. | Frequency (MHz) | Reading (dBuV) | Detector | Corr. factor (dB/m) | Result (dBuV/m) | Limit (dBuV/m) | Ant.Pos (cm) | Tab.Pos (deg.) | Margin (dB) | Comment |
|---|---|---|---|---|---|---|---|---|---|---|
| * | 17475.000 | 20.26 | peak | 23.21 | 43.47 | 74.00 | 150 | 27 | -30.53 | |

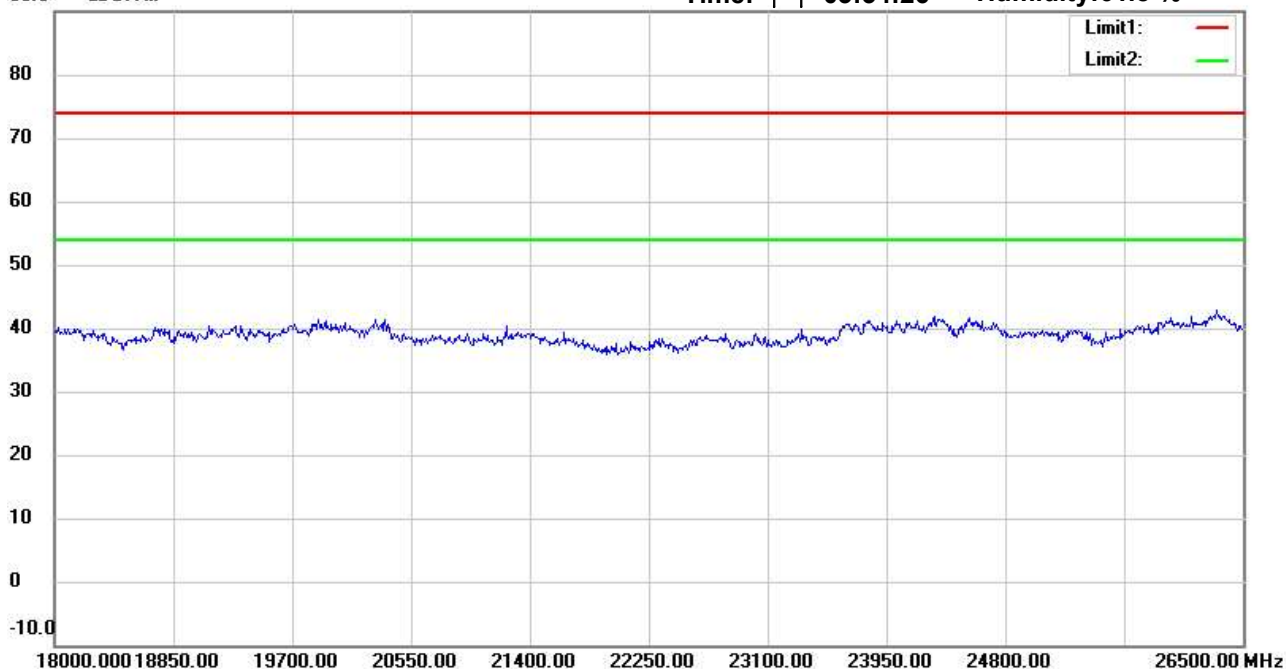
Condition : FCC\_part 15E RE\_Above 1GHz\_PK

Test Mode : TX 802.11a CH165

Polarization: Horizontal

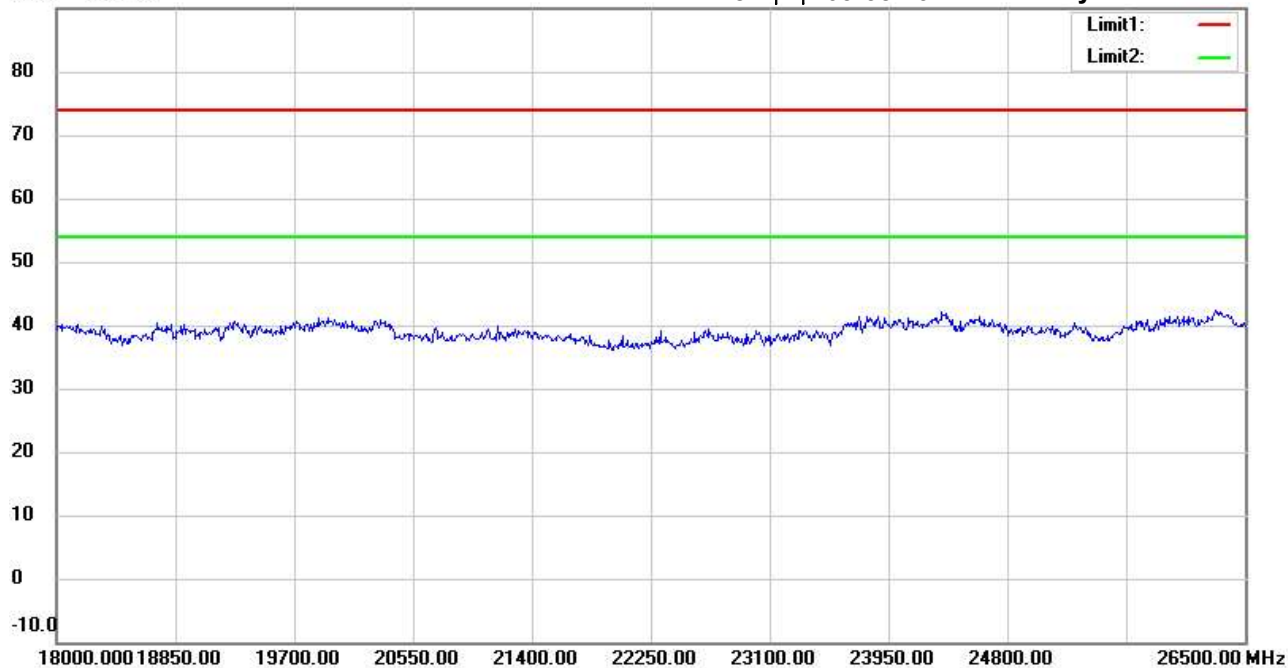
Condition : FCC\_part 15E RE\_Above 1GHz\_PK

Test Mode : TX 802.11a CH165

Polarization: Vertical

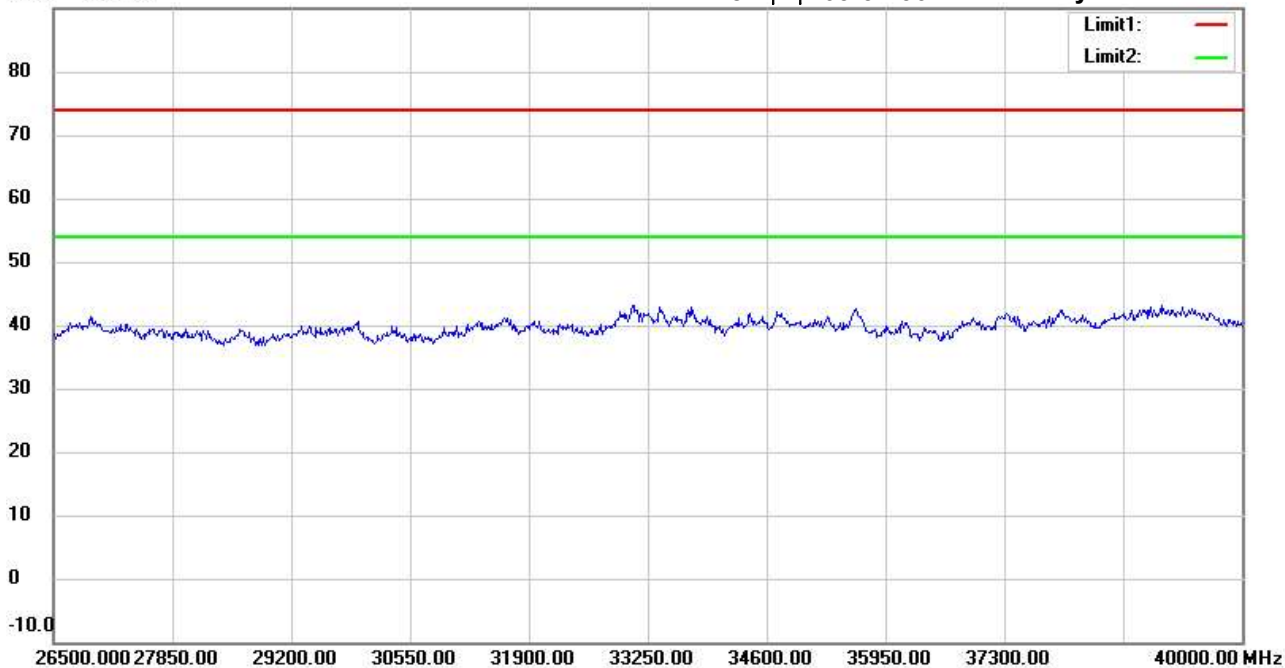
Condition : FCC\_part 15E RE\_Above 1GHz\_PK

Test Mode : TX 802.11a CH165

Polarization: **Horizontal**

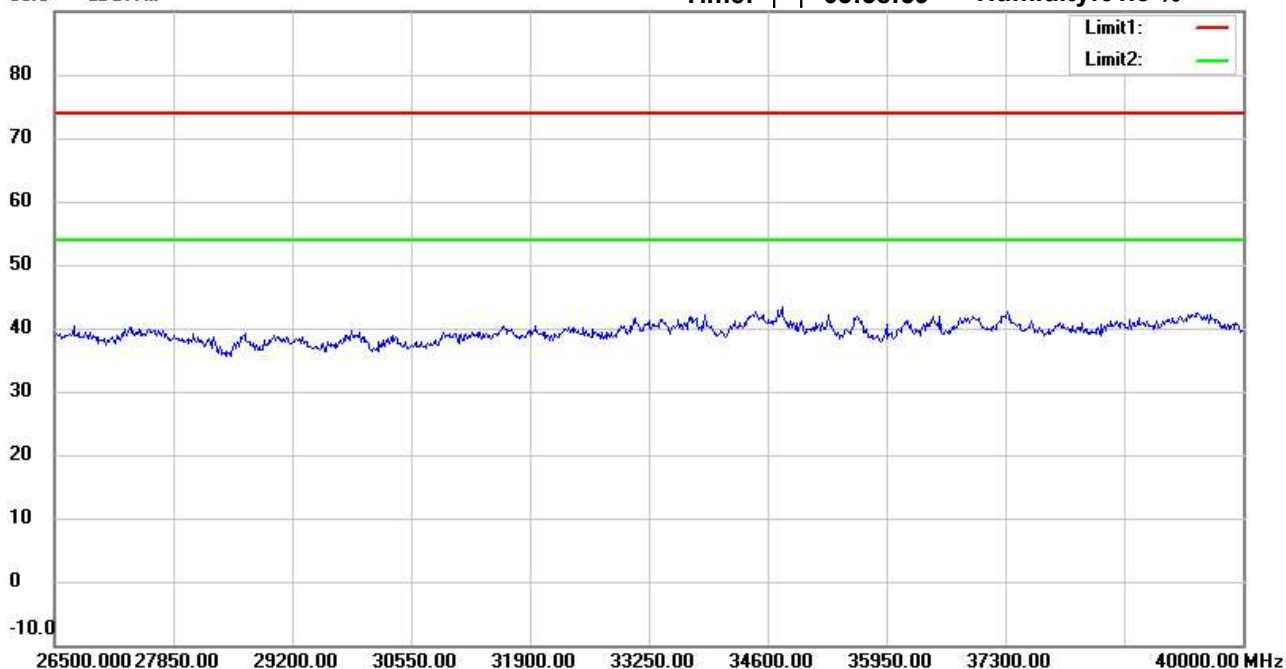
Condition : FCC\_part 15E RE\_Above 1GHz\_PK

Test Mode : TX 802.11a CH165

Polarization: **Vertical**

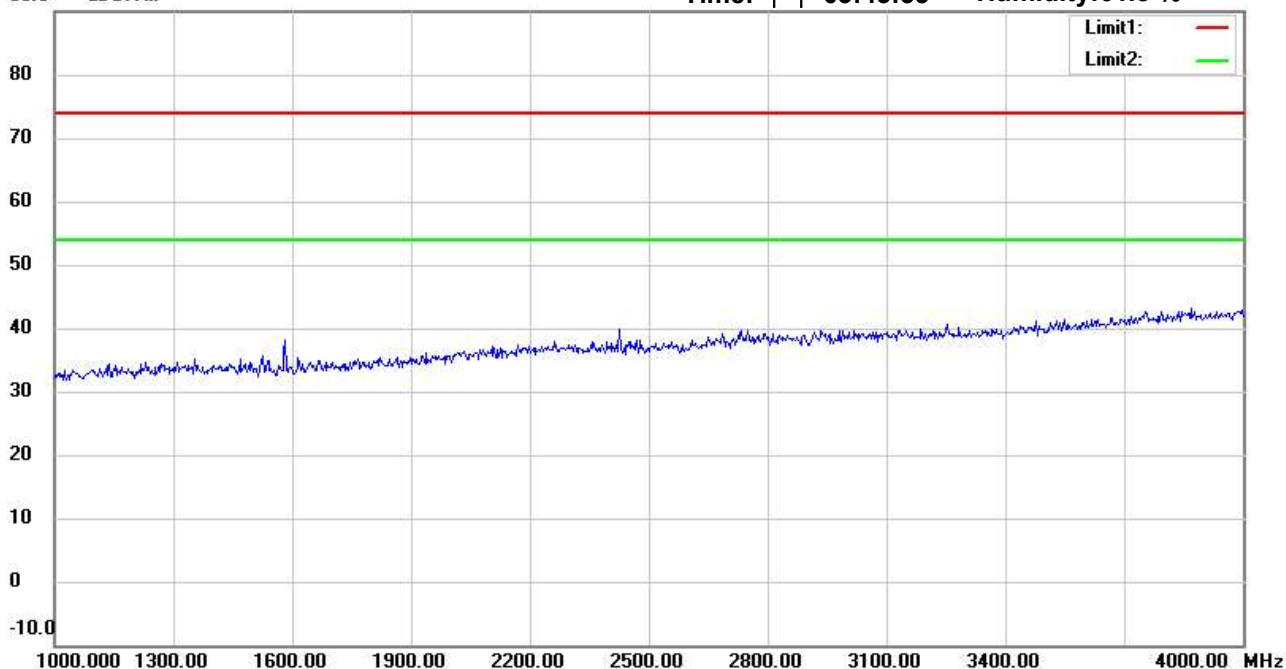
Condition : FCC\_part 15E RE\_Above 1GHz\_PK

Test Mode : TX 802.11n20 CH36

Polarization: **Horizontal**

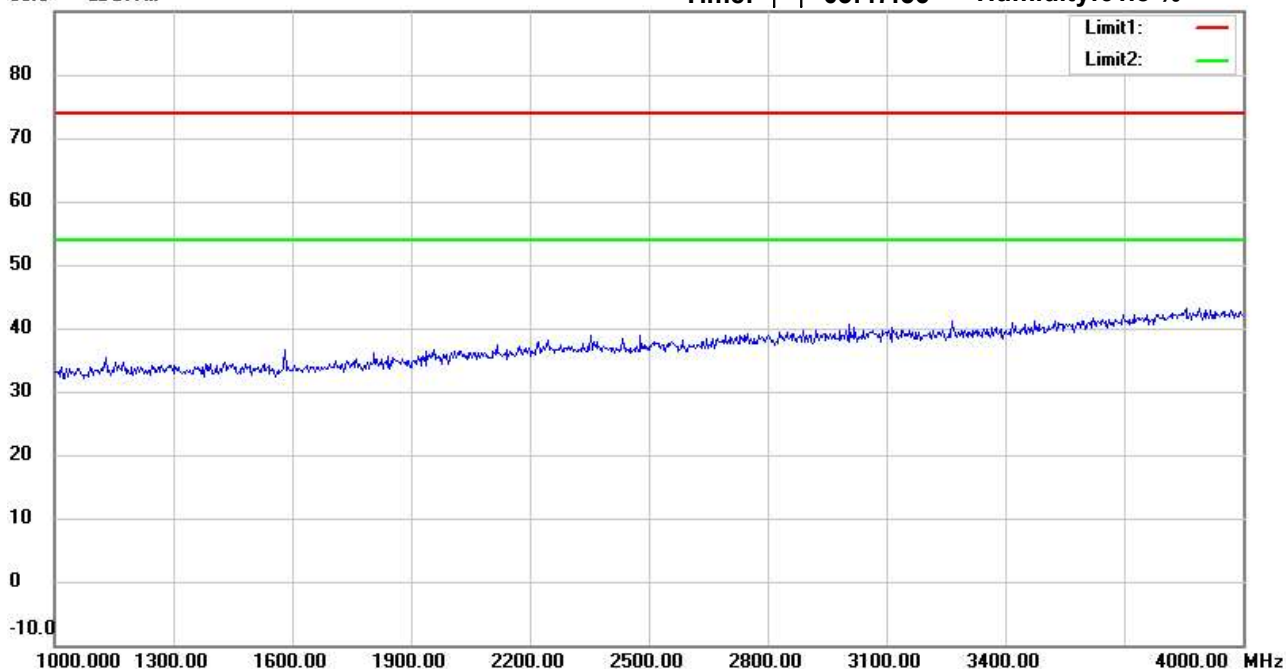
Condition : FCC\_part 15E RE\_Above 1GHz\_PK

Test Mode : TX 802.11n20 CH36

Polarization: **Vertical**

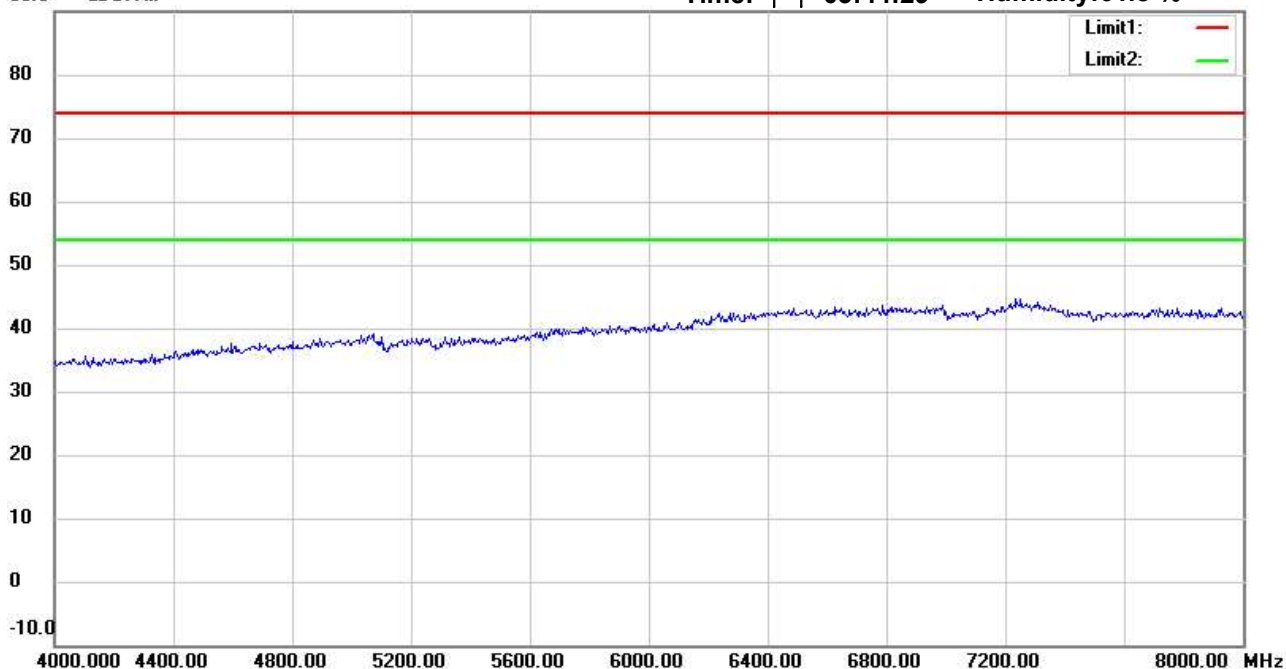
Condition : FCC\_part 15E RE\_Above 1GHz\_PK

Test Mode : TX 802.11n20 CH36

Polarization: **Horizontal**

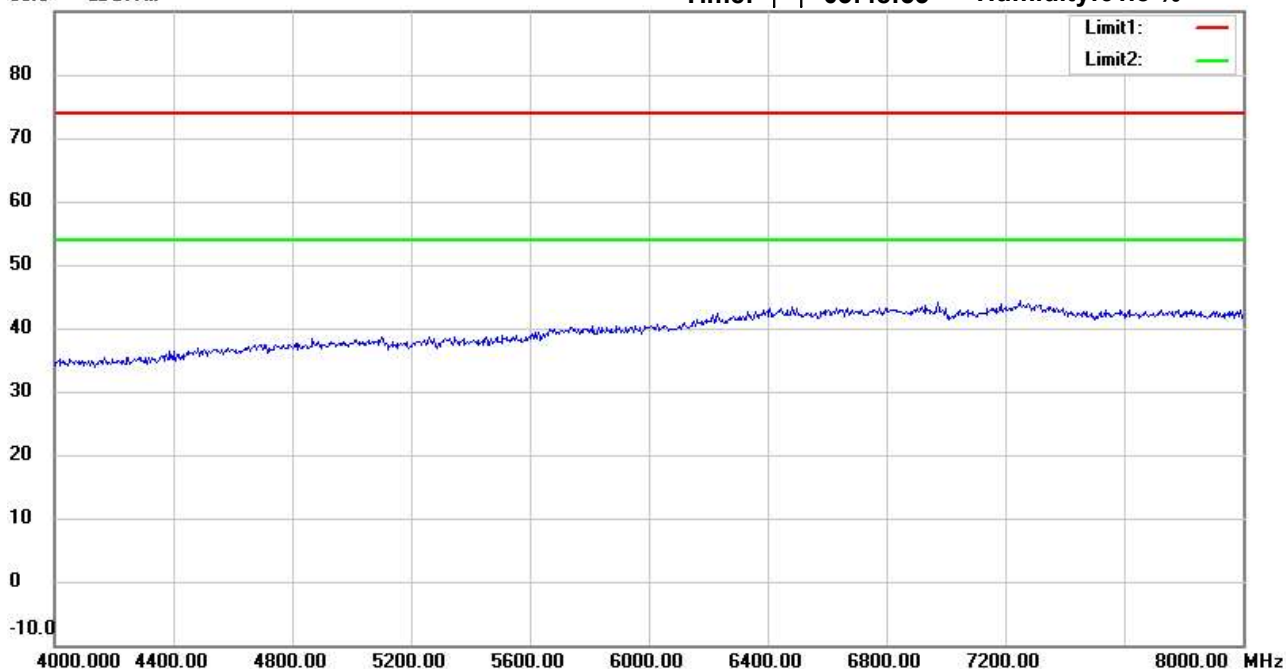
Condition : FCC\_part 15E RE\_Above 1GHz\_PK

Test Mode : TX 802.11n20 CH36

Polarization: **Vertical**

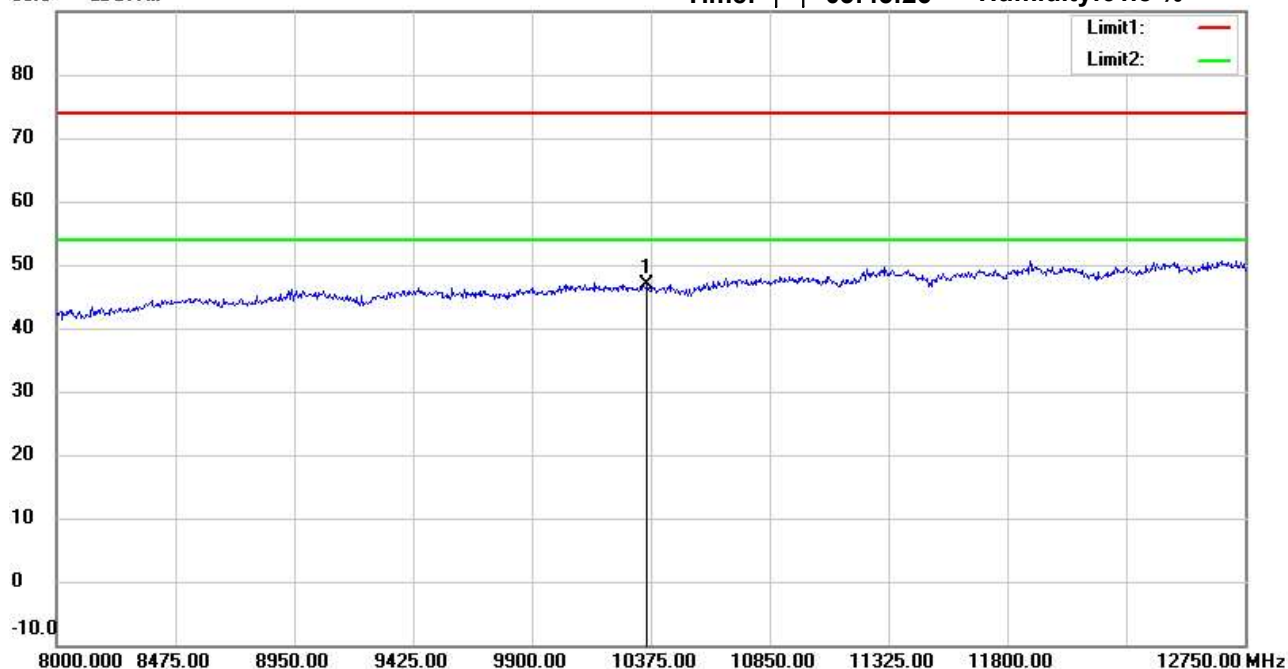
Condition : FCC\_part 15E RE\_Above 1GHz\_PK

Test Mode : TX 802.11n20 CH36

Polarization: **Horizontal**

| Mk. | Frequency (MHz) | Reading (dBuV) | Detector | Corr. factor (dB/m) | Result (dBuV/m) | Limit (dBuV/m) | Ant.Pos (cm) | Tab.Pos (deg.) | Margin (dB) | Comment |
|---|---|---|---|---|---|---|---|---|---|---|
| * | 10360.000 | 32.77 | peak | 14.15 | 46.92 | 74.00 | 150 | 342 | -27.08 | |

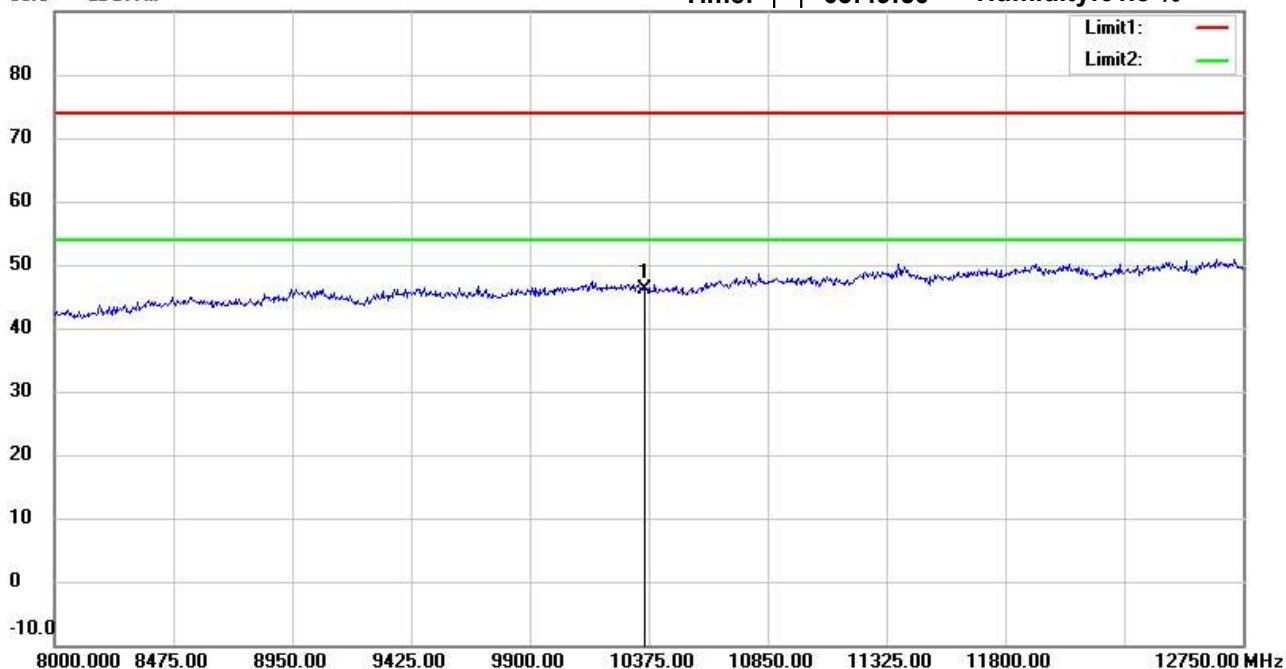
Condition : FCC\_part 15E RE\_Above 1GHz\_PK

Test Mode : TX 802.11n20 CH36

Polarization: Vertical

| Mk. | Frequency (MHz) | Reading (dBuV) | Detector | Corr. factor (dB/m) | Result (dBuV/m) | Limit (dBuV/m) | Ant.Pos (cm) | Tab.Pos (deg.) | Margin (dB) | Comment |
|---|---|---|---|---|---|---|---|---|---|---|
| * | 10360.000 | 31.88 | peak | 14.15 | 46.03 | 74.00 | 150 | 213 | -27.97 | |

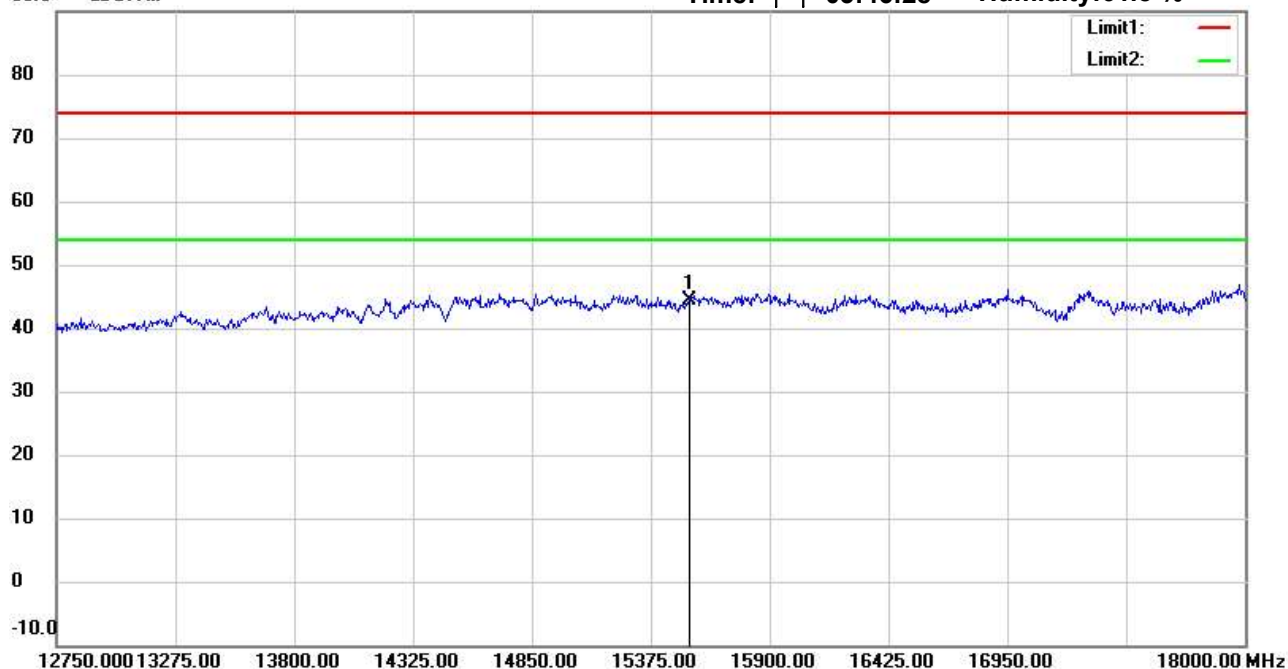
Condition : FCC\_part 15E RE\_Above 1GHz\_PK

Test Mode : TX 802.11n20 CH36

Polarization: **Horizontal**

| Mk. | Frequency (MHz) | Reading (dBuV) | Detector | Corr. factor (dB/m) | Result (dBuV/m) | Limit (dBuV/m) | Ant.Pos (cm) | Tab.Pos (deg.) | Margin (dB) | Comment |
|---|---|---|---|---|---|---|---|---|---|---|
| * | 15540.000 | 21.07 | peak | 23.41 | 44.48 | 74.00 | 150 | 93 | -29.52 | |

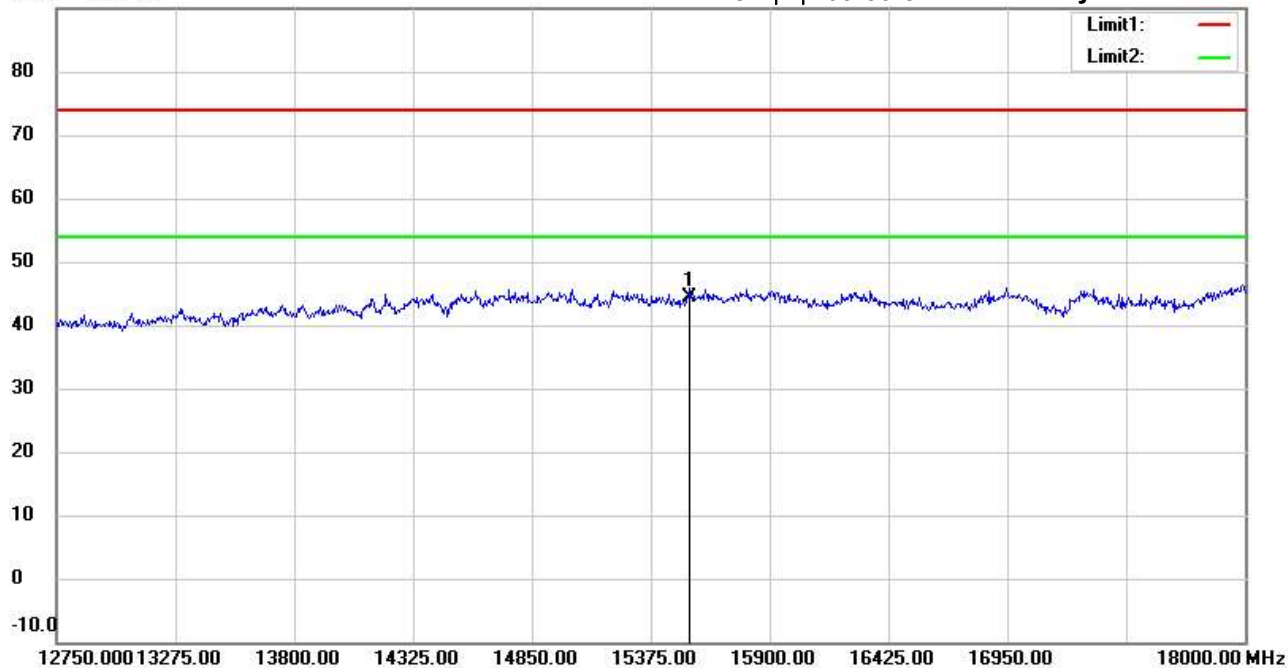
Condition : FCC\_part 15E RE\_Above 1GHz\_PK

Test Mode : TX 802.11n20 CH36

Polarization: **Vertical**

| Mk. | Frequency (MHz) | Reading (dBuV) | Detector | Corr. factor (dB/m) | Result (dBuV/m) | Limit (dBuV/m) | Ant.Pos (cm) | Tab.Pos (deg.) | Margin (dB) | Comment |
|---|---|---|---|---|---|---|---|---|---|---|
| * | 15540.000 | 21.04 | peak | 23.41 | 44.45 | 74.00 | 150 | 287 | -29.55 | |

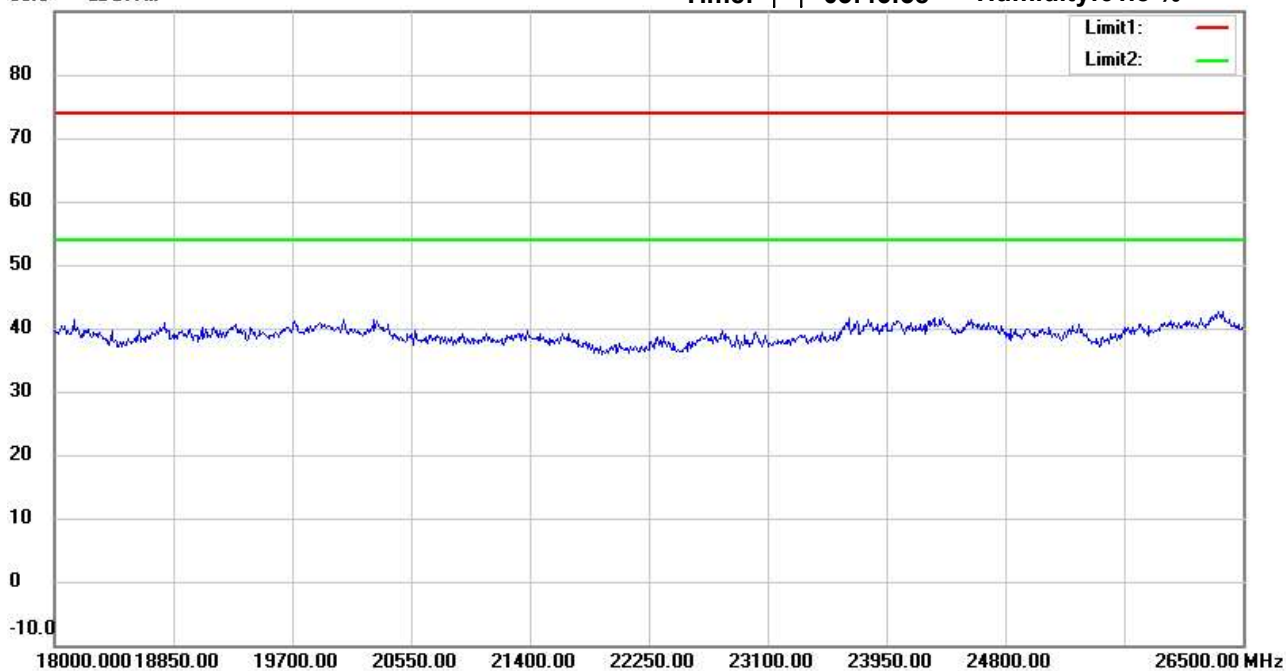
Condition : FCC\_part 15E RE\_Above 1GHz\_PK

Test Mode : TX 802.11n20 CH36

Polarization: Horizontal

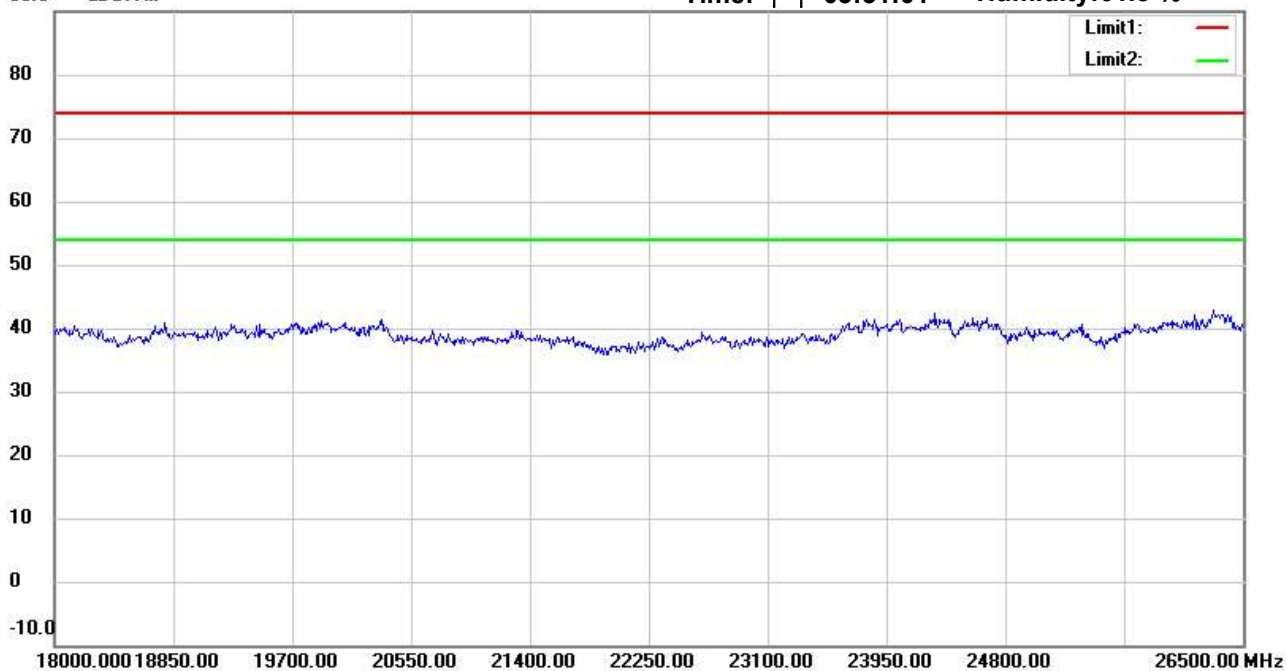
Condition : FCC\_part 15E RE\_Above 1GHz\_PK

Test Mode : TX 802.11n20 CH36

Polarization: Vertical

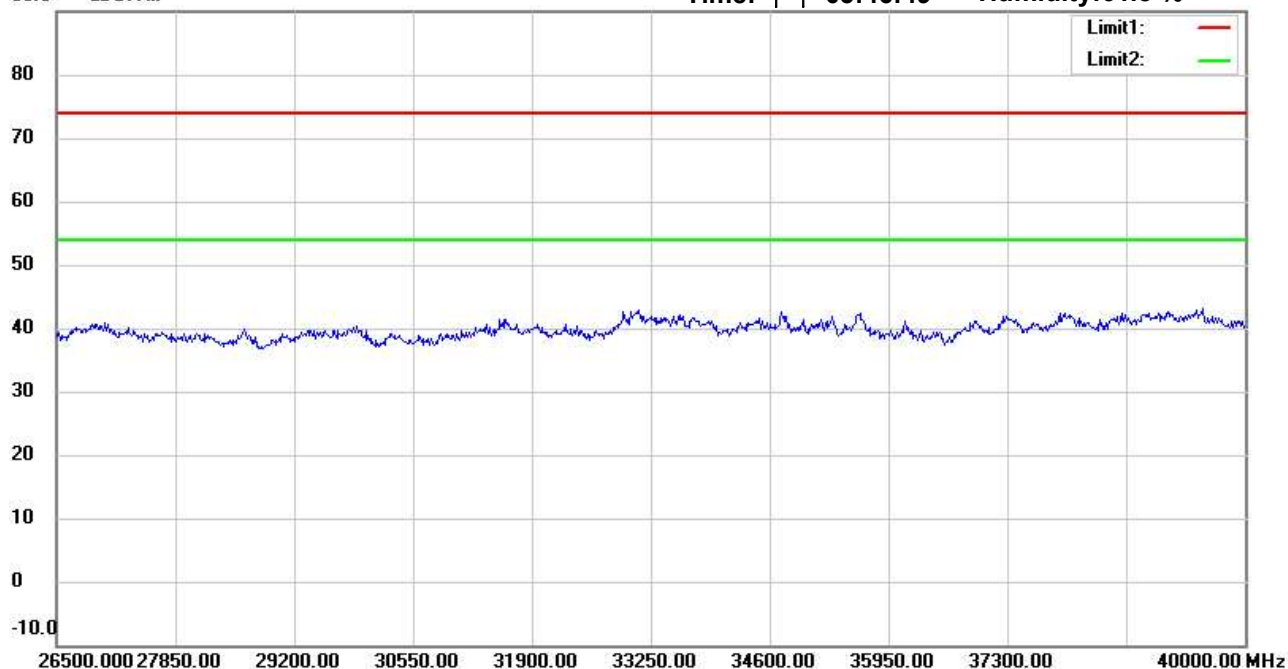
Condition : FCC\_part 15E RE\_Above 1GHz\_PK

Test Mode : TX 802.11n20 CH36

Polarization: **Horizontal**

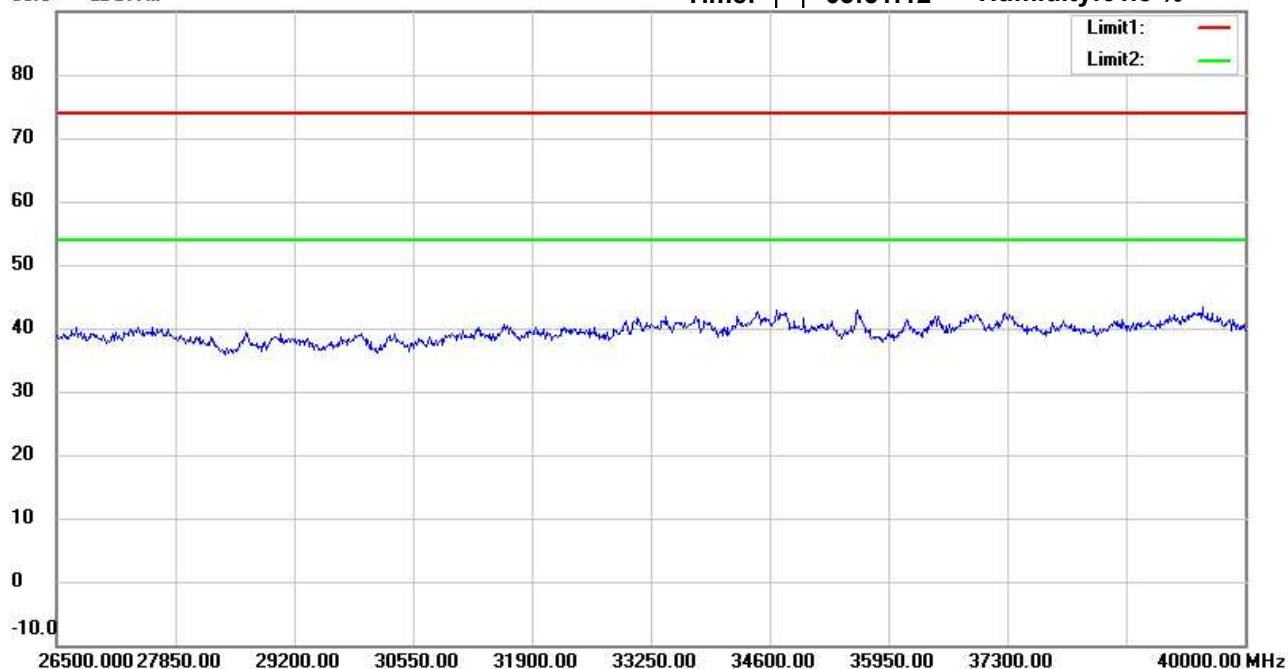
Condition : FCC\_part 15E RE\_Above 1GHz\_PK

Test Mode : TX 802.11n20 CH36

Polarization: Vertical

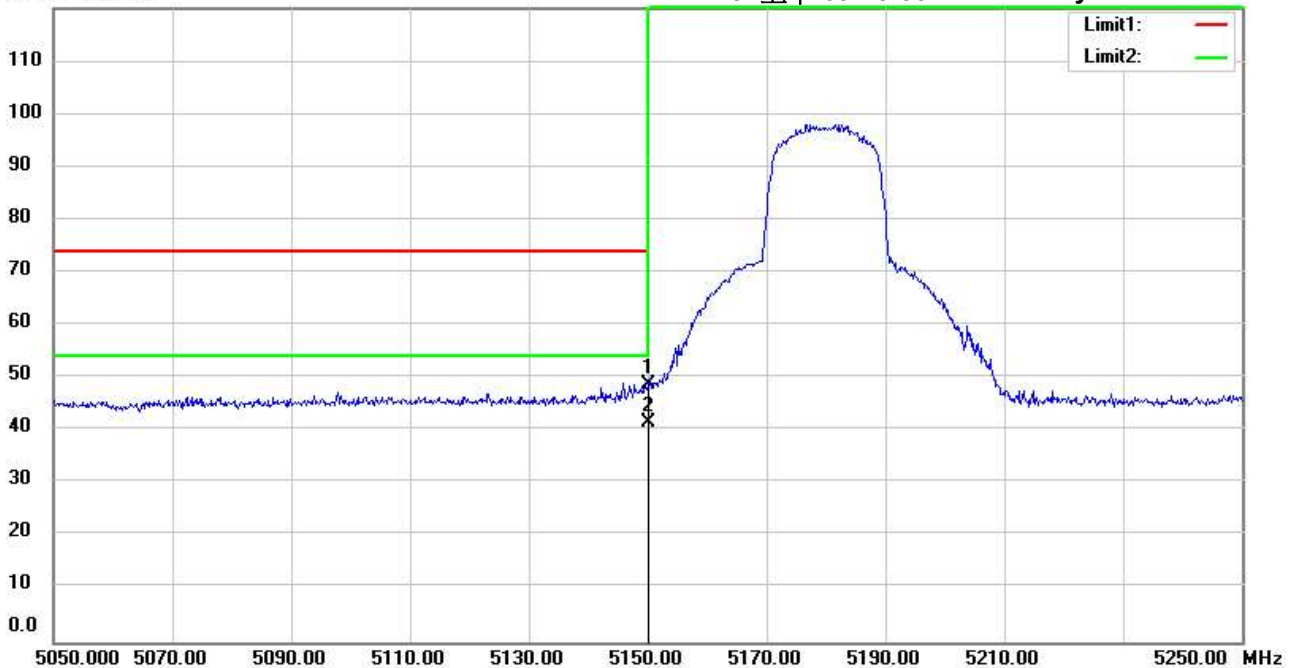
Condition : FCC 15.407 PK (Bandedge)(B1\_5150\_5250)

Polarization: **Horizontal**

Test Mode : TX 802.11n20 CH36

| Mk. | Frequency (MHz) | Reading (dBuV) | Detector | Corr. factor (dB/m) | Result (dBuV/m) | Limit (dBuV/m) | Ant.Pos (cm) | Tab.Pos (deg.) | Margin (dB) | Comment |
|---|---|---|---|---|---|---|---|---|---|---|
| | 5150.000 | 43.41 | peak | 5.31 | 48.72 | 74.00 | 150 | 312 | -25.28 | |
| * | 5150.000 | 36.25 | AVG | 5.31 | 41.56 | 54.00 | 150 | 312 | -12.44 | |

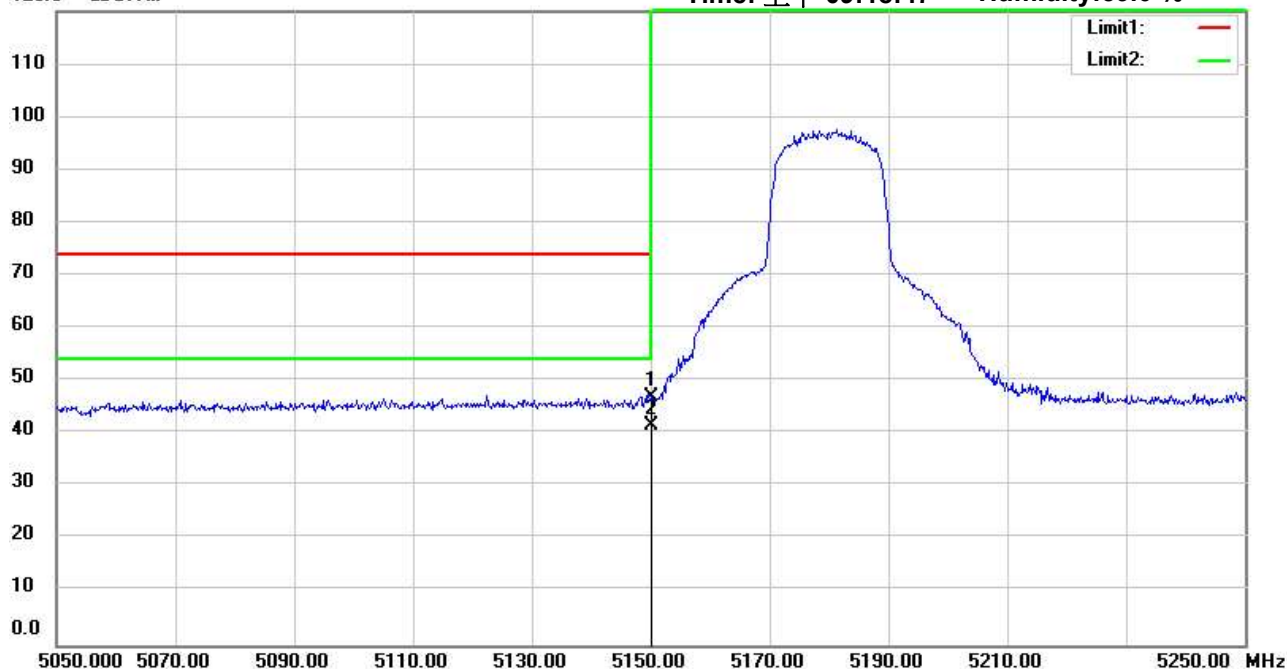
Condition : FCC 15.407 PK (Bandedge)(B1\_5150\_5250)

Polarization: **Vertical**

Test Mode : TX 802.11n20 CH36

| Mk. | Frequency (MHz) | Reading (dBuV) | Detector | Corr. factor (dB/m) | Result (dBuV/m) | Limit (dBuV/m) | Ant.Pos (cm) | Tab.Pos (deg.) | Margin (dB) | Comment |
|---|---|---|---|---|---|---|---|---|---|---|
| | 5150.000 | 41.76 | peak | 5.31 | 47.07 | 74.00 | 150 | 82 | -26.93 | |
| * | 5150.000 | 36.21 | AVG | 5.31 | 41.52 | 54.00 | 150 | 82 | -12.48 | |

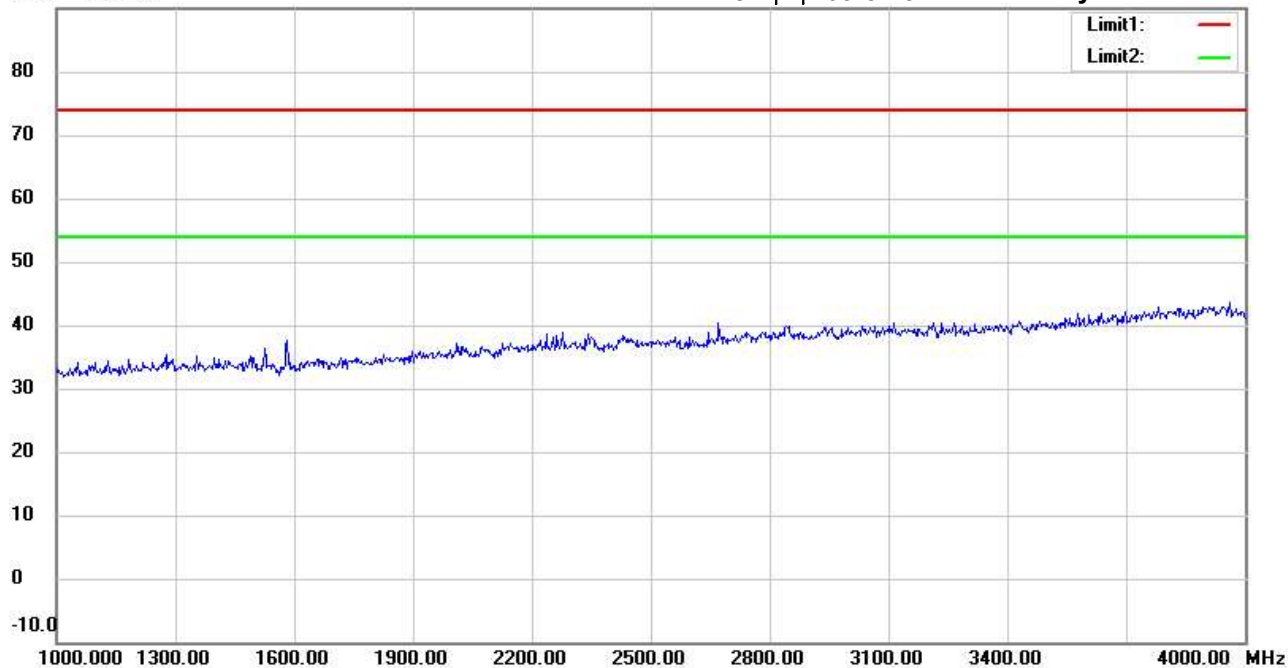
Condition : FCC\_part 15E RE\_Above 1GHz\_PK

Test Mode : TX 802.11n20 CH44

Polarization: **Horizontal**

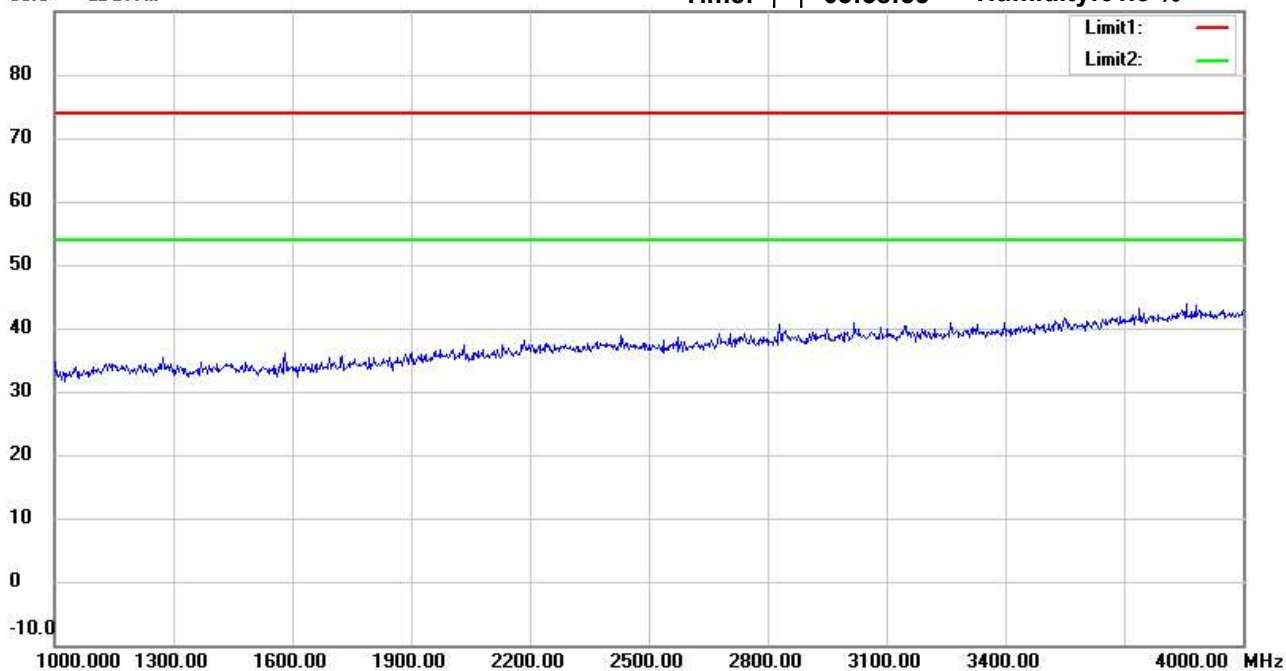
Condition : FCC\_part 15E RE\_Above 1GHz\_PK

Test Mode : TX 802.11n20 CH44

Polarization: **Vertical**

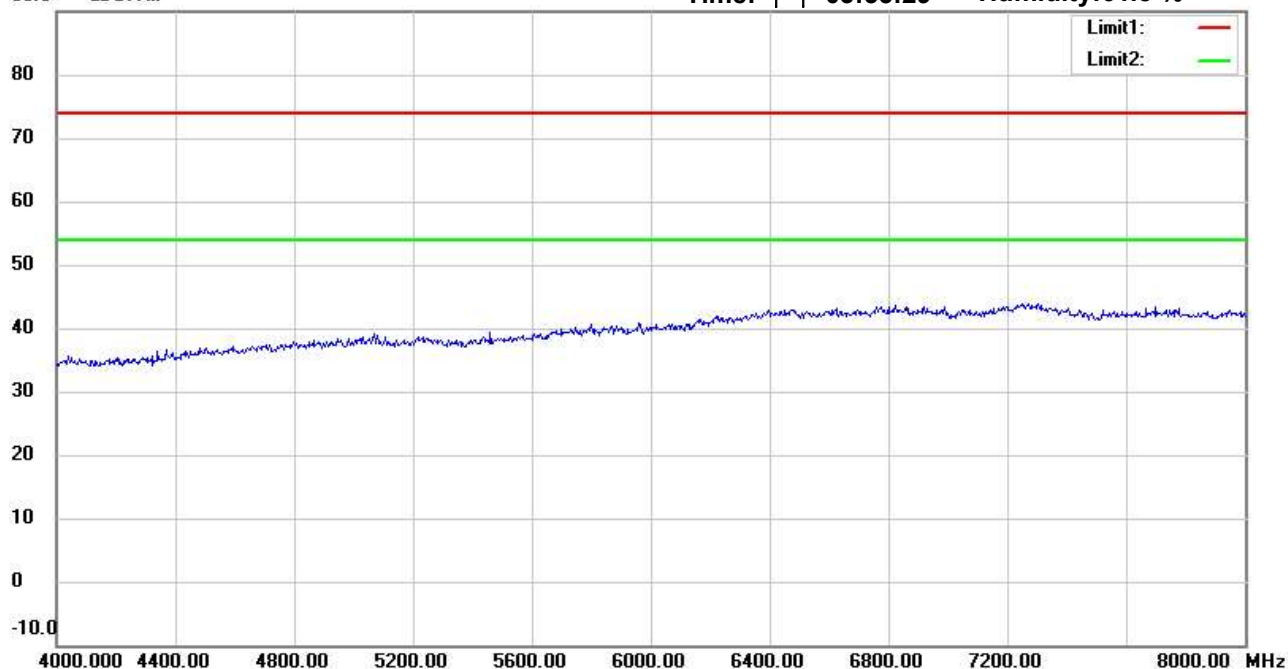
Condition : FCC\_part 15E RE\_Above 1GHz\_PK

Test Mode : TX 802.11n20 CH44

Polarization: **Horizontal**

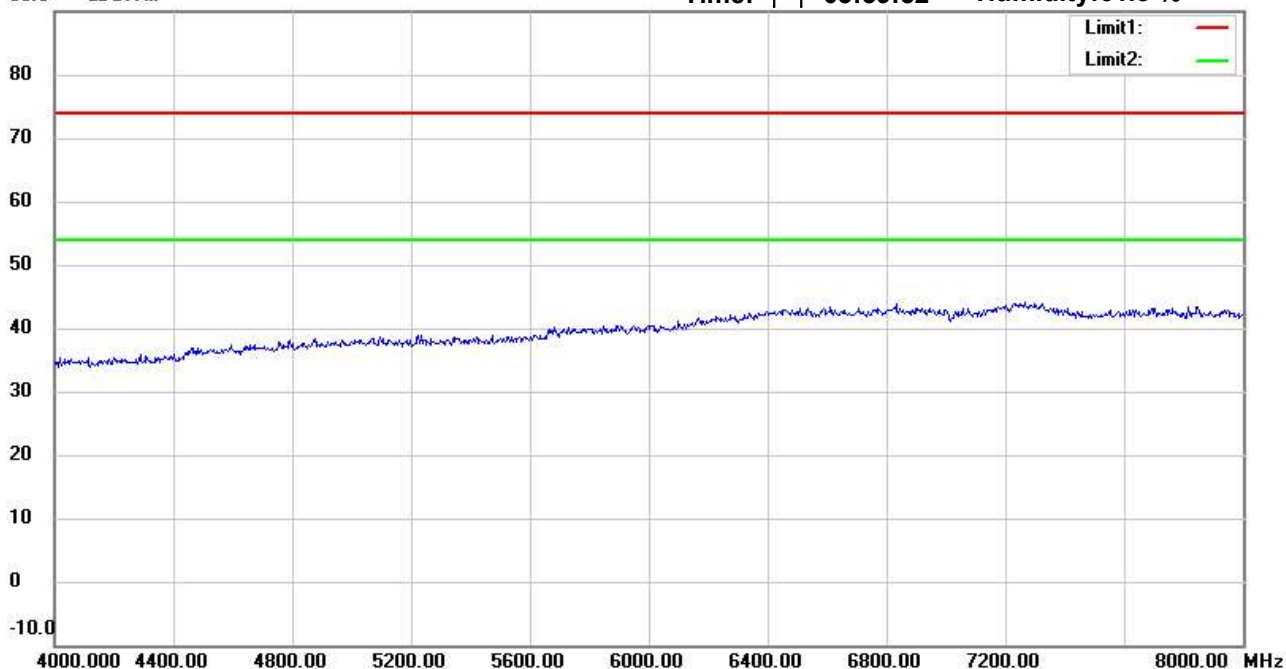
Condition : FCC\_part 15E RE\_Above 1GHz\_PK

Test Mode : TX 802.11n20 CH44

Polarization: **Vertical**

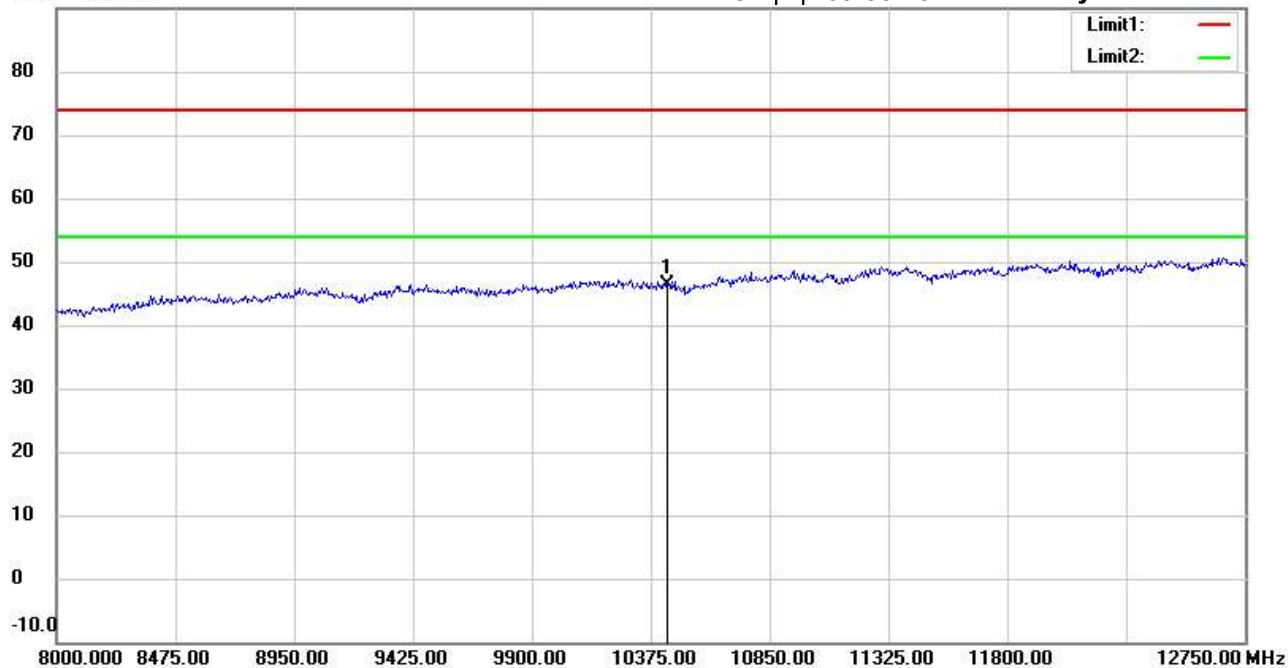
Condition : FCC\_part 15E RE\_Above 1GHz\_PK

Test Mode : TX 802.11n20 CH44

Polarization: **Horizontal**

| Mk. | Frequency (MHz) | Reading (dBuV) | Detector | Corr. factor (dB/m) | Result (dBuV/m) | Limit (dBuV/m) | Ant.Pos (cm) | Tab.Pos (deg.) | Margin (dB) | Comment |
|---|---|---|---|---|---|---|---|---|---|---|
| * | 10440.000 | 32.34 | peak | 14.11 | 46.45 | 74.00 | 150 | 76 | -27.55 | |

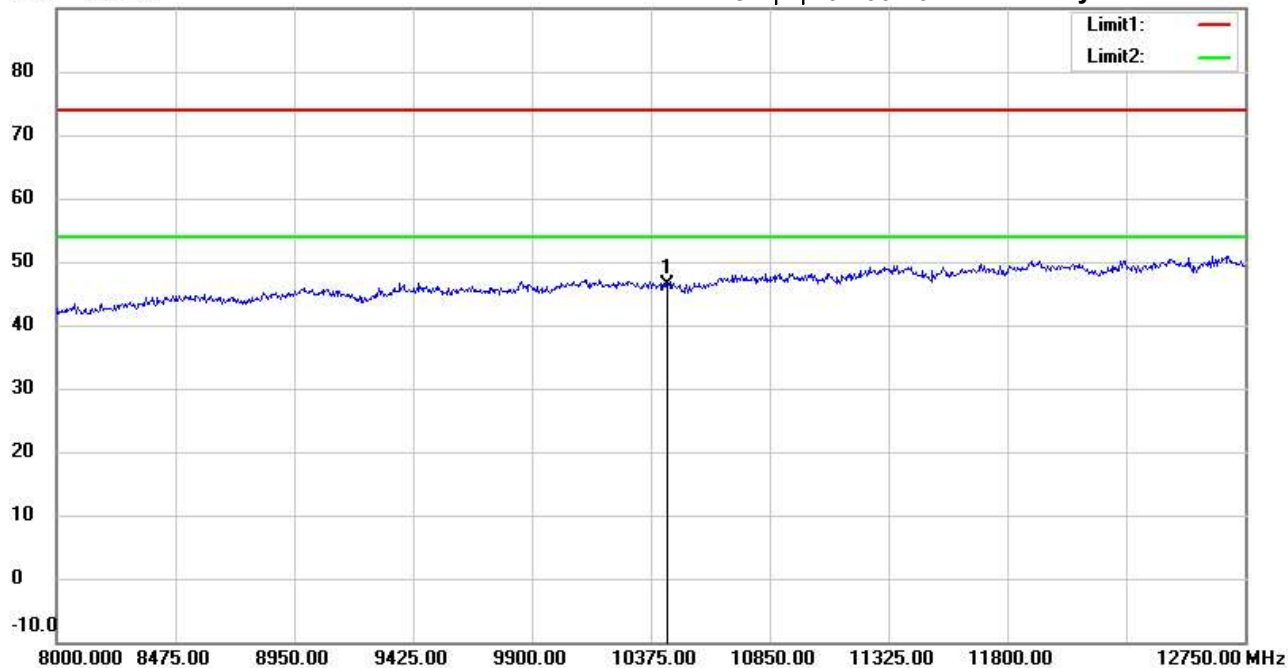
Condition : FCC\_part 15E RE\_Above 1GHz\_PK

Test Mode : TX 802.11n20 CH44

Polarization: Vertical

| Mk. | Frequency (MHz) | Reading (dBuV) | Detector | Corr. factor (dB/m) | Result (dBuV/m) | Limit (dBuV/m) | Ant.Pos (cm) | Tab.Pos (deg.) | Margin (dB) | Comment |
|---|---|---|---|---|---|---|---|---|---|---|
| * | 10440.000 | 32.23 | peak | 14.11 | 46.34 | 74.00 | 150 | 237 | -27.66 | |
