# Radiated Emission Measurement

Condition : FCC\_part 15E RE\_Above 1GHz\_PK

EUT : W6M22311-23090

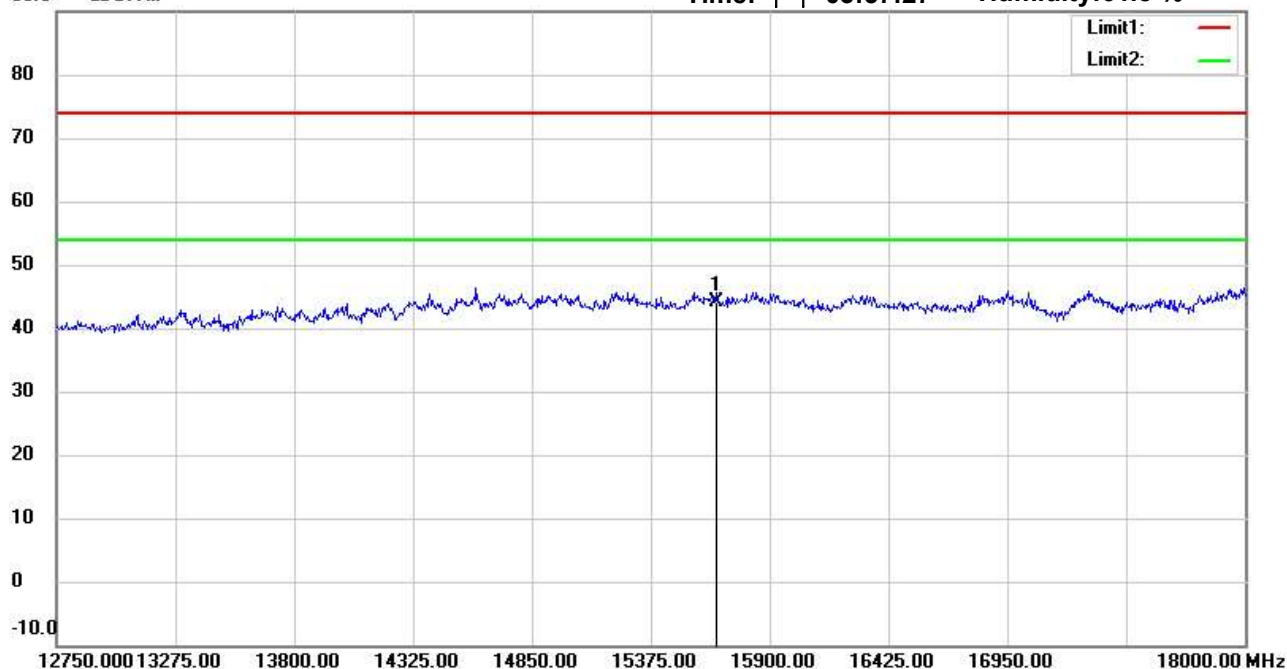
Condition : FCC\_part 15E RE\_Above 1GHz\_PK

Test Mode : TX 802.11n20 CH44

Polarization: **Horizontal**

| Mk. | Frequency (MHz) | Reading (dBuV) | Detector | Corr. factor (dB/m) | Result (dBuV/m) | Limit (dBuV/m) | Ant.Pos (cm) | Tab.Pos (deg.) | Margin (dB) | Comment |
|---|---|---|---|---|---|---|---|---|---|---|
| * | 15660.000 | 21.07 | peak | 23.15 | 44.22 | 74.00 | 150 | 119 | -29.78 | |

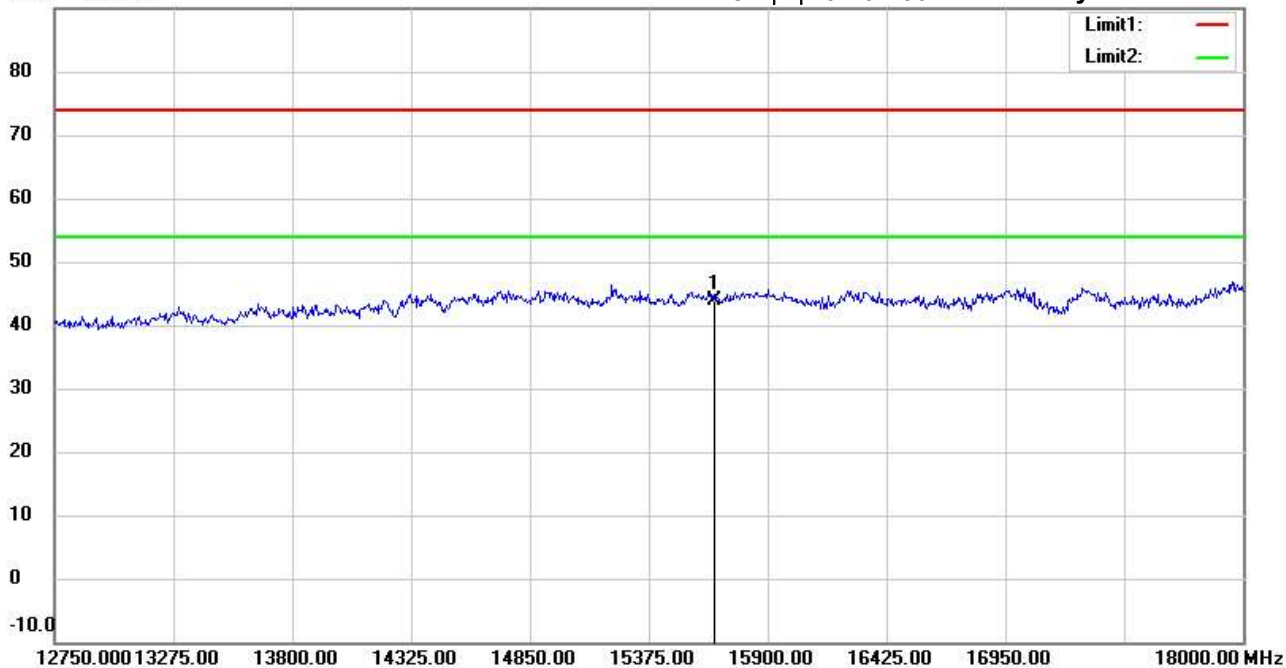
Condition : FCC\_part 15E RE\_Above 1GHz\_PK

Test Mode : TX 802.11n20 CH44

Polarization: **Vertical**

| Mk. | Frequency (MHz) | Reading (dBuV) | Detector | Corr. factor (dB/m) | Result (dBuV/m) | Limit (dBuV/m) | Ant.Pos (cm) | Tab.Pos (deg.) | Margin (dB) | Comment |
|---|---|---|---|---|---|---|---|---|---|---|
| * | 15660.000 | 20.83 | peak | 23.15 | 43.98 | 74.00 | 150 | 230 | -30.02 | |
