Setup photos for HAC RF Emissions and T-Coil Test Report

Test report no.:	HAC_Photo_RM-1154_03	Date of report:	2015-12-30
Template version:	4.0	Number of pages:	3
Testing laboratory:	TCC Microsoft Salo Laboratory P.O.Box 303 Joensuunkatu 7E FIN-24101 SALO, FINLAND Tel. +358 71 800 8000 Fax. +358 71 80 44122	Client:	Microsoft P.O. Box 68 Sinitaival 5 FIN-33721 TAMPERE, FINLAND Tel. +358 (0) 7180 08000 Fax. +358 (0) 7180 46880
Responsible test engineer:	Janne Hirsimäki	Product contact person:	Juha Paukku
Measurements made by:	Janne Hirsimäki		
Tested devices:	RM-1154, HW: 1560		
FCC ID:	PYARM-1154	IC:	661X-RM1154
Supplement reports:	RF_RM-1154_01, T-Coil_RM-1154_02		
Testing has been carried out in accordance with:	ANSI C63.19-2011 American National Standard for Methods of Measurement of Compatibility between Wireless Communications Devices and Hearing Aids CTIA Test Plan for Hearing Aid Compatibility, Revision 3.0, November 2013		
Documentation:	The documentation of the testing performed on the tested devices is archived for 15 years at TCC Microsoft.

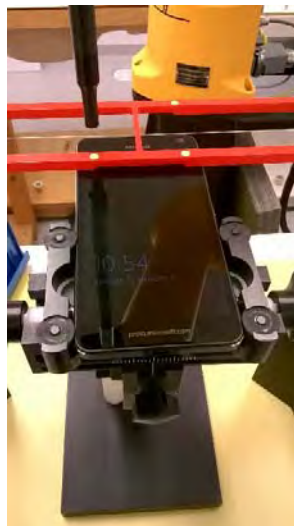
The device was positioned such that Device Reference plane was touching the bottom of the Test Arch. The scan is centered at the acoustic output by aligning the acoustic output with the intersection of the Test Arch's middle bar and dielectric wire.

Photo of the device positioned under Test Arch
