ML3 Asset Tracker

Instructions for Installing the Telematics Module

No.: 98-02739-00	Rev: B Authorization #: ECN1146067
Title: Telematics Device Instructions. Kits 76-00980-00	Supersedes:	Page: 10 of 11

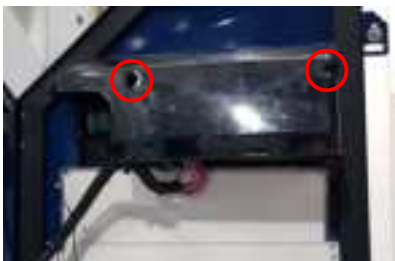
Figure 2a: Removal of Rain Shield

4. Remove the rain shield by removing the screws using a flat head screwdriver. Temporarily reinstall the two screws to hold display in place for the next step. See Figure 2a and 2b.

5. Clean area of any residue caulk on either the rain shield or the control box door.

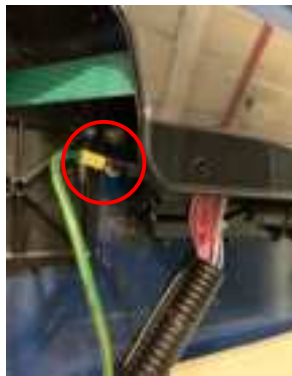
Figure 4a: Module Installation

8. Note the ground screw location and wire orientation. See Figure 4a. The module may need to be pushed up when tightening it down to clear the ground screw.

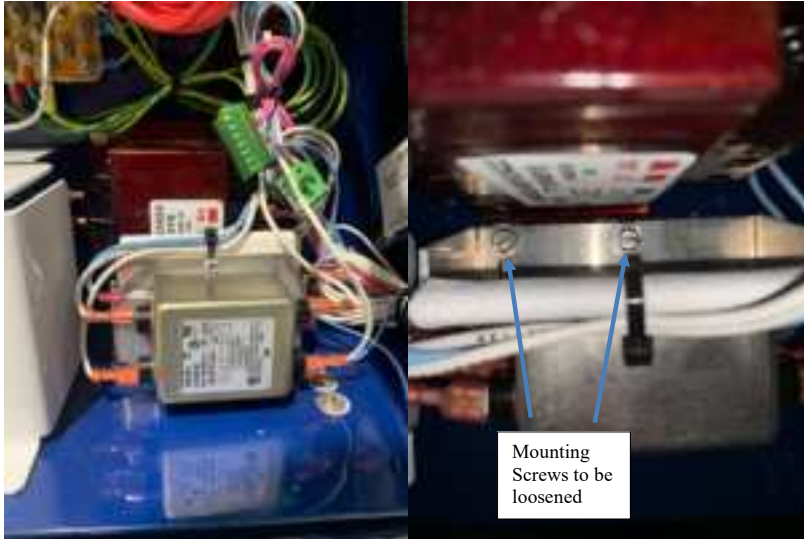
Figure 6a: Filter location

15. Loosen the mounting screws of the filter in front of the transformer using a flathead screwdriver so it can be rotated out of the way. See fig. 6a and 6b.

17. Move the filter back to its original place and secure it with the mounting screw.
18. With the door fully open, neatly secure the wire harness using the wire ties and securing to existing display cable conduit. See Figure 7a.

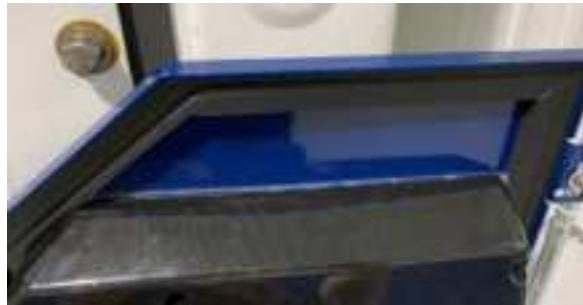
Figure 7b: Caulking of Rain Shield

19. Remove the top screws on the display. Reinstall rain shield using these screws.
20. Caulk along the top of the rain shield to prevent water ingress. See figure 7b.

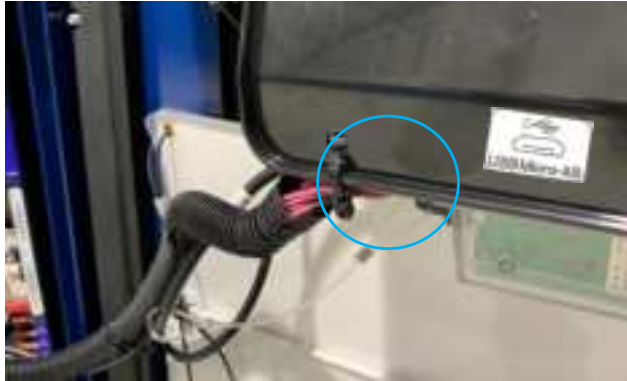
Figure 7c: Routing wire harness and label location

21. Secure the wire harnesses to the rain shield via the hole as shown below in figure 7c.
If there is no hole, drill a hole with a 1/4" or 6mm drill bit.
22. Clean the rain shield with an appropriate cleaner and add the USB label (item 5) to the rain shield to the right of the harness mounting hole. Location shown in figure 7c.
