## 7.5Band Edge

## 7.6 Conducted RF Spurious Emission

## Appendix B: photographs of test setup

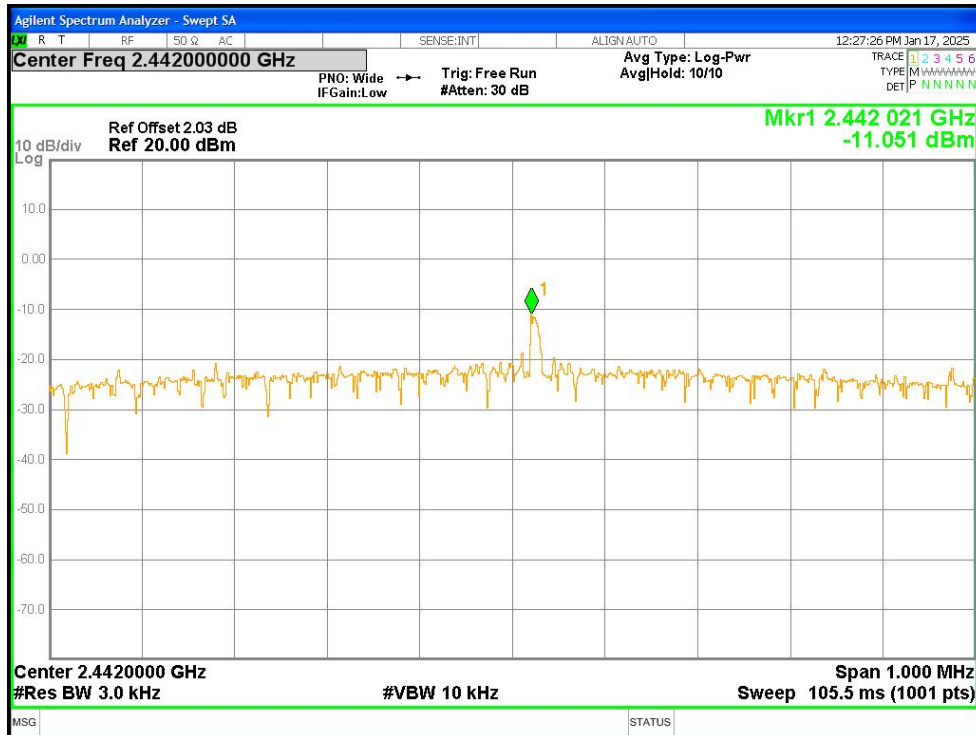
PSD NVNT BLE 2M 2442MHz Ant1

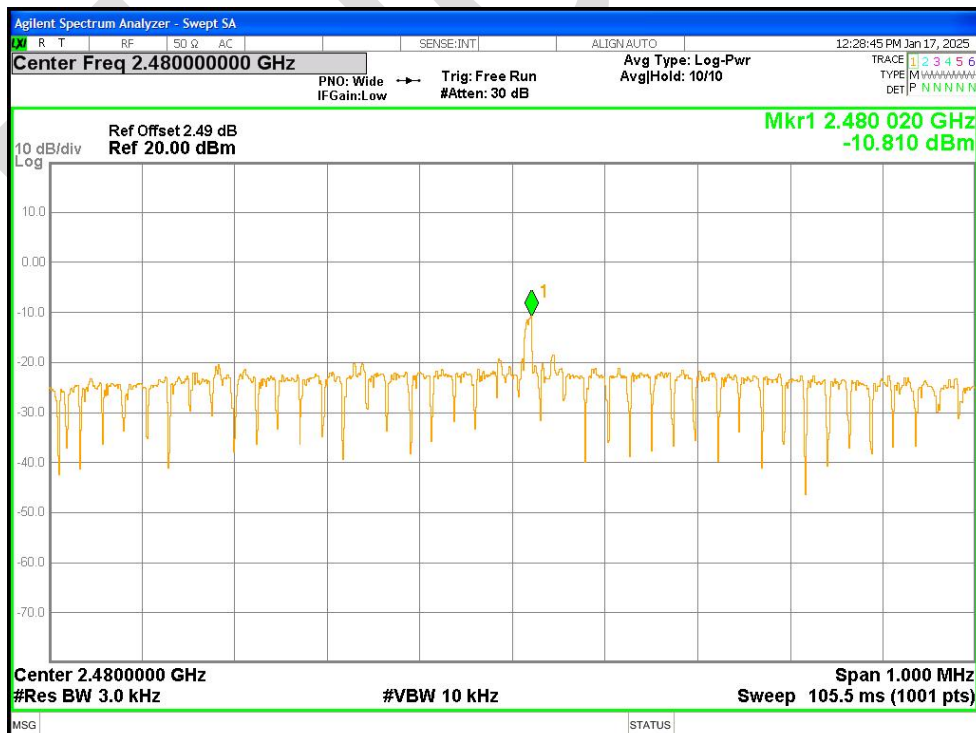
PSD NVNT BLE 2M 2480MHz Ant1

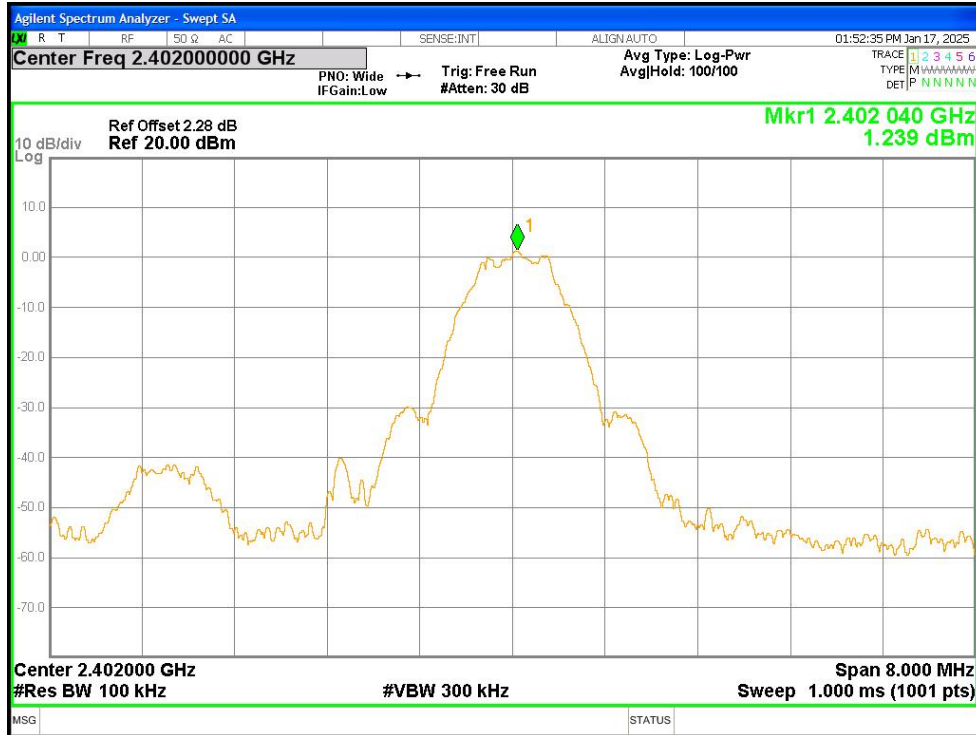
Band Edge NVNT BLE 1M 2402MHz Ant1 Ref

| Condition | Mode | Frequency (MHz) | Antenna | Max Value (dBc) | Limit (dBc) | Verdict |
|---|---|---|---|---|---|---|
| NVNT | BLE 1M | 2402 | Ant1 | -55.25 | -20 | Pass |

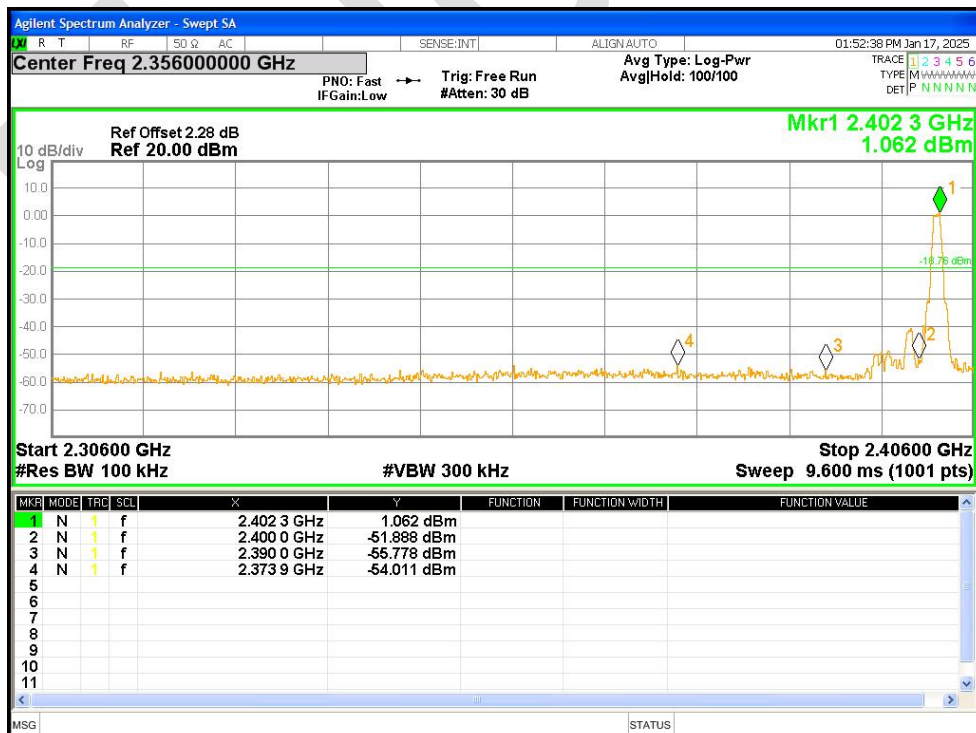
Band Edge NVNT BLE 1M 2402MHz Ant1 Emission

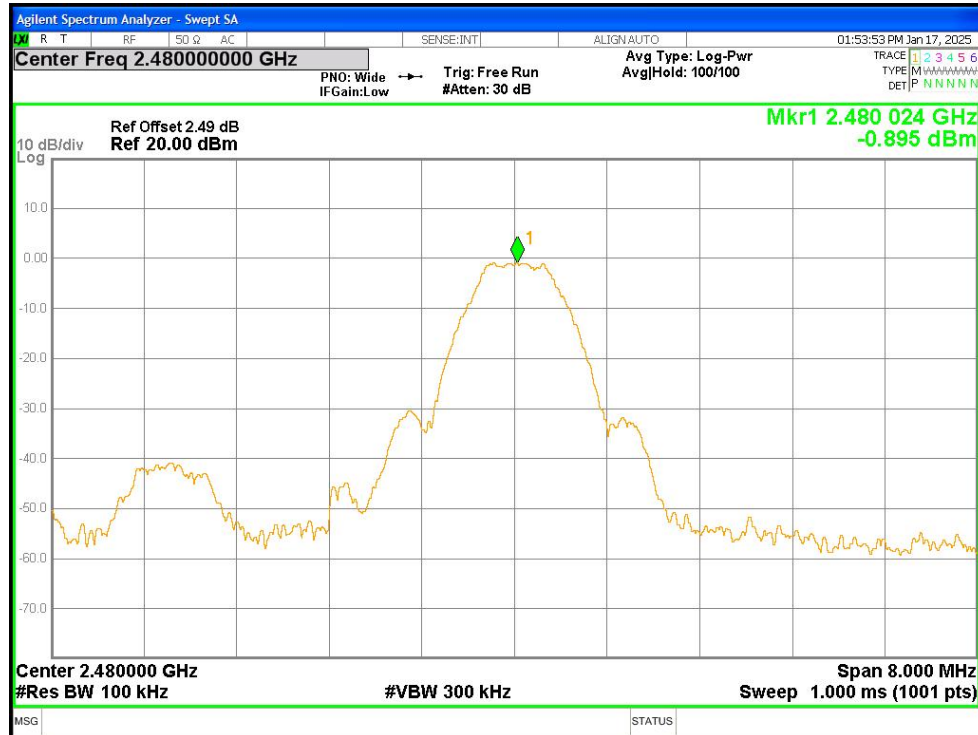
Band Edge NVNT BLE 1M 2480MHz Ant1 Ref

| Condition | Mode | Frequency (MHz) | Antenna | Max Value (dBc) | Limit (dBc) | Verdict |
|---|---|---|---|---|---|---|
| NVNT | BLE 1M | 2480 | Ant1 | -53.29 | -20 | Pass |

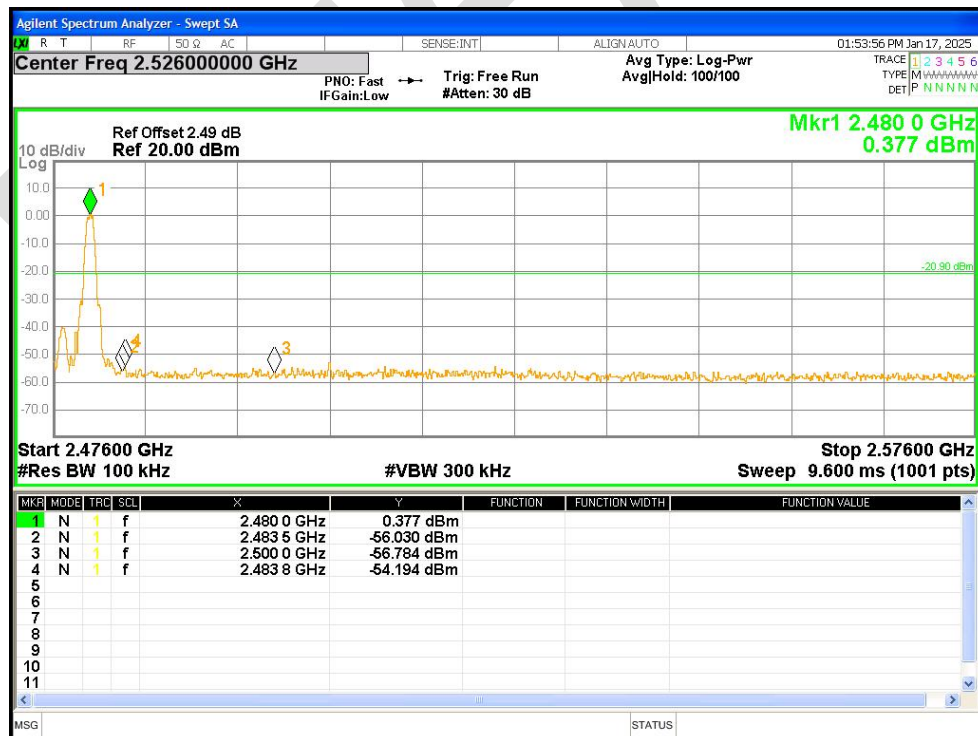
Band Edge NVNT BLE 1M 2480MHz Ant1 Emission

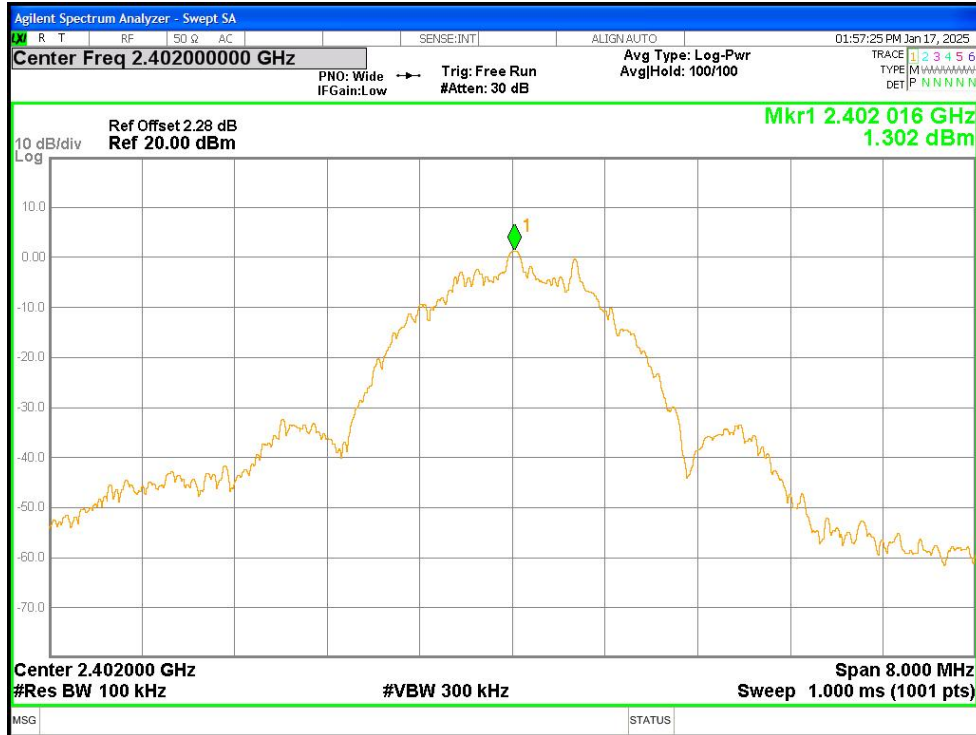
Band Edge NVNT BLE 2M 2402MHz Ant1 Ref

| Condition | Mode | Frequency (MHz) | Antenna | Max Value (dBc) | Limit (dBc) | Verdict |
|---|---|---|---|---|---|---|
| NVNT | BLE 2M | 2402 | Ant1 | -55.4 | -20 | Pass |

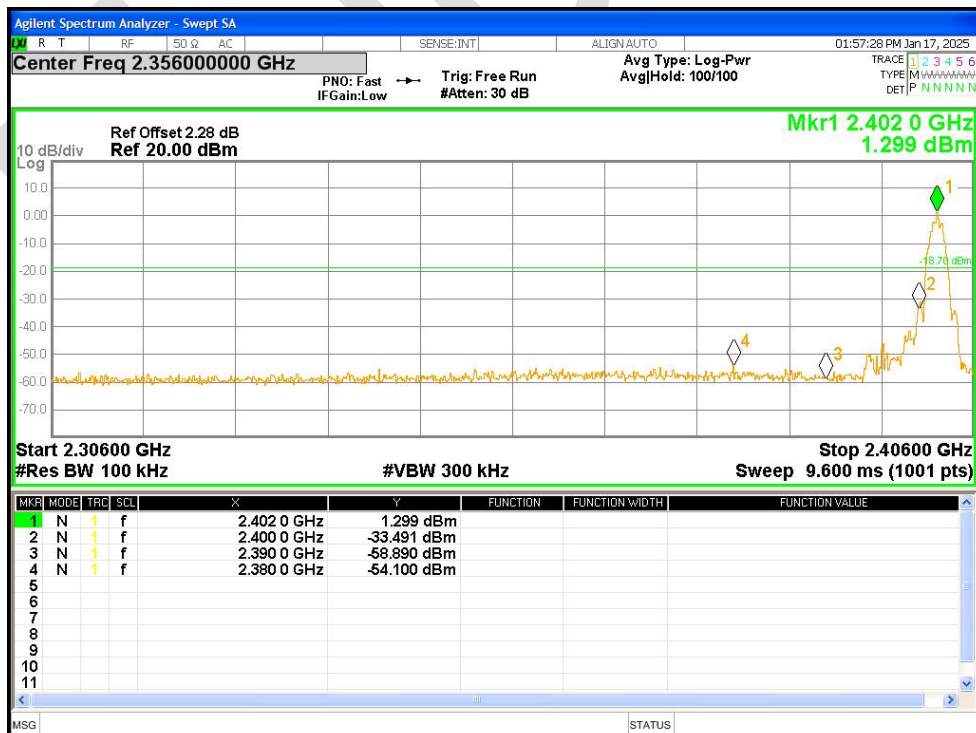
Band Edge NVNT BLE 2M 2402MHz Ant1 Emission

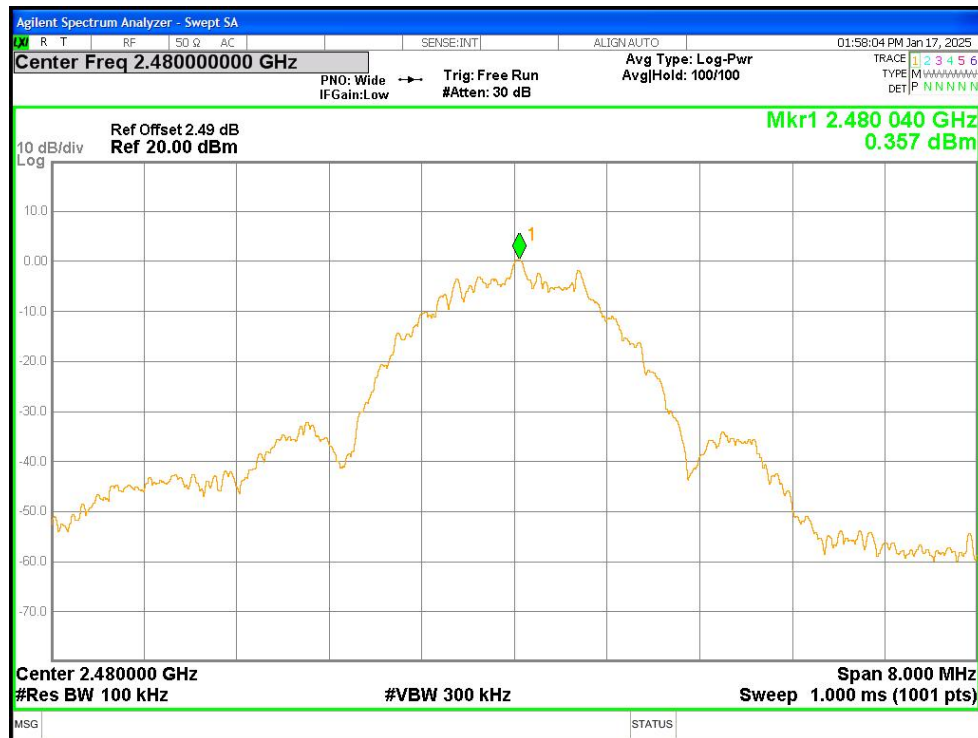
Band Edge NVNT BLE 2M 2480MHz Ant1 Ref

| Condition | Mode | Frequency (MHz) | Antenna | Max Value (dBc) | Limit (dBc) | Verdict |
|---|---|---|---|---|---|---|
| NVNT | BLE 2M | 2480 | Ant1 | -56.05 | -20 | Pass |

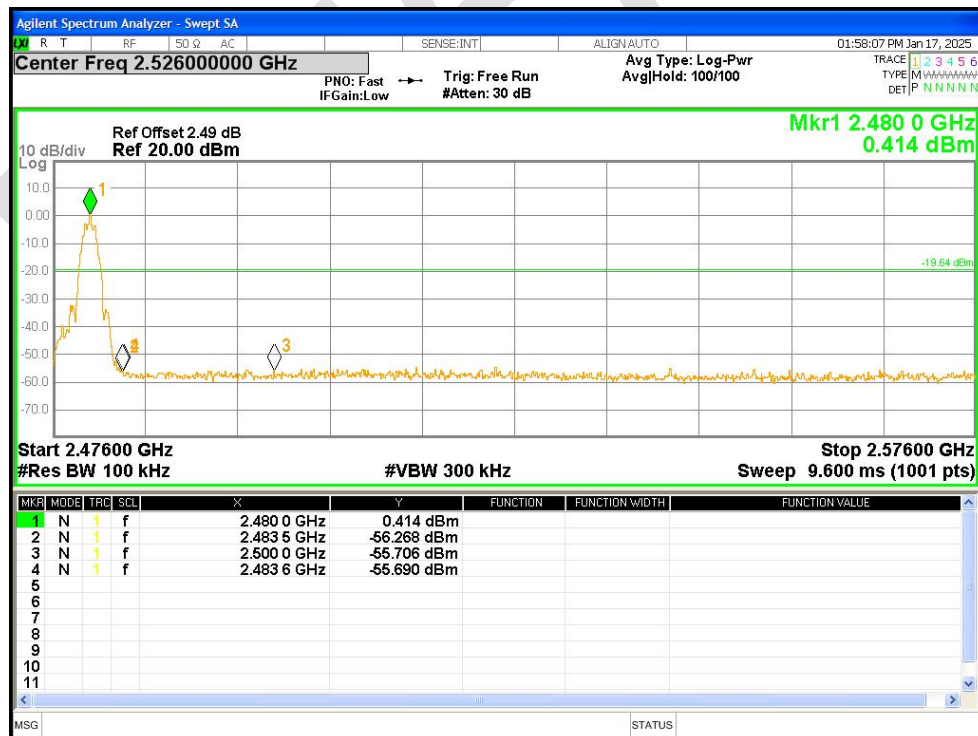
Band Edge NVNT BLE 2M 2480MHz Ant1 Emission

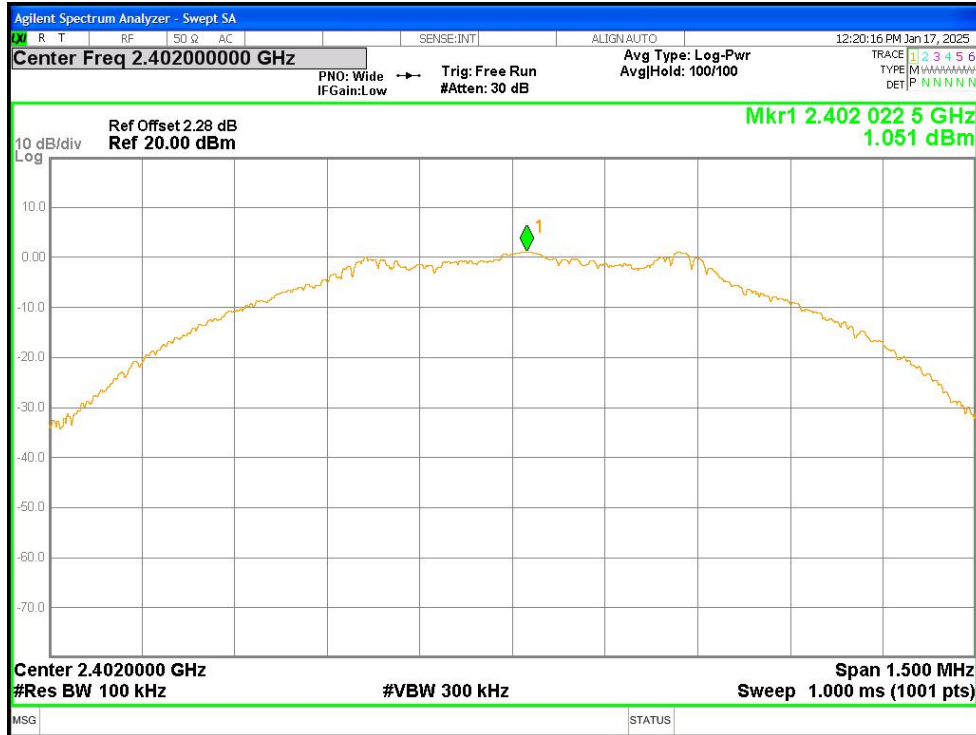
Tx. Spurious NVNT BLE 1M 2402MHz Ant1 Ref

| Condition | Mode | Frequency (MHz) | Antenna | Max Value (dBc) | Limit (dBc) | Verdict |
|---|---|---|---|---|---|---|
| NVNT | BLE 1M | 2402 | Ant1 | -46.36 | -20 | Pass |

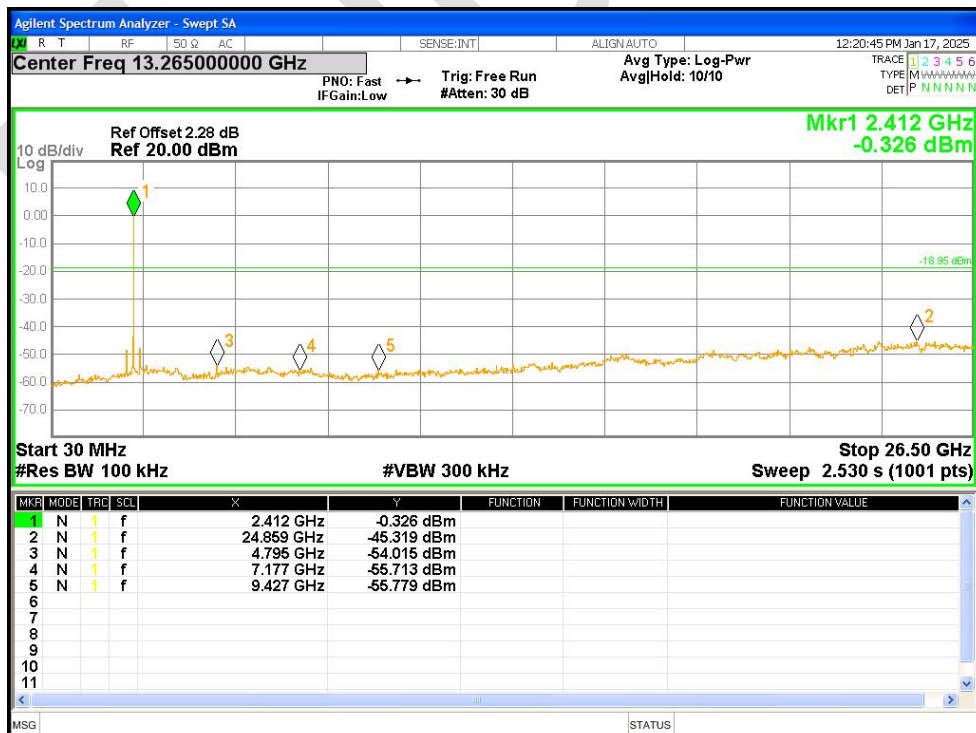
Tx. Spurious NVNT BLE 1M 2402MHz Ant1 Emission

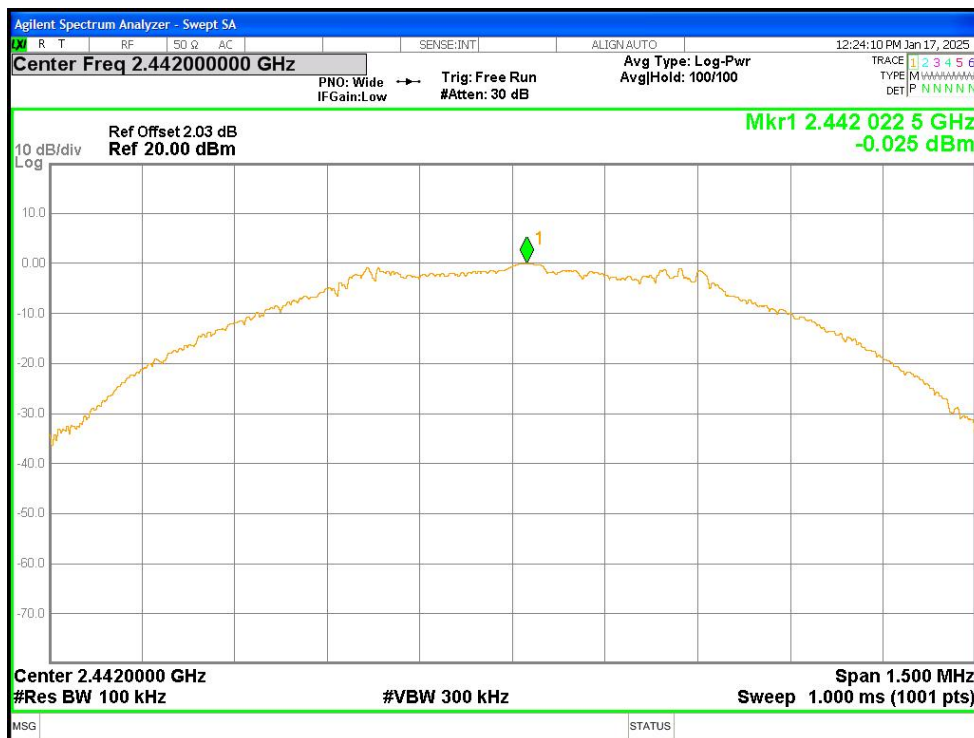
Tx. Spurious NVNT BLE 1M 2442MHz Ant1 Ref

| Condition | Mode | Frequency (MHz) | Antenna | Max Value (dBc) | Limit (dBc) | Verdict |
|---|---|---|---|---|---|---|
| NVNT | BLE 1M | 2442 | Ant1 | -44.62 | -20 | Pass |

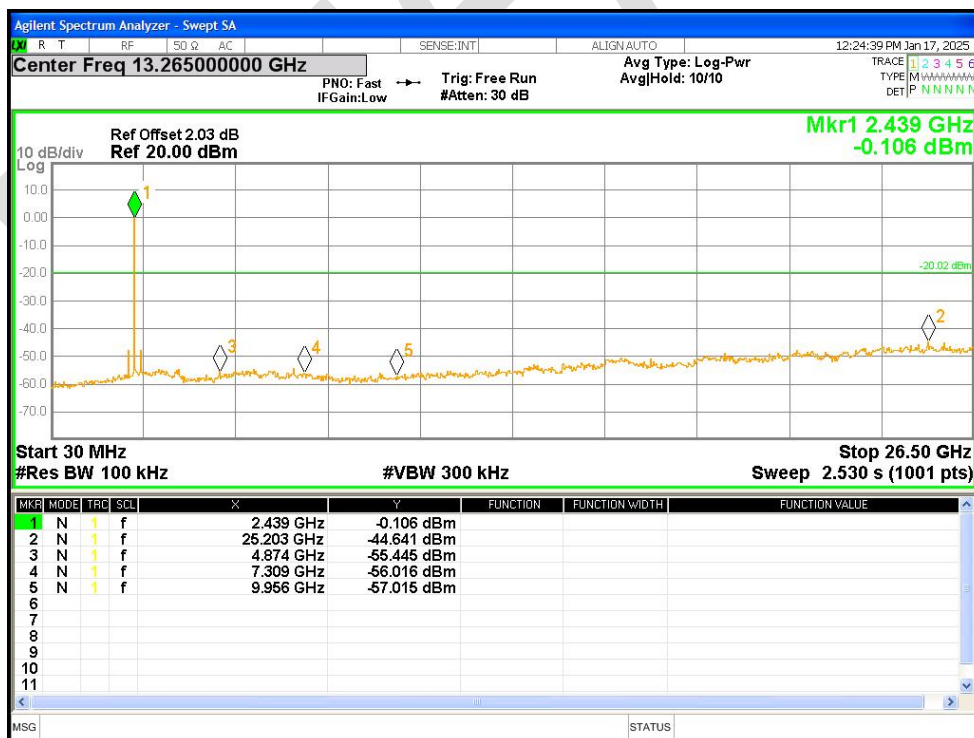
Tx. Spurious NVNT BLE 1M 2442MHz Ant1 Emission

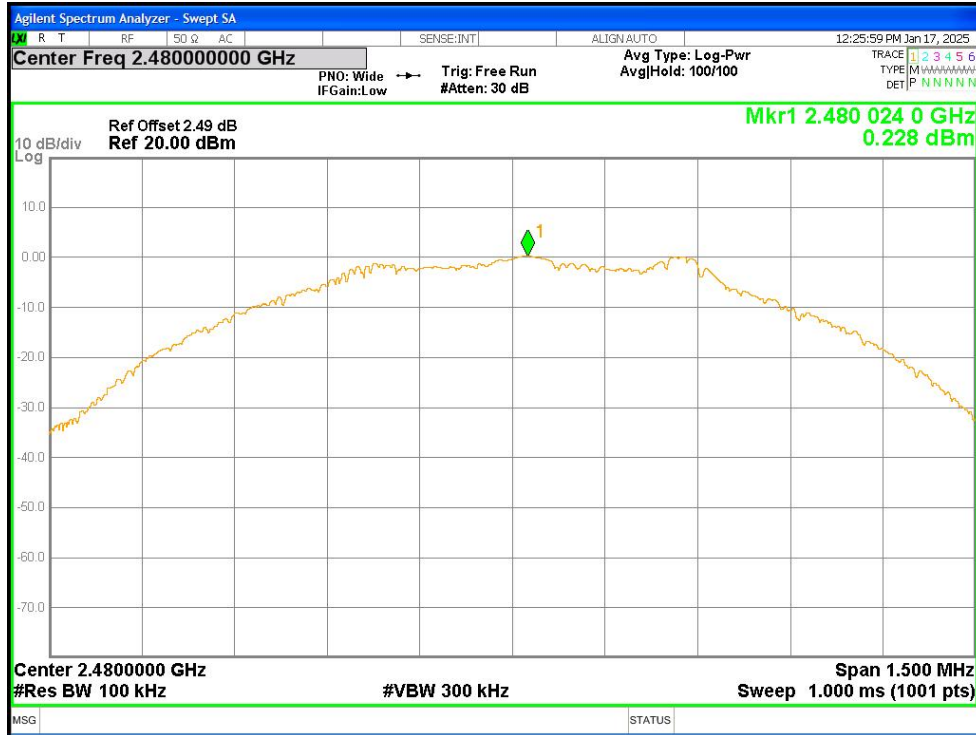
Tx. Spurious NVNT BLE 1M 2480MHz Ant1 Ref

| Condition | Mode | Frequency (MHz) | Antenna | Max Value (dBc) | Limit (dBc) | Verdict |
|---|---|---|---|---|---|---|
| NVNT | BLE 1M | 2480 | Ant1 | -45.9 | -20 | Pass |

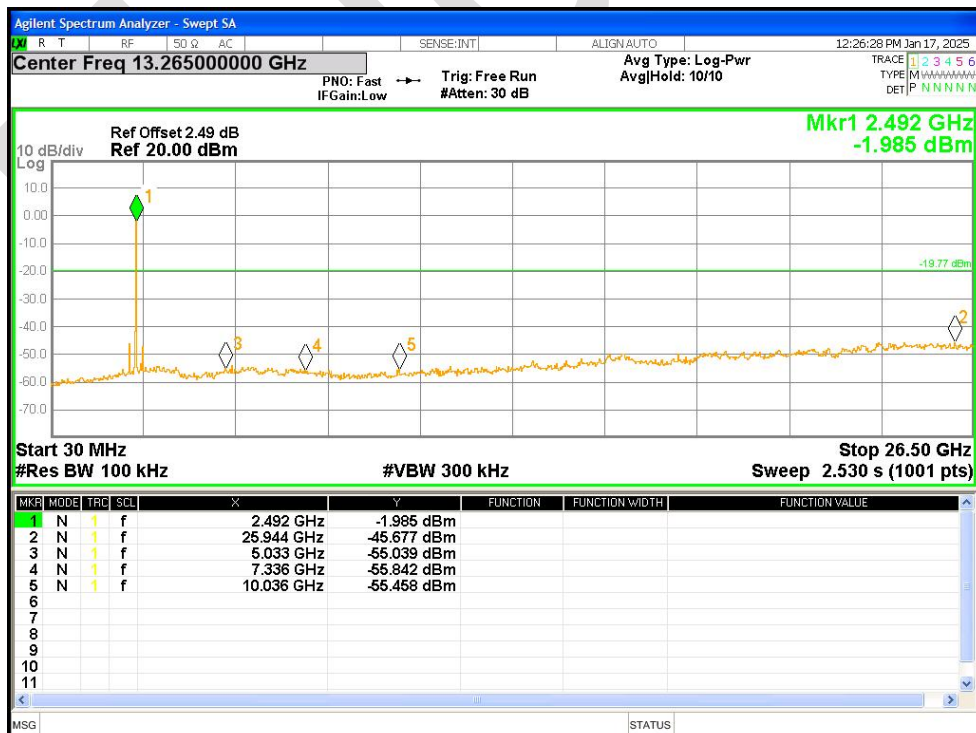
Tx. Spurious NVNT BLE 1M 2480MHz Ant1 Emission

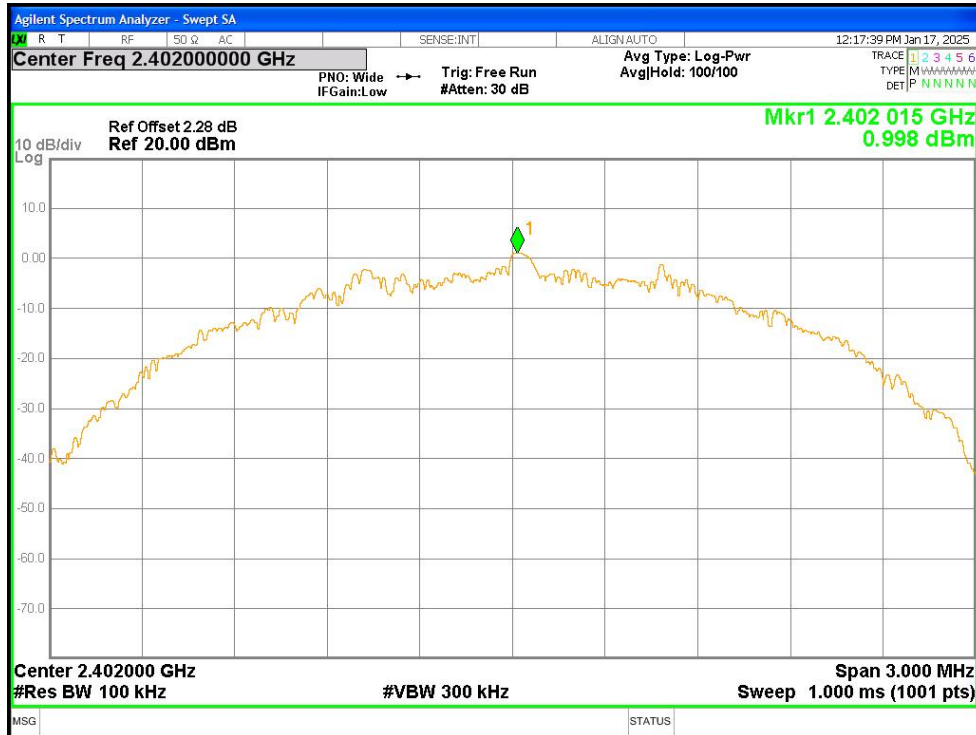
Tx. Spurious NVNT BLE 2M 2402MHz Ant1 Ref

| Condition | Mode | Frequency (MHz) | Antenna | Max Value (dBc) | Limit (dBc) | Verdict |
|---|---|---|---|---|---|---|
| NVNT | BLE 2M | 2402 | Ant1 | -46.01 | -20 | Pass |

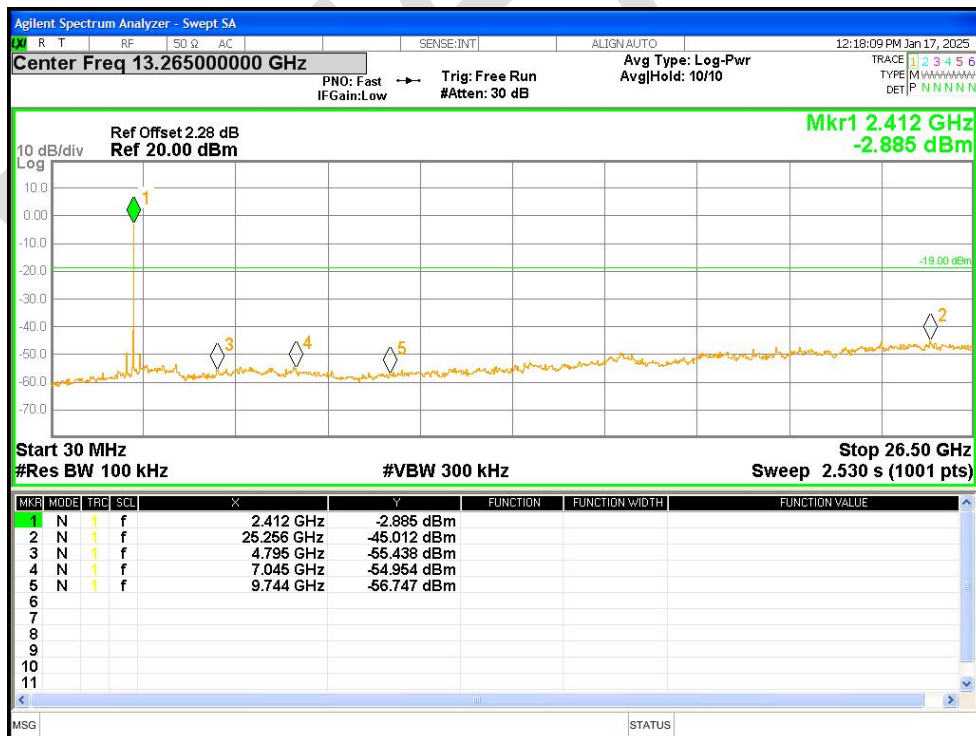
Tx. Spurious NVNT BLE 2M 2402MHz Ant1 Emission

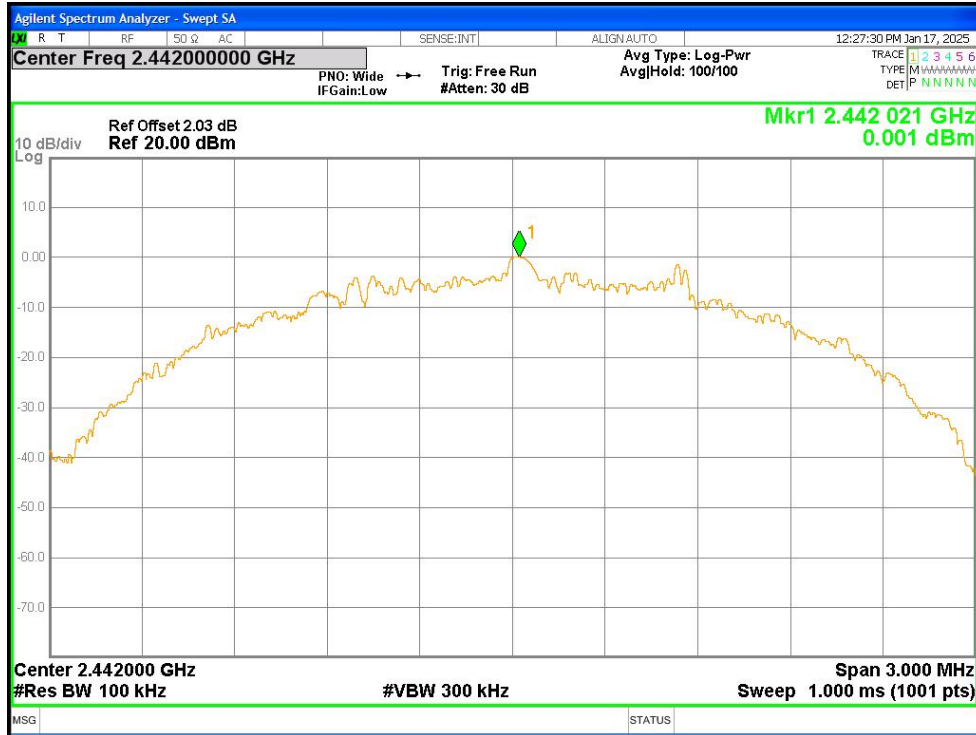
Tx. Spurious NVNT BLE 2M 2442MHz Ant1 Ref

| Condition | Mode | Frequency (MHz) | Antenna | Max Value (dBc) | Limit (dBc) | Verdict |
|---|---|---|---|---|---|---|
| NVNT | BLE 2M | 2442 | Ant1 | -45.47 | -20 | Pass |

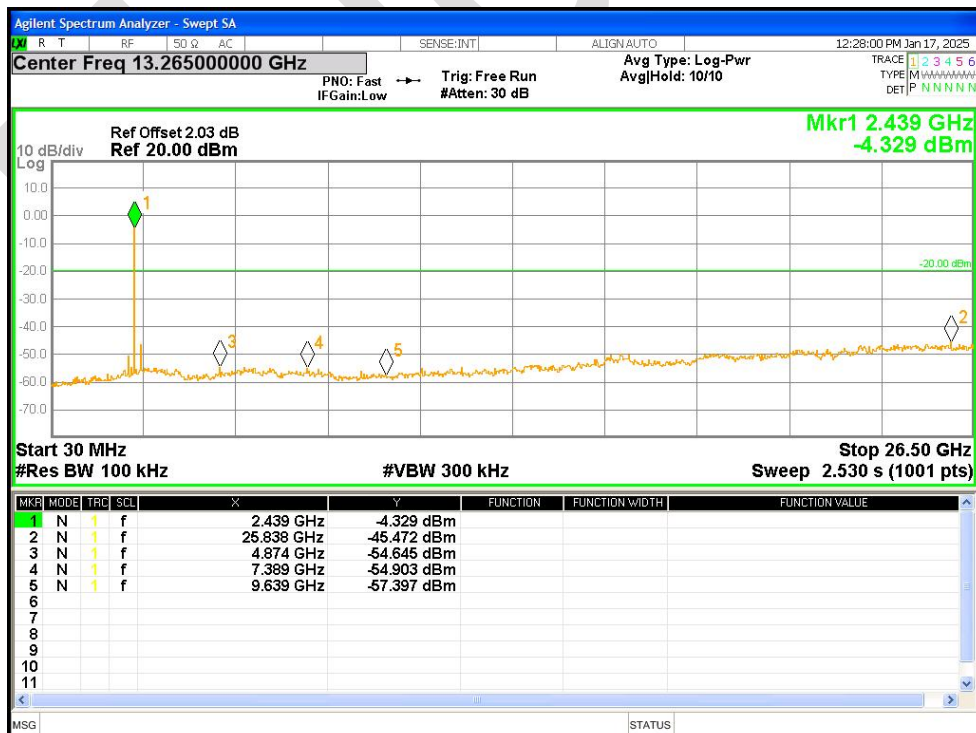
Tx. Spurious NVNT BLE 2M 2442MHz Ant1 Emission

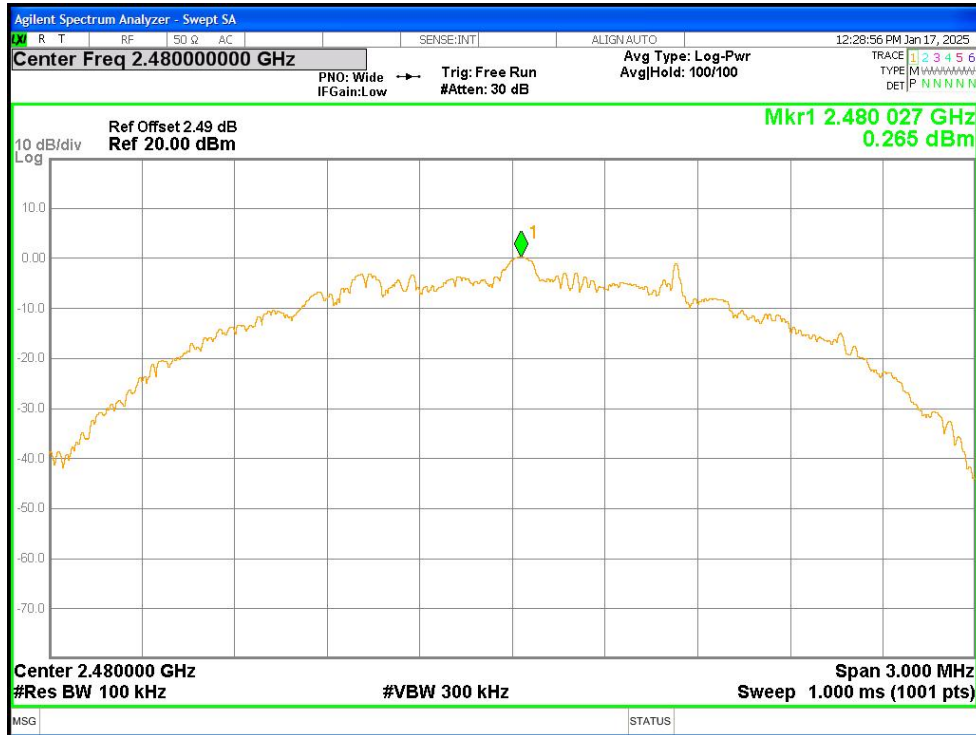
Tx. Spurious NVNT BLE 2M 2480MHz Ant1 Ref

| Condition | Mode | Frequency (MHz) | Antenna | Max Value (dBc) | Limit (dBc) | Verdict |
|---|---|---|---|---|---|---|
| NVNT | BLE 2M | 2480 | Ant1 | -45.43 | -20 | Pass |

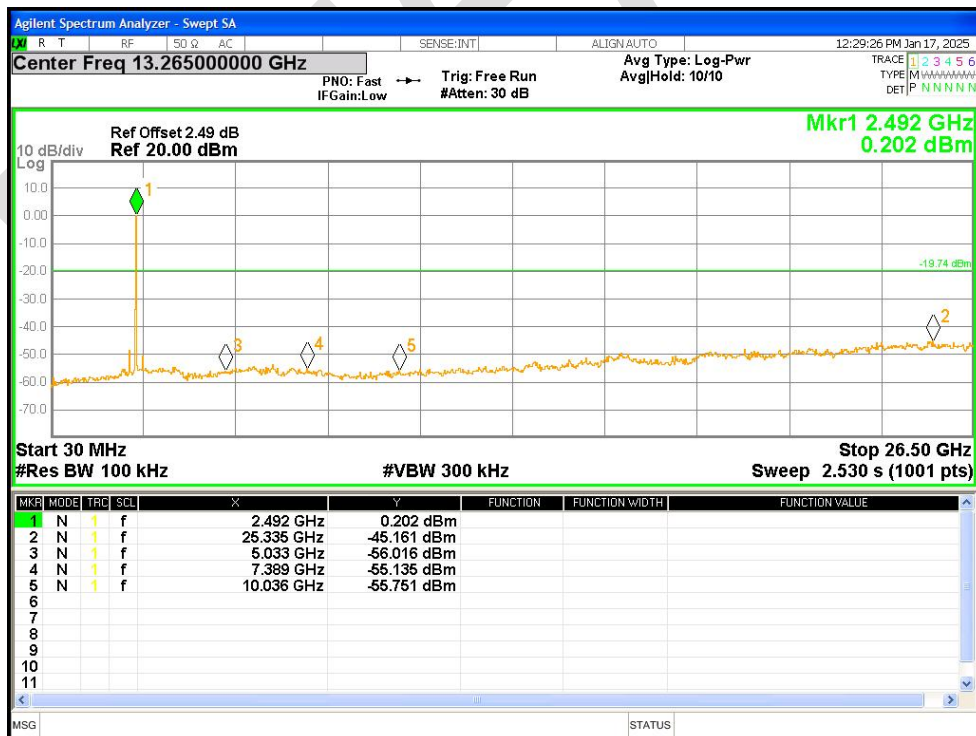
Tx. Spurious NVNT BLE 2M 2480MHz Ant1 Emission

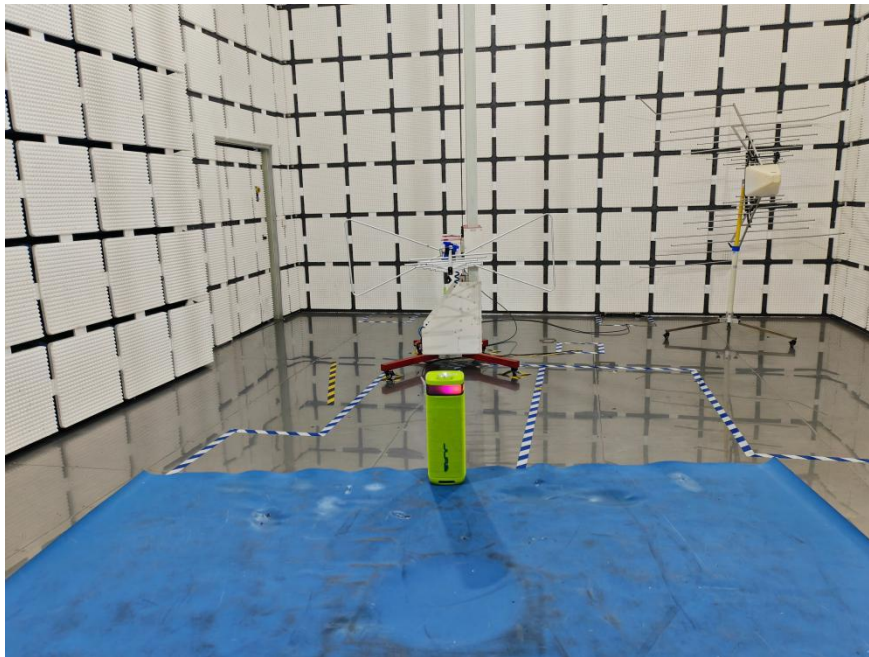
Radiated Emissions (30MHz-1GHz)

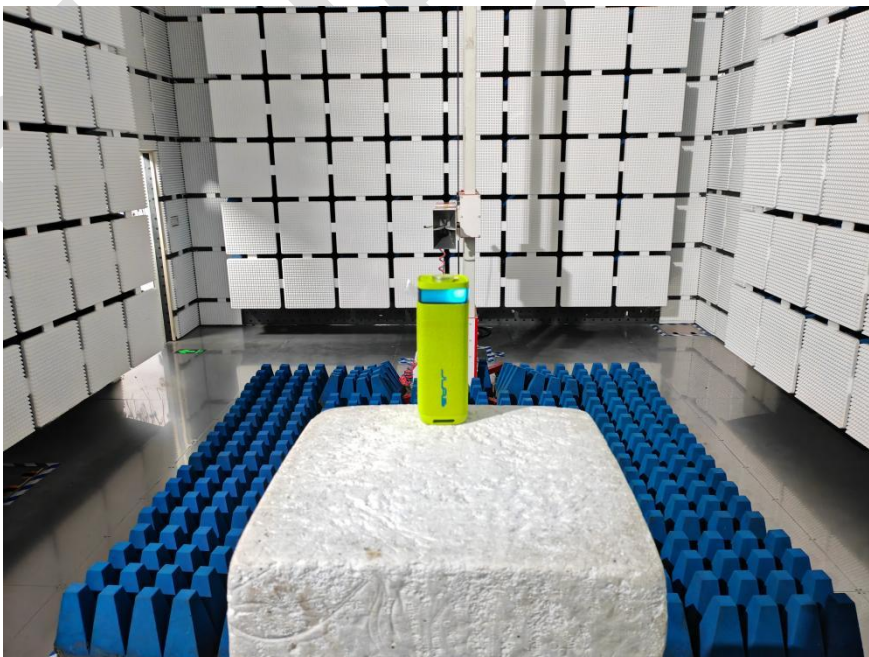
Radiated Emissions (above 1GHz)

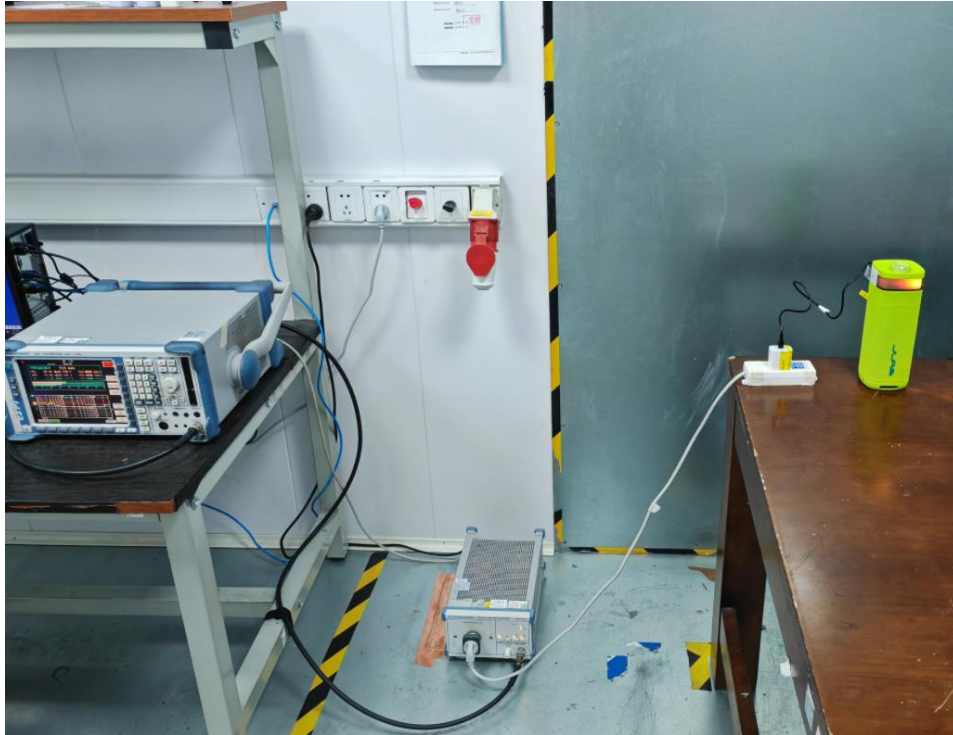
Conducted Emissions at Mains Terminals (150 kHz-30MHz)
