# Internal Photos

## II. LRR-25

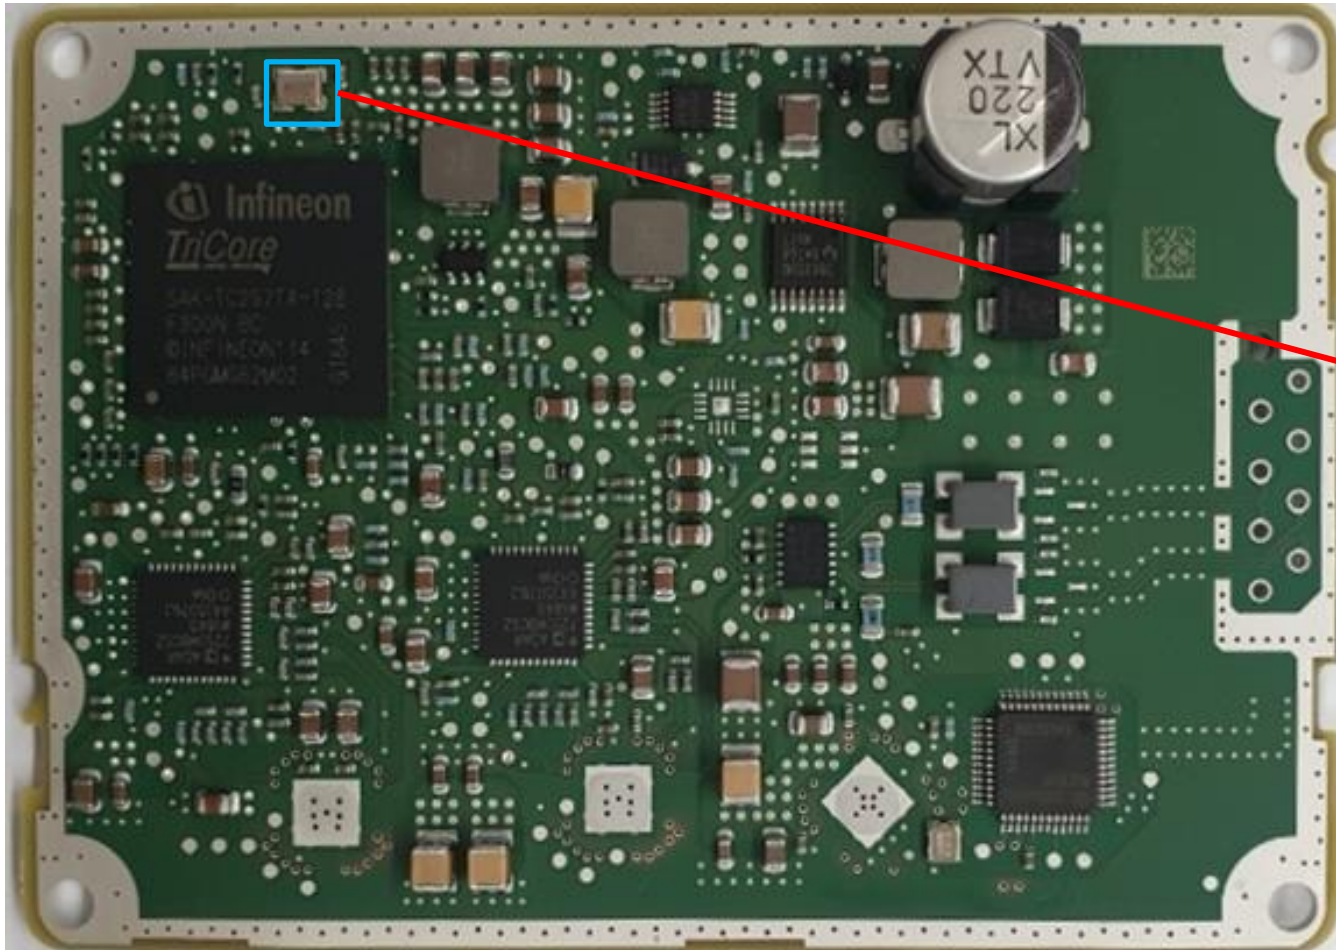
**Change Parts : 20 MHz Crystal**

**Kyocera CX3225SA20000D0PTWZ1**

**NDK NX3225GA STD-CRA-1**

- 1) Pin to Pin Changed
- 2) No S/W Changed

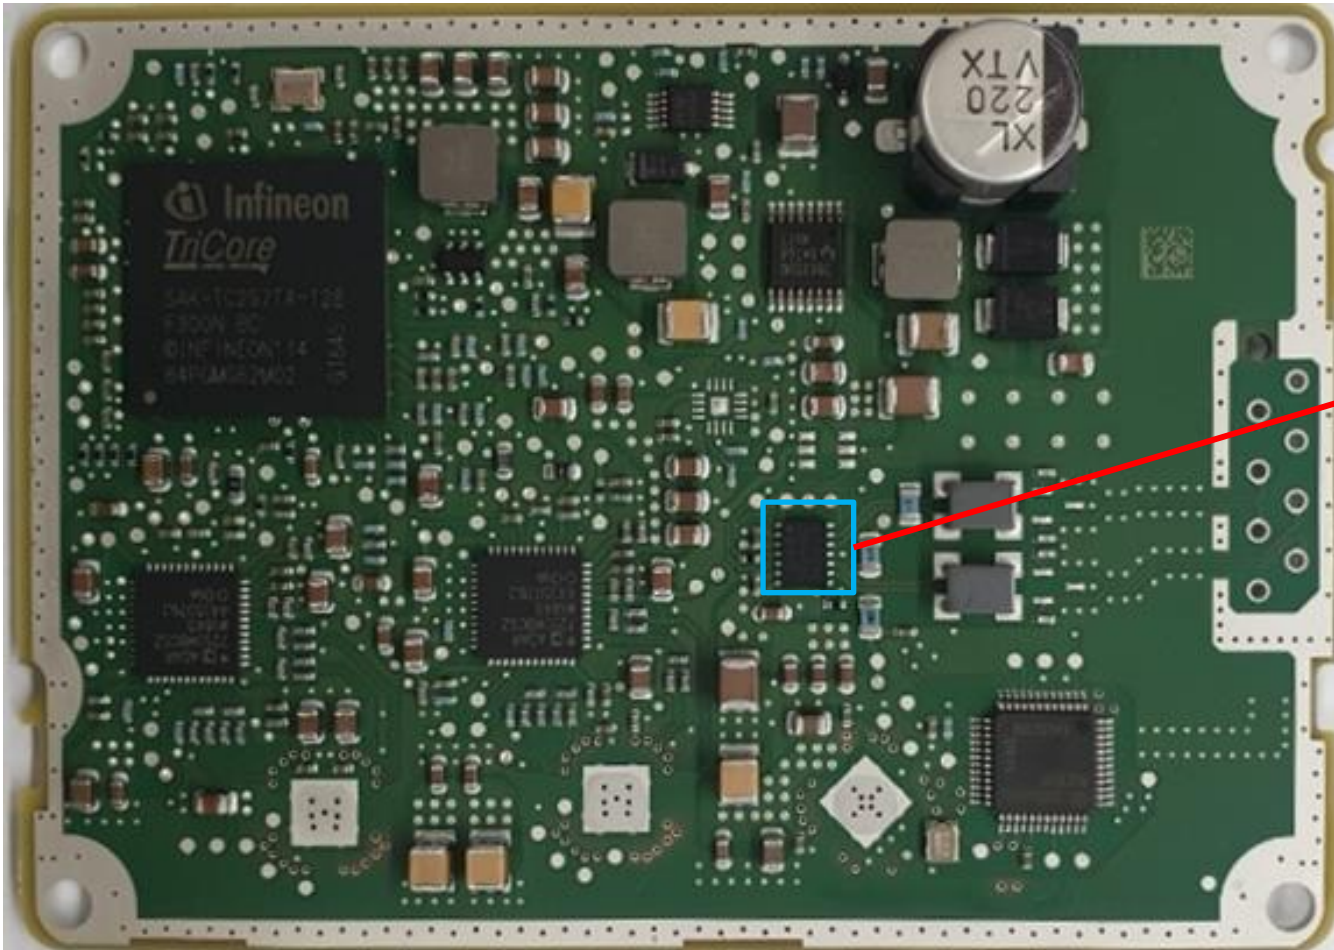
Change parts : CAN IC

NXP TJA1046TK

TI TCAN1046DMTRQ1

- 1) Pin to Pin Changed
- 2) No S/W Changed

< Before & After >
