**n\_10MHz**

**CH 10 (Horizontal) Average**

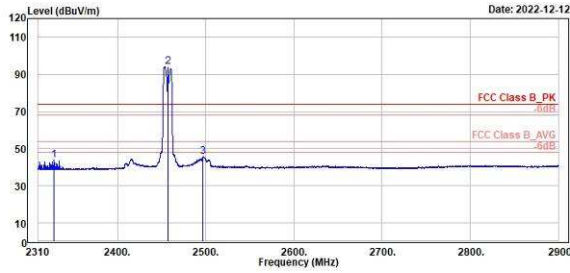
| Freq | Level | Read | Level | Factor | Limit | Over | APos | TPos | Remark | Pol/Phase | Note |
|---|---|---|---|---|---|---|---|---|---|---|---|
| 1 | 2327.936 | 43.72 | 7.47 | 36.25 | 54.00 | -10.28 | 323 | 299 | Average | Horizontal | |
| 2 | * 2457.000 | 94.14 | 57.09 | 37.05 | 54.00 | 40.14 | 323 | 299 | Average | Horizontal | |
| 3 | 2497.030 | 45.80 | 8.79 | 37.01 | 54.00 | -8.20 | 323 | 299 | Average | Horizontal | |

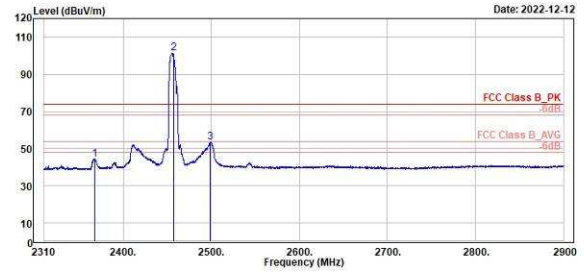
**CH 10 (Vertical) Average**

| Freq | Level | Read | Level | Factor | Limit | Over | APos | TPos | Remark | Pol/Phase | Note |
| MHz | dBuV/m | dBuV | dB/m | dBuV/m | dB | cm | deg | | | | |
| 1 | 2367.584 | 44.48 | 7.99 | 36.49 | 54.00 | -9.52 | 100 | 183 | Average | Vertical | |
| 2 | * 2457.000 | 101.40 | 64.35 | 37.05 | 54.00 | 47.40 | 100 | 183 | Average | Vertical | |
| 3 | 2499.272 | 53.40 | 16.40 | 37.00 | 54.00 | -0.60 | 100 | 183 | Average | Vertical | |

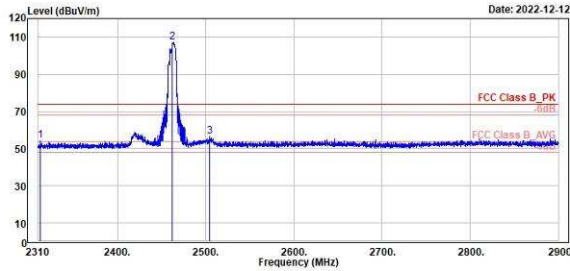
**CH 11 (Horizontal) Peak**

| Freq | Level | Read | Level | Factor | Limit | Over | APos | TPos | Remark | Pol/Phase | Note |
|---|---|---|---|---|---|---|---|---|---|---|---|
| 1 | 2312.050 | 54.11 | 16.05 | 37.26 | 74.00 | -19.09 | 320 | 100 | Peak | Horizontal | |
| 2 | * 2462.000 | 107.41 | 69.68 | 37.73 | 74.00 | 33.41 | 320 | 100 | Peak | Horizontal | |
| 3 | 2504.700 | 56.44 | 18.58 | 37.86 | 74.00 | -17.56 | 320 | 100 | Peak | Horizontal | |

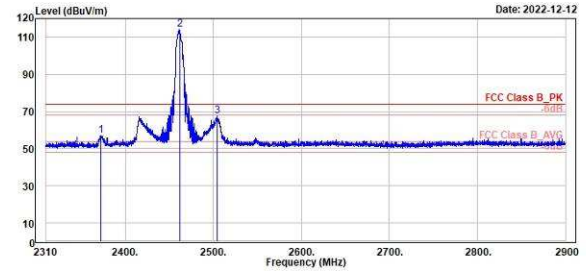
**CH 11 (Vertical) Peak**

| Freq | Level | Read | Level | Factor | Limit | Over | APos | TPos | Remark | Pol/Phase | Note |
| MHz | dBuV/m | dBuV | dB/m | dBuV/m | dB | cm | deg | | | | |
| 1 | 2372.540 | 56.09 | 19.40 | 37.49 | 74.00 | -17.11 | 100 | 180 | Peak | Vertical | |
| 2 | * 2462.000 | 113.85 | 76.12 | 37.73 | 74.00 | 39.85 | 100 | 180 | Peak | Vertical | |
| 3 | 2504.228 | 67.58 | 29.73 | 37.85 | 74.00 | -6.42 | 100 | 180 | Peak | Vertical | |

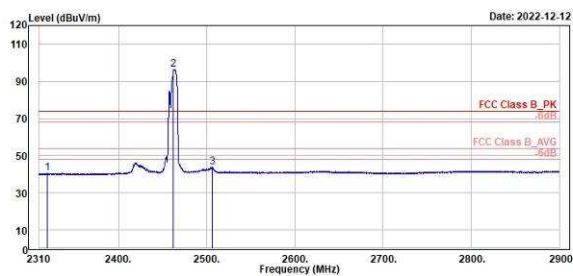
**CH 11 (Horizontal) Average**

| Freq | Level | Read | Level | Factor | Limit | Over | APos | TPos | Remark | Pol/Phase | Note |
| MHz | dBuV/m | dBuV | dB/m | dBuV/m | dB | cm | deg | | | | |
| 1 | 2319.676 | 40.46 | 3.18 | 37.28 | 54.00 | -13.54 | 320 | 100 | Average | Horizontal | |
| 2 | * 2462.000 | 96.31 | 58.58 | 37.73 | 54.00 | 42.31 | 320 | 100 | Average | Horizontal | |
| 3 | 2506.824 | 43.71 | 5.85 | 37.86 | 54.00 | -10.29 | 320 | 100 | Average | Horizontal | |

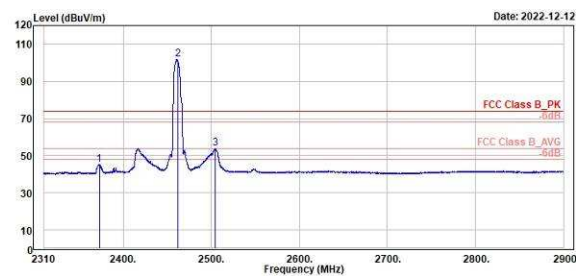
| Freq | Level | Read | Level | Factor | Limit | Over | APos | TPos | Remark | Pol/Phase | Note |
| MHz | dBuV/m | dBuV | dB/m | dBuV/m | dB | cm | deg | | | | |
| 1 | 2373.012 | 45.15 | 7.06 | 37.49 | 54.00 | -8.85 | 100 | 180 | Average | Vertical | |
| 2 | * 2462.000 | 101.83 | 64.10 | 37.73 | 54.00 | 47.83 | 100 | 180 | Average | Vertical | |
| 3 | 2505.054 | 53.79 | 15.93 | 37.86 | 54.00 | -0.21 | 100 | 180 | Average | Vertical | |

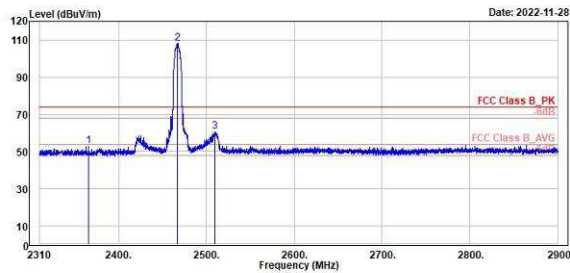
**CH 12 (Horizontal) Peak**

| Freq | Level | Read | Factor | Limit | Over | APos | TPos | Remark | Pol/Phase | Note |
|---|---|---|---|---|---|---|---|---|---|---|
| 1 | 2365.578 | 52.75 | 16.21 | 36.54 | 74.00 | -21.25 | 320 | 296 Peak | Horizontal | |
| 2 | 2467.000 | 106.20 | 71.40 | 36.80 | 74.00 | 34.20 | 320 | 296 Peak | Horizontal | |
| 3 | 2509.184 | 60.81 | 23.90 | 36.91 | 74.00 | -13.19 | 320 | 296 Peak | Horizontal | |

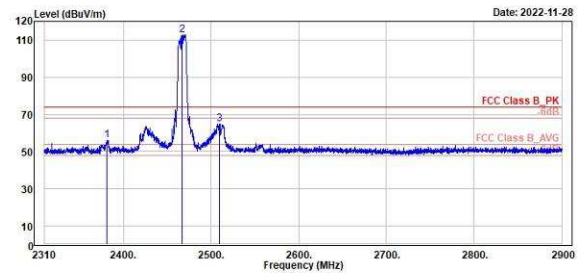
**CH 12 (Vertical) Peak**

| Freq | Level | Read | Factor | Limit | Over | APos | TPos | Remark | Pol/Phase | Note |
| MHz | dBuV/m | dBuV | dB/m | dBuV/m | dB | cm | deg | | | |
| 1 | 2380.000 | 55.95 | 19.34 | 36.61 | 74.00 | -18.05 | 116 | 172 Peak | Vertical | |
| 2 | 2467.000 | 112.52 | 75.72 | 36.80 | 74.00 | 38.52 | 116 | 172 Peak | Vertical | |
| 3 | 2509.774 | 65.01 | 28.10 | 36.91 | 74.00 | -8.99 | 116 | 172 Peak | Vertical | |

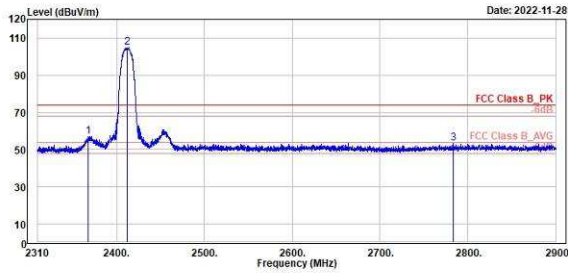
**CH 1 (Horizontal) Peak**

| Freq | Level | Read | Factor | Limit | Over | APos | TPos | Remark | Pol/Phase | Note |
|---|---|---|---|---|---|---|---|---|---|---|
| 1 | 2367.348 | 57.11 | 20.56 | 36.55 | 74.00 | -16.89 | 132 | 295 Peak | Horizontal | |
| 2 | 2412.000 | 104.93 | 68.21 | 36.72 | 74.00 | 38.93 | 132 | 295 Peak | Horizontal | |
| 3 | 2783.062 | 53.35 | 16.19 | 37.16 | 74.00 | -20.65 | 132 | 295 Peak | Horizontal | |

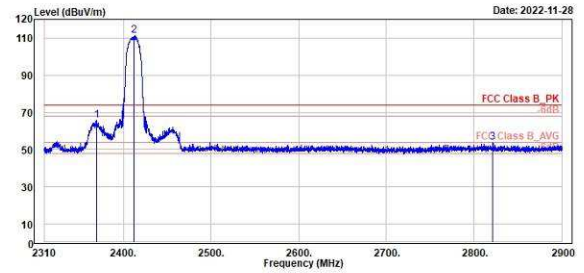
**CH 1 (Vertical) Peak**

| Freq | Level | Read | Factor | Limit | Over | APos | TPos | Remark | Pol/Phase | Note |
| MHz | dBuV/m | dBuV | dB/m | dBuV/m | dB | cm | deg | | | |
| 1 | 2369.236 | 65.67 | 29.11 | 36.56 | 74.00 | -8.33 | 235 | 291 Peak | Vertical | |
| 2 | 2412.000 | 111.93 | 74.61 | 36.72 | 74.00 | 37.33 | 235 | 291 Peak | Vertical | |
| 3 | 2821.530 | 53.77 | 16.61 | 37.16 | 74.00 | -20.23 | 235 | 291 Peak | Vertical | |

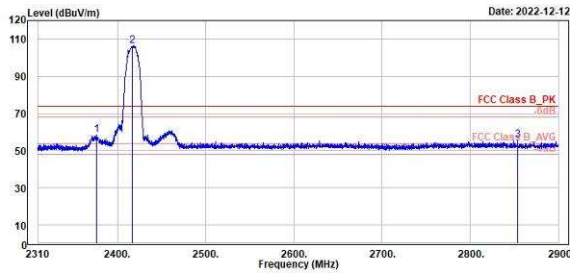
**CH 2 (Horizontal) Peak**

| Peak | Freq | Level | Read | Level | Factor | Limit | Over | APos | TPos | Remark | Pol/Phase | Note |
|---|---|---|---|---|---|---|---|---|---|---|---|---|
| 1 | 2376.198 | 58.37 | 20.87 | 37.50 | 74.00 | -15.63 | 327 | 124 | Peak | Horizontal | | |
| 2 * | 2417.000 | 106.49 | 68.84 | 37.65 | 74.00 | 32.49 | 327 | 124 | Peak | Horizontal | | |
| 3 | 2853.862 | 55.51 | 17.32 | 38.19 | 74.00 | -18.49 | 327 | 124 | Peak | Horizontal | | |

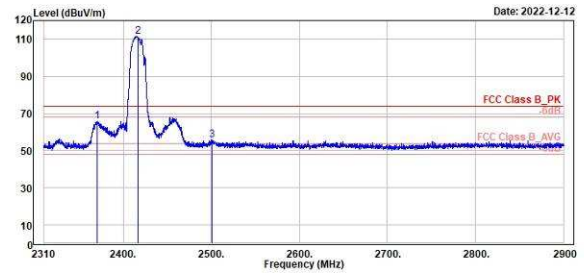
**CH 2 (Vertical) Peak**

| Peak | Freq | Level | Read | Level | Factor | Limit | Over | APos | TPos | Remark | Pol/Phase | Note |
| | MHz | dBuV/m | dBuV | dB/m | dBuV/m | dB | cm | deg | | | | |
| 1 | 2376.198 | 65.62 | 28.14 | 37.48 | 74.00 | -8.38 | 100 | 183 | Peak | Vertical | | |
| 2 * | 2417.000 | 111.49 | 73.84 | 37.65 | 74.00 | 37.49 | 100 | 183 | Peak | Vertical | | |
| 3 | 2500.806 | 55.60 | 17.75 | 37.85 | 74.00 | -18.40 | 100 | 183 | Peak | Vertical | | |

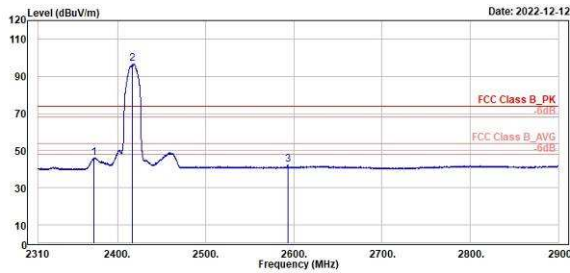
**CH 2 (Horizontal) Average**

| Freq | Level | Read | Level | Factor | Limit | Over | APos | TPos | Remark | Pol/Phase | Note |
|---|---|---|---|---|---|---|---|---|---|---|---|
| 1 | 2373.484 | 46.13 | 8.64 | 37.49 | 54.00 | -7.87 | 327 | 124 | Average | Horizontal | |
| 2 | * 2417.000 | 96.55 | 58.99 | 37.65 | 54.00 | 42.55 | 327 | 124 | Average | Horizontal | |
| 3 | 2593.082 | 42.46 | 4.58 | 37.96 | 54.00 | -11.54 | 327 | 124 | Average | Horizontal | |

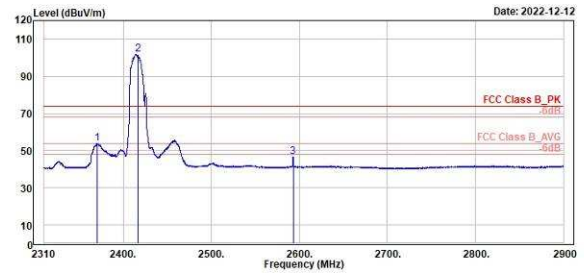
**CH 2 (Vertical) Average**

| Freq | Level | Read | Level | Factor | Limit | Over | APos | TPos | Remark | Pol/Phase | Note |
| MHz | dBuV/m | dBuV | dB/m | dBuV/m | dB | cm | deg | | | | |
| 1 | 2370.416 | 53.88 | 16.49 | 37.48 | 54.00 | -0.12 | 100 | 183 | Average | Vertical | |
| 2 | * 2417.000 | 101.66 | 64.01 | 37.65 | 54.00 | 47.66 | 100 | 183 | Average | Vertical | |
| 3 | 2592.964 | 46.53 | 8.57 | 37.96 | 54.00 | -7.47 | 100 | 183 | Average | Vertical | |

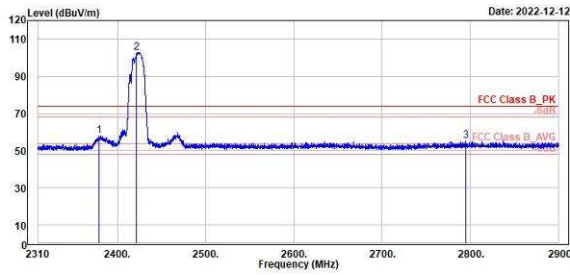
**CH 3 (Horizontal) Peak**

| Freq | Level | Read | Level | Factor | Limit | Over | APos | TPos | Remark | Pol/Phase | Note |
| MHz | dBuV/m | dBuV | dB/m | dBuV/m | dB | cm | deg | | | | |
| 1 | 2379.148 | 58.06 | 20.53 | 37.53 | 74.00 | -15.04 | 120 | 120 | Peak | Horizontal | |
| 2 | * 2422.000 | 102.81 | 65.15 | 37.66 | 74.00 | 28.81 | 120 | 120 | Peak | Horizontal | |
| 3 | 2795.334 | 55.21 | 17.01 | 38.20 | 74.00 | -18.79 | 120 | 120 | Peak | Horizontal | |

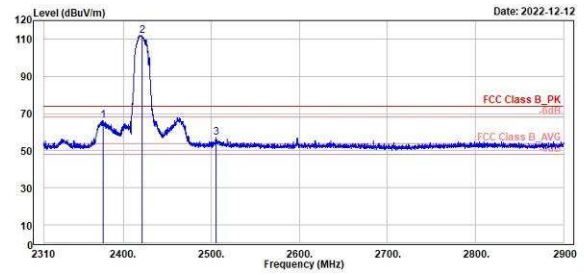
**CH 3 (Vertical) Peak**

| Freq | Level | Read | Level | Factor | Limit | Over | APos | TPos | Remark | Pol/Phase | Note |
| MHz | dBuV/m | dBuV | dB/m | dBuV/m | dB | cm | deg | | | | |
| 1 | 2376.906 | 66.36 | 28.85 | 37.51 | 74.00 | -7.64 | 100 | 182 | Peak | Vertical | |
| 2 | * 2422.000 | 111.85 | 74.19 | 37.66 | 74.00 | 37.85 | 100 | 182 | Peak | Vertical | |
| 3 | 2505.998 | 56.90 | 19.04 | 37.86 | 74.00 | -17.10 | 100 | 182 | Peak | Vertical | |

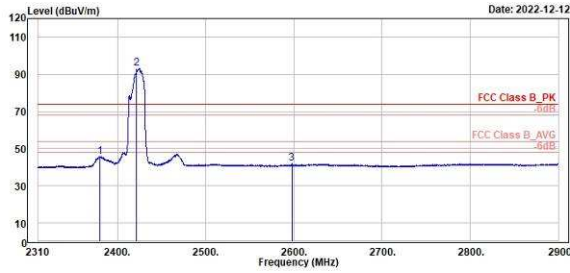
**CH 3 (Horizontal) Average**

| Freq | Level | Read | Level | Factor | Limit | Over | APos | TPos | Remark | Pol/Phase | Note |
|---|---|---|---|---|---|---|---|---|---|---|---|
| 1 | 2380.564 | 45.84 | 8.31 | 37.53 | 54.00 | -8.16 | 120 | 120 | Average | Horizontal | |
| 2 | 2422.000 | 93.15 | 55.49 | 37.66 | 54.00 | 39.15 | 120 | 120 | Average | Horizontal | |
| 3 | 2597.802 | 41.98 | 4.01 | 37.97 | 54.00 | -12.02 | 120 | 120 | Average | Horizontal | |

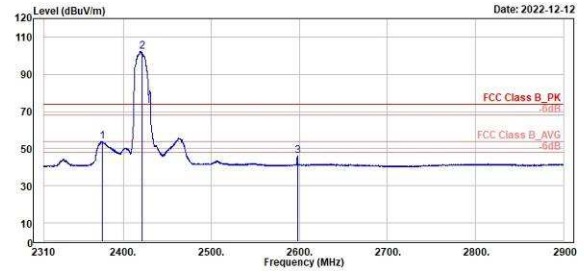
**CH 3 (Vertical) Average**

| Freq | Level | Read | Level | Factor | Limit | Over | APos | TPos | Remark | Pol/Phase | Note |
| MHz | dBuV/m | dBuV | dB/m | dBuV/m | dB | cm | deg | | | | |
| 1 | 2376.670 | 53.81 | 16.30 | 37.51 | 54.00 | -0.19 | 100 | 182 | Average | Vertical | |
| 2 | 2422.000 | 102.35 | 64.69 | 37.66 | 54.00 | 48.35 | 100 | 182 | Average | Vertical | |
| 3 | 2597.920 | 46.00 | 8.03 | 37.97 | 54.00 | -8.00 | 100 | 182 | Average | Vertical | |

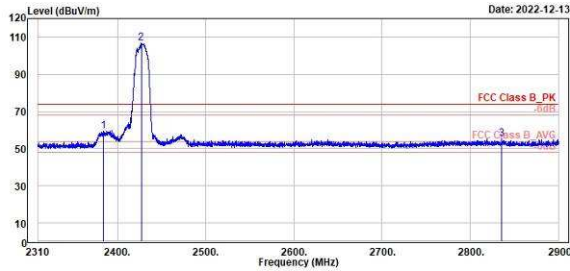
**CH 4 (Horizontal) Peak**

| Peak | Freq | Level | Read | Level | Factor | Limit | Over | APos | TPos | Remark | Pol/Phase | Note |
|---|---|---|---|---|---|---|---|---|---|---|---|---|
| 1 | 2384.222 | 59.27 | 21.72 | 37.55 | 74.00 | -14.73 | 296 | 121 | Peak | Horizontal | | |
| 2 * | 2427.000 | 106.54 | 68.68 | 37.86 | 74.00 | 32.54 | 296 | 121 | Peak | Horizontal | | |
| 3 | 2835.926 | 55.28 | 17.10 | 38.18 | 74.00 | -18.72 | 296 | 121 | Peak | Horizontal | | |

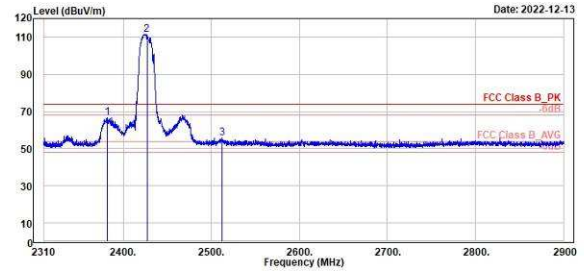
**CH 4 (Vertical) Peak**

| Peak | Freq | Level | Read | Level | Factor | Limit | Over | APos | TPos | Remark | Pol/Phase | Note |
| | MHz | dBuV/m | dBuV | dB/m | dBuV/m | dB | cm | deg | | | | |
| 1 | 2381.062 | 66.71 | 29.17 | 37.54 | 74.00 | -7.29 | 100 | 183 | Peak | Vertical | | |
| 2 * | 2427.000 | 111.43 | 73.77 | 37.66 | 74.00 | 37.43 | 100 | 183 | Peak | Vertical | | |
| 3 | 2512.606 | 55.56 | 17.70 | 37.86 | 74.00 | -18.44 | 100 | 183 | Peak | Vertical | | |

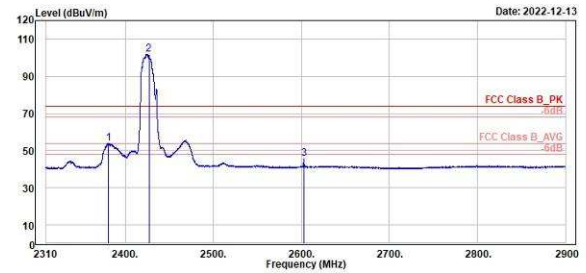
**CH 4 (Vertical) Average**

| Freq | Level | Read | Level | Factor | Limit | Over | APos | TPos | Remark | Pol/Phase | Note |

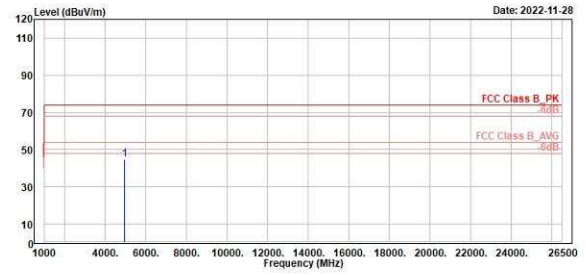
| Freq | Level | Read | Level | Factor | Limit | Over | APos | TPos | Remark | Pol/Phase | Note |
| MHz | dBuV/m | dBuV | dB/m | dBuV/m | dB | cm | deg | | | | |
| 1 4934.000 | 44.81 | 55.97 | -11.16 | 74.00 | -29.19 | 100 | 188 | Peak | Vertical | | |

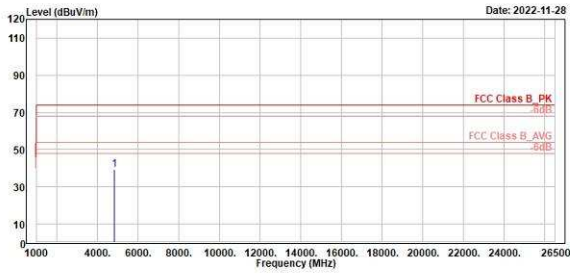
**CH 1 (Horizontal)**

**g\_20MHz**

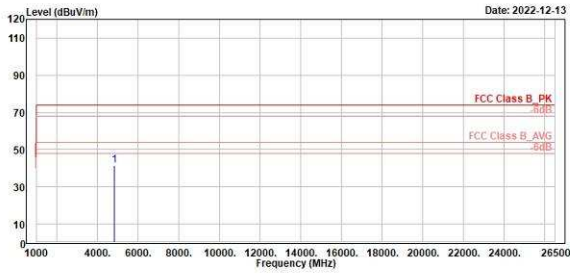
**CH 3 (Horizontal)**

| Freq | Level | Read | Level | Factor | Limit | Over | APos | TPos | Remark | Pol/Phase | Note |
| MHz | dBuV/m | dBuV | dB/m | dBuV/m | dB | cm | deg | | | | |
| 1 4844.000 | 41.52 | 52.78 | -11.26 | 74.00 | -32.48 | 200 | 303 | Peak | Horizontal | | |

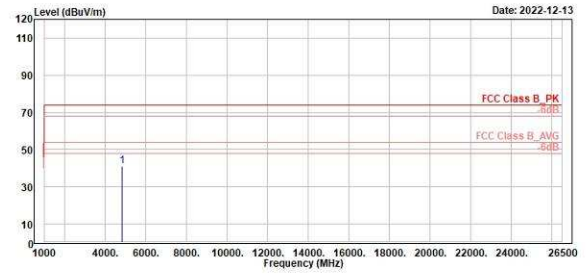
**CH 3 (Vertical)**

| Freq | Level | Read | Level | Factor | Limit | Over | APos | TPos | Remark | Pol/Phase | Note |
| MHz | dBuV/m | dBuV | dB/m | dBuV/m | dB | cm | deg | | | | |
| 1 4844.000 | 41.27 | 52.53 | -11.26 | 74.00 | -32.73 | 100 | 294 | Peak | Vertical | | |

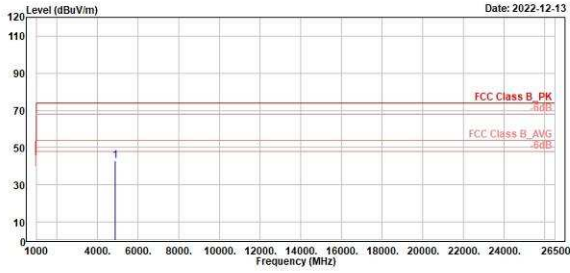
**CH 4 (Horizontal)**

| Freq | Level | Read | Level | Factor | Limit | Over | APos | TPos | Remark | Pol/Phase | Note |
| MHz | dBuV/m | dBuV | dB/m | dBuV/m | dB | cm | deg | | | | |
| 1 4854.000 | 42.73 | 53.97 | -11.24 | 74.00 | -31.27 | 100 | 270 | Peak | Horizontal | | |

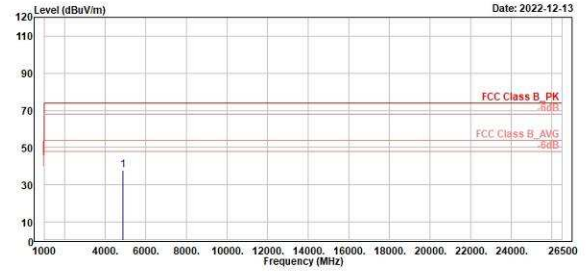
**CH 4 (Vertical)**

| Freq | Level | Read | Level | Factor | Limit | Over | APos | TPos | Remark | Pol/Phase | Note |
| MHz | dBuV/m | dBuV | dB/m | dBuV/m | dB | cm | deg | | | | |
| 1 4854.000 | 37.79 | 49.03 | -11.24 | 74.00 | -36.21 | 100 | 24 | Peak | Vertical | | |

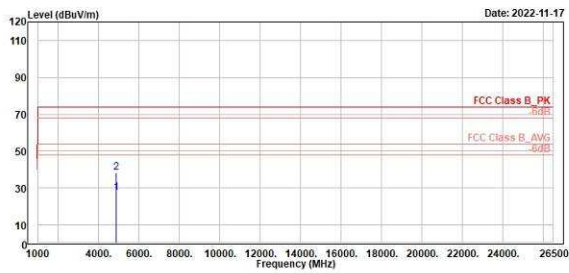
**CH 6 (Horizontal)**

| Freq | Level | Read | Level | Factor | Limit | Over | APos | TPos | Remark | Pol/Phase | Note |
| MHz | dBuV/m | dBuV | dB/m | dBuV/m | dB | cm | deg | | | | |
| 1 | 4874.000 | 27.46 | 39.74 | -11.28 | 54.00 | -26.54 | 300 | 330 | Average | Horizontal | |
| 2 | 4874.000 | 38.24 | 49.52 | -11.28 | 74.00 | -35.76 | 300 | | Peak | Horizontal | |

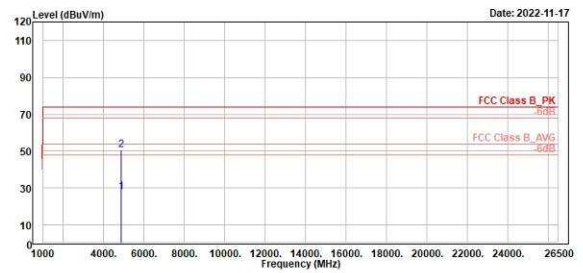
**CH 6 (Vertical)**

| Freq | Level | Read | Level | Factor | Limit | Over | APos | TPos | Remark | Pol/Phase | Note |
| MHz | dBuV/m | dBuV | dB/m | dBuV/m | dB | cm | deg | | | | |
| 1 | 4874.000 | 27.77 | 39.05 | -11.28 | 54.00 | -26.23 | 300 | 13 | Average | Vertical | |
| 2 | 4874.000 | 50.62 | 61.90 | -11.28 | 74.00 | -23.38 | 300 | | Peak | Vertical | |

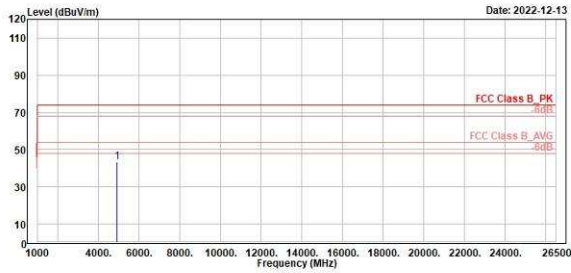
**CH 8 (Horizontal)**

| Freq | Level | Read | Level | Factor | Limit | Over | APos | TPos | Remark | Pol/Phase | Note |
| MHz | dBuV/m | dBuV | dB/m | dBuV/m | dB | cm | deg | | | | |
| 1 4894.000 | 43.55 | 54.77 | -11.22 | 74.00 | -30.45 | 100 | 290 | Peak | Horizontal | | |

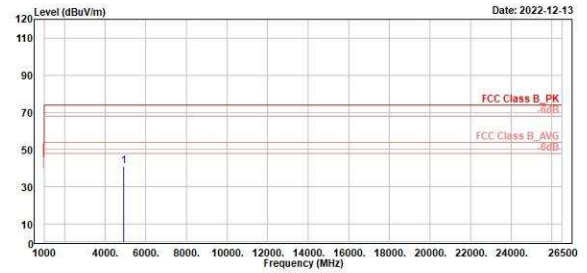
**CH 8 (Vertical)**

| Freq | Level | Read | Level | Factor | Limit | Over | APos | TPos | Remark | Pol/Phase | Note |
| MHz | dBuV/m | dBuV | dB/m | dBuV/m | dB | cm | deg | | | | |
| 1 4894.000 | 40.95 | 52.17 | -11.22 | 74.00 | -33.05 | 200 | 294 | Peak | Vertical | | |

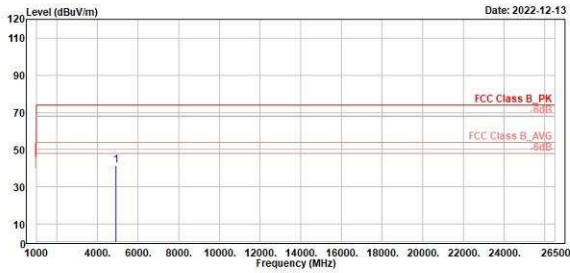
**CH 9 (Horizontal)**

| Freq | Level | Read | Level | Factor | Limit | Over | APos | TPos | Remark | Pol/Phase | Note |
| MHz | dBuV/m | dBuV | dB/m | dBuV/m | dB | cm | deg | | | | |
| 1 4904.000 | 41.34 | 52.54 | -11.20 | 74.00 | -32.66 | 100 | 183 | Peak | Horizontal | | |

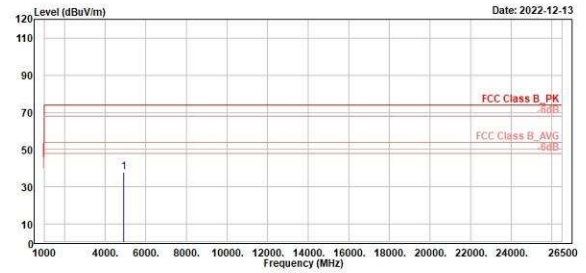
**CH 9 (Vertical)**

| Freq | Level | Read | Level | Factor | Limit | Over | APos | TPos | Remark | Pol/Phase | Note |
| MHz | dBuV/m | dBuV | dB/m | dBuV/m | dB | cm | deg | | | | |
| 1 4904.000 | 37.86 | 49.06 | -11.20 | 74.00 | -36.14 | 100 | 11 | Peak | Vertical | | |

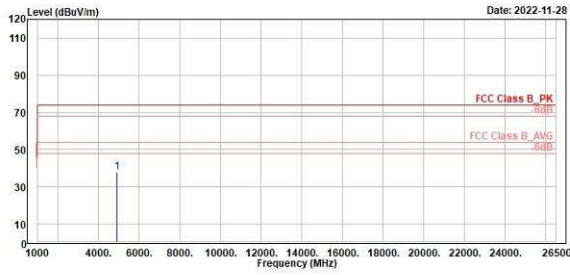
**CH 11 (Horizontal)**

| Freq | Level | Read | Level | Factor | Limit | Over | APos | TPos | Remark | Pol/Phase | Note |
| MHz | dBuV/m | dBuV | dB/m | dBuV/m | dB | cm | deg | | | | |
| 1 | 4924.000 | 37.88 | 49.08 | -11.20 | 74.00 | -36.12 | 400 | 160 | Peak | Horizontal | |

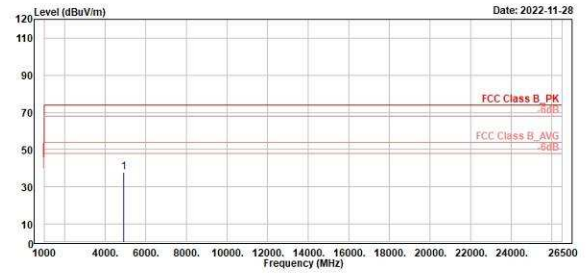
**CH 11 (Vertical)**

| Freq | Level | Read | Level | Factor | Limit | Over | APos | TPos | Remark | Pol/Phase | Note |
| MHz | dBuV/m | dBuV | dB/m | dBuV/m | dB | cm | deg | | | | |
| 1 | 4924.000 | 37.68 | 48.88 | -11.20 | 74.00 | -36.32 | 399 | 360 | Peak | Vertical | |

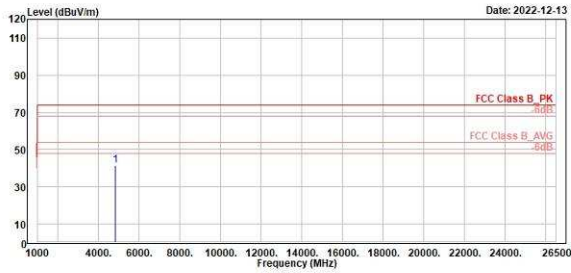
**CH 2 (Horizontal)**

| Freq | Level | Read | Level | Factor | Limit | Over | APos | TPos | Remark | Pol/Phase | Note |
| MHz | dBuV/m | dBuV | dB/m | dBuV/m | dB | cm | deg | | | | |
| 1 4834.000 | 41.51 | 52.80 | -11.29 | 74.00 | -32.49 | 200 | 298 | Peak | Horizontal | | |

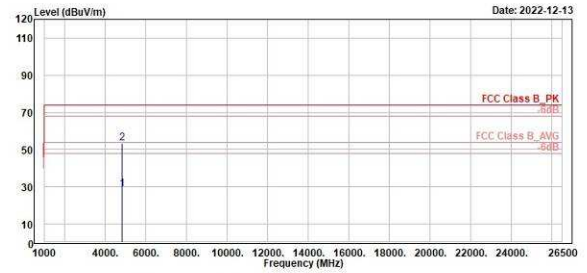
**CH 2 (Vertical)**

| Freq | Level | Read | Level | Factor | Limit | Over | APos | TPos | Remark | Pol/Phase | Note |
| MHz | dBuV/m | dBuV | dB/m | dBuV/m | dB | cm | deg | | | | |
| 1 4834.000 | 28.88 | 40.17 | -11.29 | 54.00 | -25.12 | 100 | 14 | Average | Vertical | | |
| 2 4834.000 | 53.46 | 64.75 | -11.29 | 74.00 | -20.54 | 100 | 14 | Peak | Vertical | | |

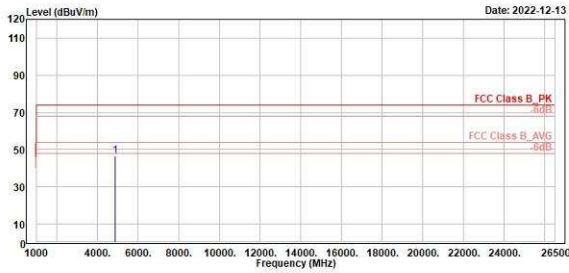
**CH 4 (Horizontal)**

| Freq | Level | Read | Level | Factor | Limit | Over | APos | TPos | Remark | Pol/Phase | Note |
| MHz | dBuV/m | dBuV | dB/m | dBuV/m | dB | dB | cm | deg | | | |
| 1 4854.000 | 46.45 | 57.69 | -11.24 | 74.00 | -27.55 | | 100 | 264 | Peak | Horizontal | |

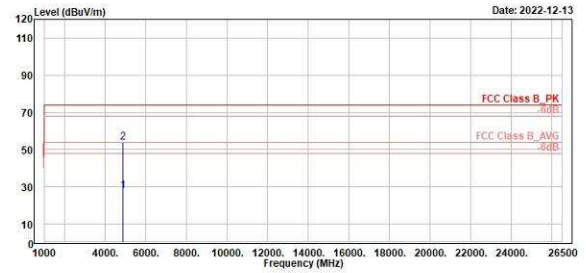
**CH 4 (Vertical)**

| Freq | Level | Read | Level | Factor | Limit | Over | APos | TPos | Remark | Pol/Phase | Note |
| MHz | dBuV/m | dBuV | dB/m | dBuV/m | dB | dB | cm | deg | | | |
| 1 4854.000 | 27.75 | 38.99 | -11.24 | 54.00 | -26.25 | | 200 | 118 | Average | Vertical | |
| 2 4854.000 | 53.93 | 65.17 | -11.24 | 74.00 | -20.87 | | 200 | 118 | Peak | Vertical | |

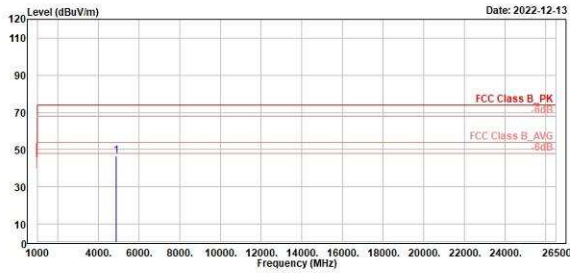
**CH 5 (Horizontal)**

| Freq | Level | Read | Level | Factor | Limit | Over | APos | TPos | Remark | Pol/Phase | Note |
| MHz | dBuV/m | dBuV | dB/m | dBuV/m | dB | dB | cm | deg | | | |
| 1 4864.000 | 46.60 | 57.84 | -11.24 | 74.00 | -27.40 | | 100 | 108 | Peak | Horizontal | |

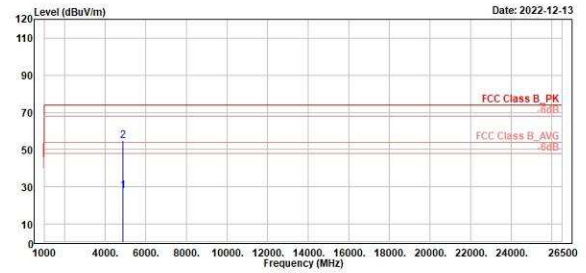
**CH 5 (Vertical)**

| Freq | Level | Read | Level | Factor | Limit | Over | APos | TPos | Remark | Pol/Phase | Note |
| MHz | dBuV/m | dBuV | dB/m | dBuV/m | dB | dB | cm | deg | | | |
| 1 4864.000 | 27.90 | 39.14 | -11.24 | 54.00 | -26.10 | | 200 | 282 | Average | Vertical | |
| 2 4864.000 | 54.81 | 66.05 | -11.24 | 74.00 | -19.19 | | 200 | 282 | Peak | Vertical | |

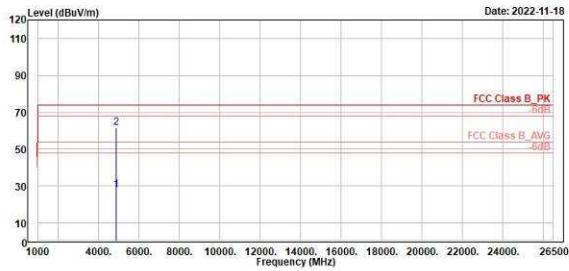
**CH 6 (Horizontal)**

| Freq | Level | Read | Level | Factor | Limit | Over | APos | TPos | Remark | Pol/Phase | Note |
| MHz | dBuV/m | dBuV | dB/m | dBuV/m | dB | | cm | deg | | | |
| 1 | 4874.000 | 27.74 | 39.82 | -11.28 | 54.00 | -26.26 | 100 | 211 | Average | Horizontal | |
| 2 | 4874.000 | 61.63 | 72.91 | -11.28 | 74.00 | -12.37 | 100 | 211 | Peak | Horizontal | |

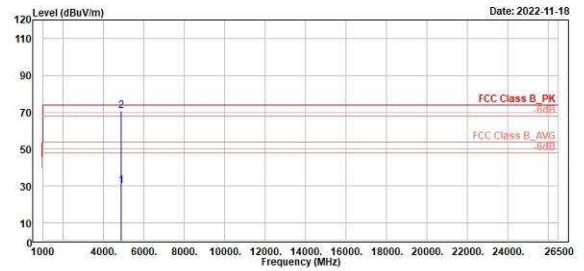
**CH 6 (Vertical)**

| Freq | Level | Read | Level | Factor | Limit | Over | APos | TPos | Remark | Pol/Phase | Note |
| MHz | dBuV/m | dBuV | dB/m | dBuV/m | dB | | cm | deg | | | |
| 1 | 4874.000 | 30.16 | 41.44 | -11.28 | 54.00 | -23.84 | 100 | 14 | Average | Vertical | |
| 2 | 4874.000 | 70.75 | 82.03 | -11.28 | 74.00 | -3.25 | 100 | 14 | Peak | Vertical | |

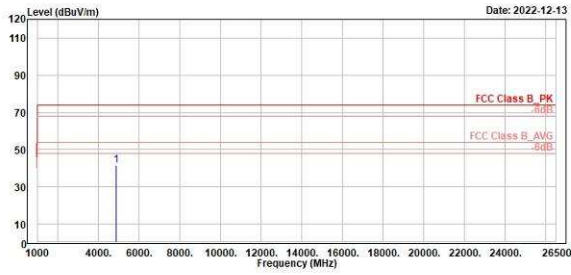
**CH 7 (Horizontal)**

| Freq | Level | Read | Level | Factor | Limit | Over | APos | TPos | Remark | Pol/Phase | Note |
| MHz | dBuV/m | dBuV | dB/m | dBuV/m | dB | cm | deg | | | | |
| 1 4884.000 | 41.57 | 52.80 | -11.23 | 74.00 | -32.43 | 100 | 43 | Peak | Horizontal | | |

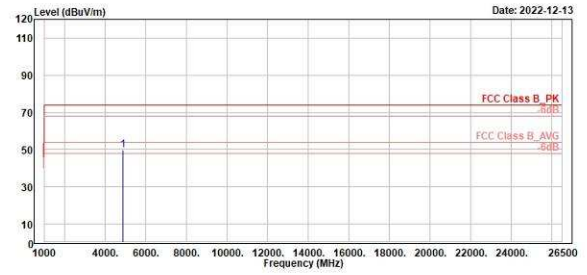
**CH 7 (Vertical)**

| Freq | Level | Read | Level | Factor | Limit | Over | APos | TPos | Remark | Pol/Phase | Note |
| MHz | dBuV/m | dBuV | dB/m | dBuV/m | dB | cm | deg | | | | |
| 1 4884.000 | 49.88 | 61.11 | -11.23 | 74.00 | -24.12 | 200 | 1 | Peak | Vertical | | |

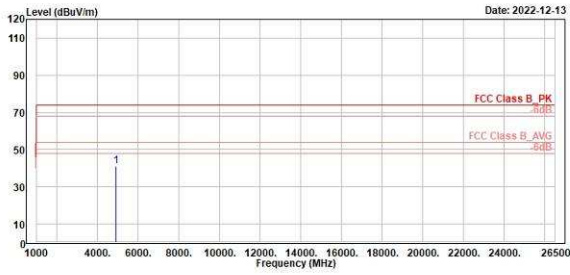
**CH 8 (Horizontal)**

| Freq | Level | Read | Level | Factor | Limit | Over | APos | TPos | Remark | Pol/Phase | Note |
| MHz | dBuV/m | dBuV | dB/m | dBuV/m | dB | cm | deg | | | | |
| 1 4894.000 | 40.93 | 52.15 | -11.22 | 74.00 | -33.07 | 100 | 308 | Peak | Horizontal | | |

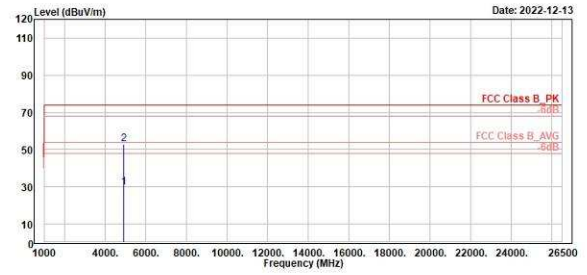
**CH 8 (Vertical)**

| Freq | Level | Read | Level | Factor | Limit | Over | APos | TPos | Remark | Pol/Phase | Note |
| MHz | dBuV/m | dBuV | dB/m | dBuV/m | dB | cm | deg | | | | |
| 1 4894.000 | 29.75 | 40.97 | -11.22 | 54.00 | -24.25 | 200 | 11 | Average | Vertical | | |
| 2 4894.000 | 53.05 | 64.28 | -11.22 | 74.00 | -20.94 | 200 | 11 | Peak | Vertical | | |

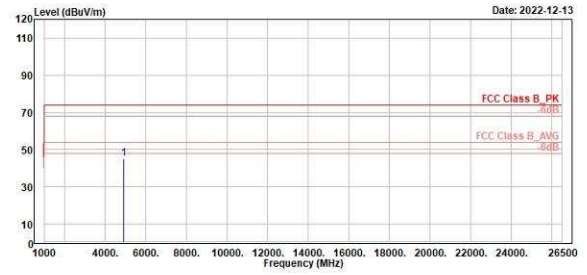
| Freq | Level | Read | Level | Factor | Limit | Over | APos | TPos | Remark | Pol/Phase | Note |
|---|---|---|---|---|---|---|---|---|---|---|---|
| 1 4904.000 | 45.36 | 56.56 | -11.20 | 74.00 | -28.64 | 133 | 42 | Peak | Vertical | | |

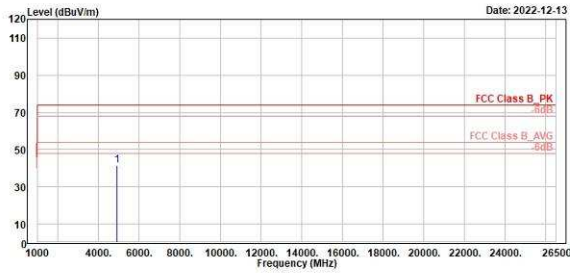
**CH 10 (Horizontal)**

| Freq | Level | Read | Level | Factor | Limit | Over | APos | TPos | Remark | Pol/Phase | Note |
|---|---|---|---|---|---|---|---|---|---|---|---|
| 1 4914.000 | 41.60 | 52.78 | -11.18 | 74.00 | -32.40 | 100 | 297 | Peak | Horizontal | | |

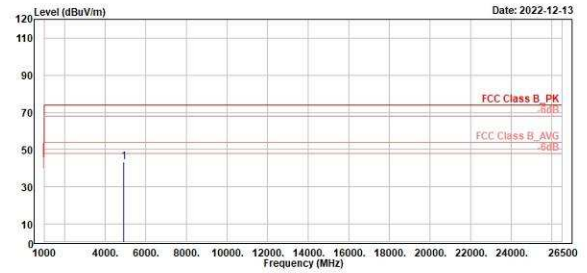
**CH 10 (Vertical)**

| Freq | Level | Read | Level | Factor | Limit | Over | APos | TPos | Remark | Pol/Phase | Note |
|---|---|---|---|---|---|---|---|---|---|---|---|
| 1 4914.000 | 43.42 | 54.60 | -11.18 | 74.00 | -30.58 | 130 | 4 | Peak | Vertical | | |

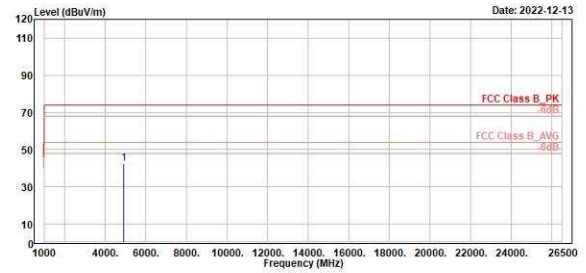
**CH 11 (Vertical)**

| Freq | Level | Read | Level | Factor | Limit | Over | APos | TPos | Remark | Pol/Phase | Note |
|---|---|---|---|---|---|---|---|---|---|---|---|
| 1 4924.000 | 42.48 | 53.63 | -11.15 | 74.00 | -31.52 | 200 | 71 | Peak | Vertical | | |

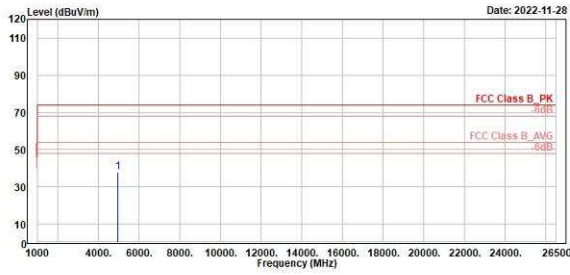
**CH 12 (Horizontal)**

| Freq | Level | Read | Level | Factor | Limit | Over | APos | TPos | Remark | Pol/Phase | Note |
|---|---|---|---|---|---|---|---|---|---|---|---|
| 1 | 4934.000 | 37.75 | 48.91 | -11.16 | 74.00 | -36.25 | 400 | 235 | Peak | Horizontal | |

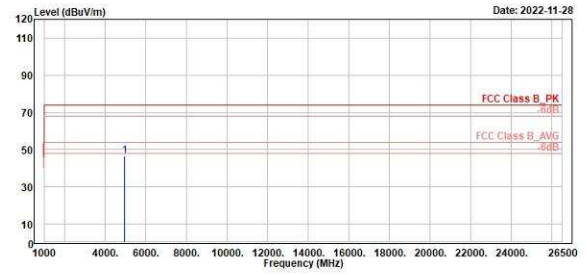
**CH 12 (Vertical)**

| Freq | Level | Read | Level | Factor | Limit | Over | APos | TPos | Remark | Pol/Phase | Note |
|---|---|---|---|---|---|---|---|---|---|---|---|
| 1 | 4934.000 | 46.60 | 57.76 | -11.16 | 74.00 | -27.40 | 246 | 6 | Peak | Vertical | |

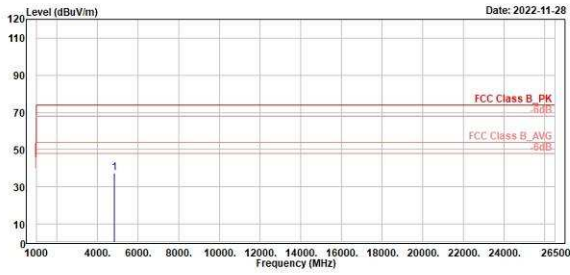
**CH 1 (Horizontal)**

| Freq | Level | Read | Level | Factor | Limit | Over | APos | TPos | Remark | Pol/Phase | Note |
|---|---|---|---|---|---|---|---|---|---|---|---|
| 1 4824.000 | 37.57 | 48.88 | -11.31 | 74.00 | -36.43 | 100 | 66 | Peak | Horizontal | | |

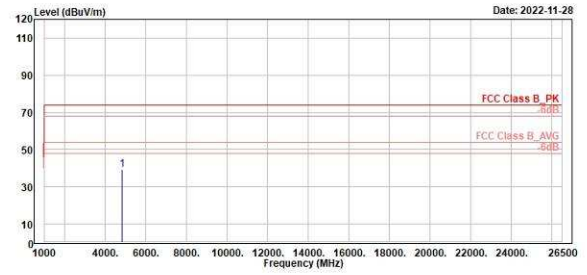
**CH 1 (Vertical)**

| Freq | Level | Read | Level | Factor | Limit | Over | APos | TPos | Remark | Pol/Phase | Note |
|---|---|---|---|---|---|---|---|---|---|---|---|
| 1 4824.000 | 39.06 | 50.37 | -11.31 | 74.00 | -34.94 | 210 | 4 | Peak | Vertical | | |

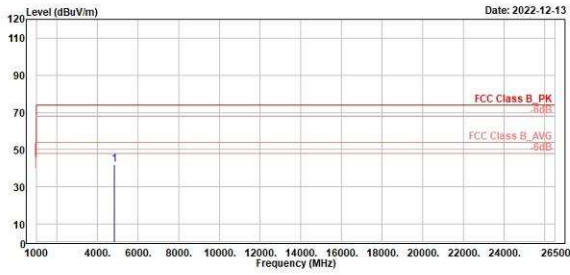
**CH 2 (Horizontal)**

| Freq | Level | Read | Level | Factor | Limit | Over | APos | TPos | Remark | Pol/Phase | Note |
|---|---|---|---|---|---|---|---|---|---|---|---|
| 1 4834.000 | 42.02 | 53.31 | -11.29 | 74.00 | -31.98 | 100 | 296 | Peak | Horizontal | | |

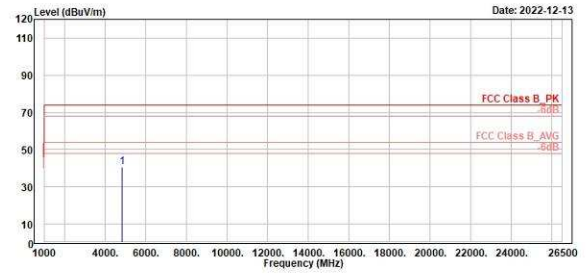
**CH 2 (Vertical)**

| Freq | Level | Read | Level | Factor | Limit | Over | APos | TPos | Remark | Pol/Phase | Note |
|---|---|---|---|---|---|---|---|---|---|---|---|
| 1 4834.000 | 40.39 | 51.68 | -11.29 | 74.00 | -33.61 | 100 | 42 | Peak | Vertical | | |

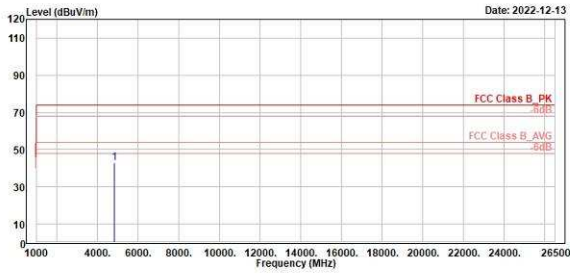
**CH 3 (Horizontal)**

| Freq | Level | Read | Level | Factor | Limit | Over | APos | TPos | Remark | Pol/Phase | Note |
|---|---|---|---|---|---|---|---|---|---|---|---|
| 1 4844.000 | 43.01 | 54.27 | -11.26 | 74.00 | -30.99 | 100 | 296 | Peak | Horizontal | | |

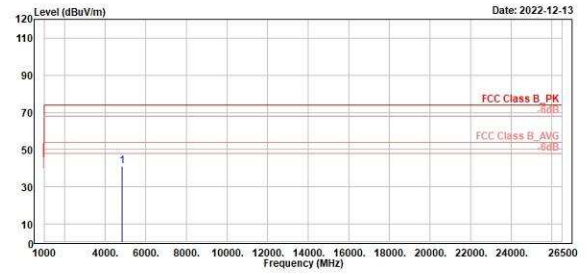
**CH 3 (Vertical)**

| Freq | Level | Read | Level | Factor | Limit | Over | APos | TPos | Remark | Pol/Phase | Note |
|---|---|---|---|---|---|---|---|---|---|---|---|
| 1 4844.000 | 41.24 | 52.50 | -11.26 | 74.00 | -32.76 | 100 | 254 | Peak | Vertical | | |

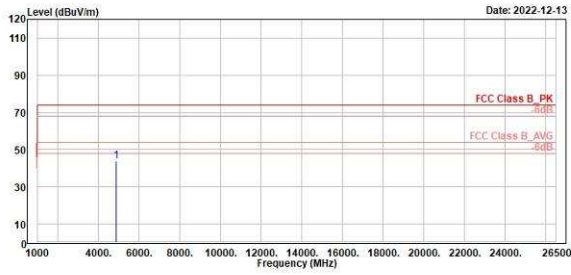
**CH 4 (Horizontal)**

| Freq | Level | Read | Level | Factor | Limit | Over | APos | TPos | Remark | Pol/Phase | Note |
|---|---|---|---|---|---|---|---|---|---|---|---|
| 1 4854.000 | 43.76 | 55.00 | -11.24 | 74.00 | -30.24 | | 100 | 300 | Peak | Horizontal | |

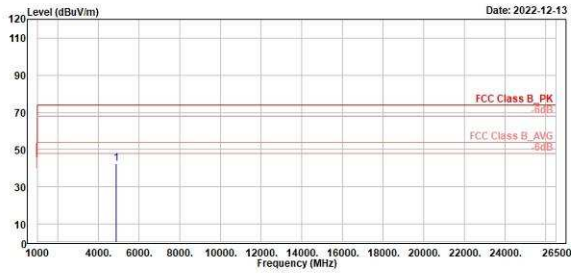
**CH 5 (Horizontal)**

| Freq | Level | Read | Level | Factor | Limit | Over | APos | TPos | Remark | Pol/Phase | Note |
|---|---|---|---|---|---|---|---|---|---|---|---|
| 1 4864.000 | 42.46 | 53.70 | -11.24 | 74.00 | -31.54 | 100 | 300 | Peak | Horizontal | | |

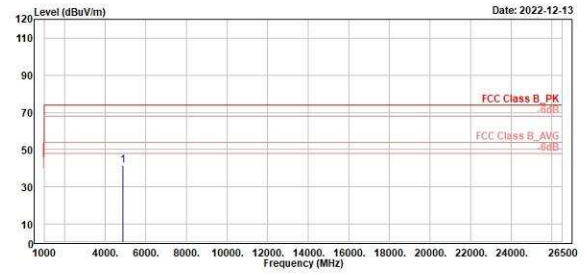
**CH 5 (Vertical)**

| Freq | Level | Read | Level | Factor | Limit | Over | APos | TPos | Remark | Pol/Phase | Note |
|---|---|---|---|---|---|---|---|---|---|---|---|
| 1 4864.000 | 41.66 | 52.90 | -11.24 | 74.00 | -32.34 | 100 | 302 | Peak | Vertical | | |

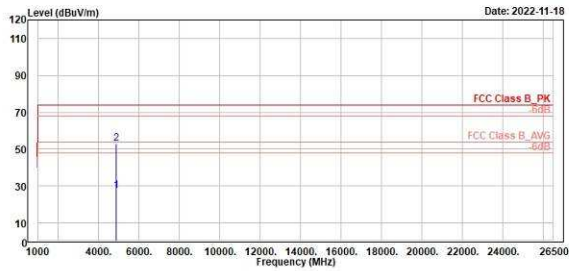
**CH 6 (Horizontal)**

| Freq | Level | Read | Level | Factor | Limit | Over | APos | TPos | Remark | Pol/Phase | Note |
|---|---|---|---|---|---|---|---|---|---|---|---|
| 1 | 4874.000 | 27.38 | 38.66 | -11.28 | 54.00 | -26.62 | 100 | 350 | Average | Horizontal | |
| 2 | 4874.000 | 52.98 | 64.26 | -11.28 | 74.00 | -21.02 | 100 | 350 | Peak | Horizontal | |

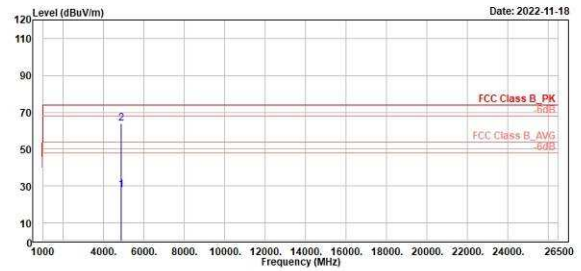
**CH 6 (Vertical)**

| Freq | Level | Read | Level | Factor | Limit | Over | APos | TPos | Remark | Pol/Phase | Note |
|---|---|---|---|---|---|---|---|---|---|---|---|
| 1 | 4874.000 | 27.67 | 38.95 | -11.28 | 54.00 | -26.33 | 156 | 360 | Average | Vertical | |
| 2 | 4874.000 | 64.10 | 75.38 | -11.28 | 74.00 | -9.90 | 156 | 360 | Peak | Vertical | |

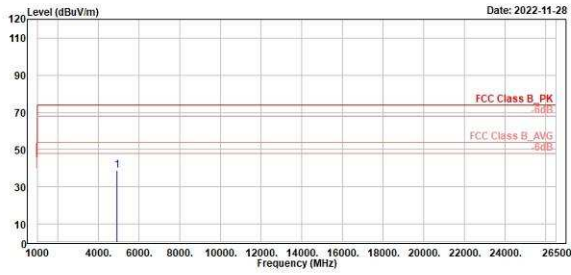
**CH 11 (Horizontal)**

| Freq | Level | Read | Level | Factor | Limit | Over | APos | TPos | Remark | Pol/Phase | Note |
|---|---|---|---|---|---|---|---|---|---|---|---|
| 1 | 4924.000 | 38.71 | 49.91 | -11.20 | 74.00 | -35.29 | 100 | 41 | Peak | Horizontal | |
