# Radiated Emission Measurement

Condition : FCC\_part 15 RE-Class C\_Above 1GHz\_PK

EUT : W6M22307-22823

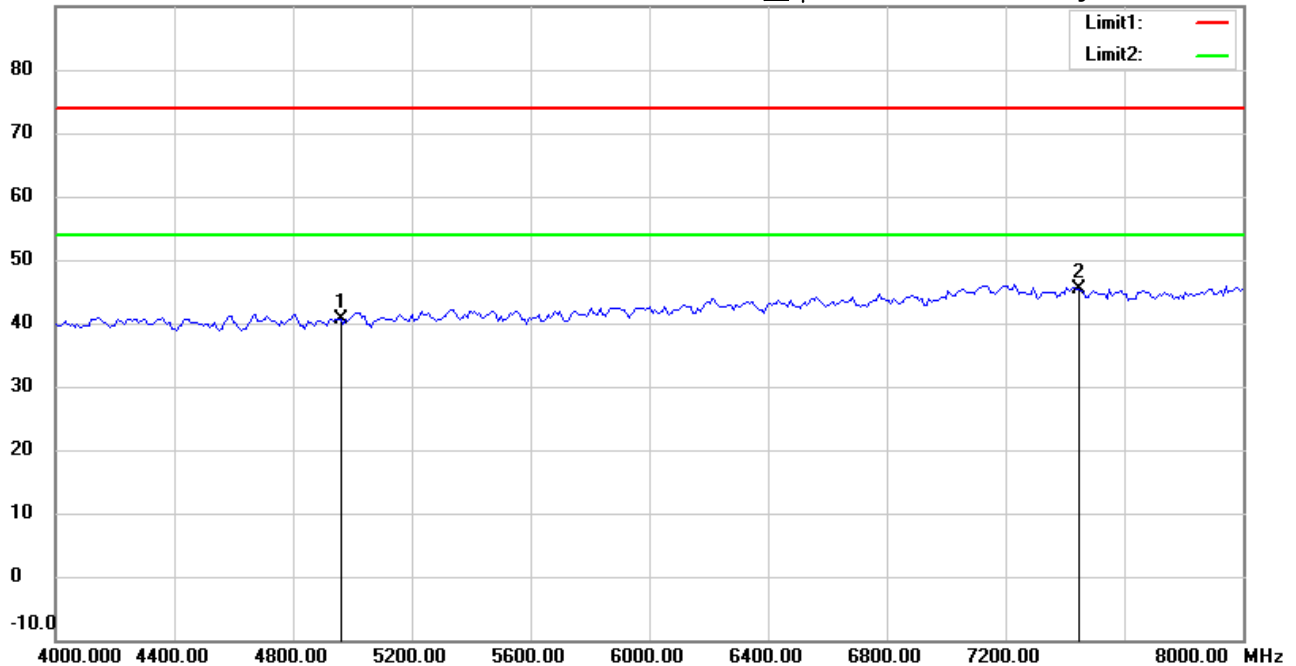
Test Mode : TX 2480MHz

Polarization: **Horizontal**

| Mk. | Frequency (MHz) | Reading (dBuV) | Detector | Corr. factor (dB/m) | Result (dBuV/m) | Limit (dBuV/m) | Ant.Pos (cm) | Tab.Pos (deg.) | Margin (dB) | Comment |
|---|---|---|---|---|---|---|---|---|---|---|
| | 4960.000 | 41.37 | peak | -0.79 | 40.58 | 74.00 | 157 | 194 | -33.42 | |
| * | 7440.000 | 41.62 | peak | 3.81 | 45.43 | 74.00 | 152 | 240 | -28.57 | |

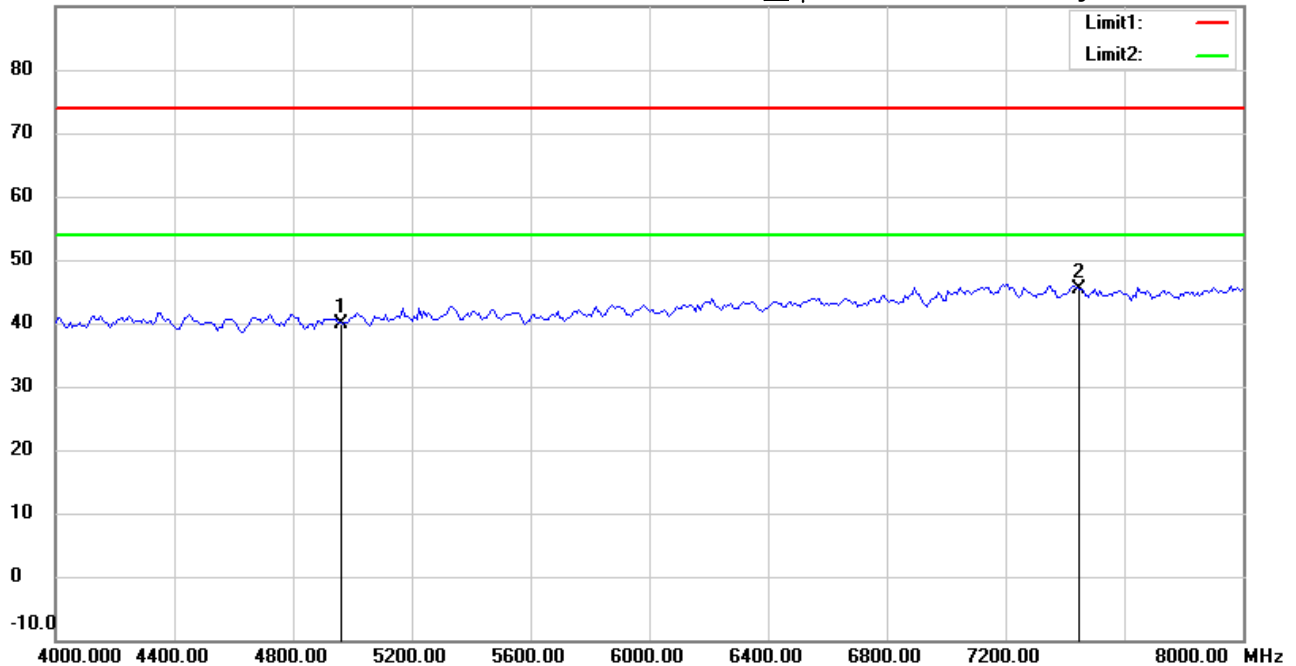
Condition : FCC\_part 15 RE-Class C\_Above 1GHz\_PK

Test Mode : TX 2480MHz

Polarization: Vertical

| Mk. | Frequency (MHz) | Reading (dBuV) | Detector | Corr. factor (dB/m) | Result (dBuV/m) | Limit (dBuV/m) | Ant.Pos (cm) | Tab.Pos (deg.) | Margin (dB) | Comment |
|---|---|---|---|---|---|---|---|---|---|---|
| | 4960.000 | 40.79 | peak | -0.79 | 40.00 | 74.00 | 153 | 228 | -34.00 | |
| * | 7440.000 | 41.47 | peak | 3.81 | 45.28 | 74.00 | 150 | 191 | -28.72 | |

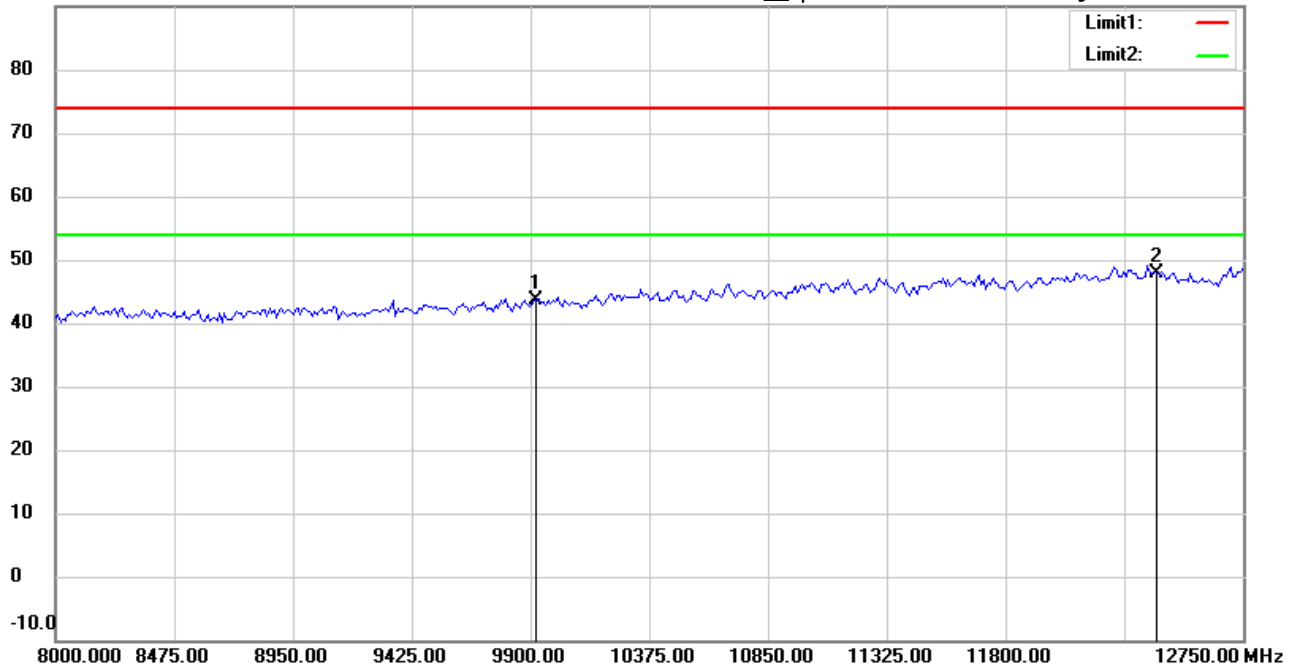
Condition : FCC\_part 15 RE-Class C\_Above 1GHz\_PK

Test Mode : TX 2480MHz

Polarization: Vertical

| Mk. | Frequency (MHz) | Reading (dBuV) | Detector | Corr. factor (dB/m) | Result (dBuV/m) | Limit (dBuV/m) | Ant.Pos (cm) | Tab.Pos (deg.) | Margin (dB) | Comment |
|---|---|---|---|---|---|---|---|---|---|---|
| | 9920.000 | 36.15 | peak | 7.56 | 43.71 | 74.00 | 150 | 117 | -30.29 | |
| * | 12400.000 | 34.47 | peak | 13.51 | 47.98 | 74.00 | 157 | 124 | -26.02 | |

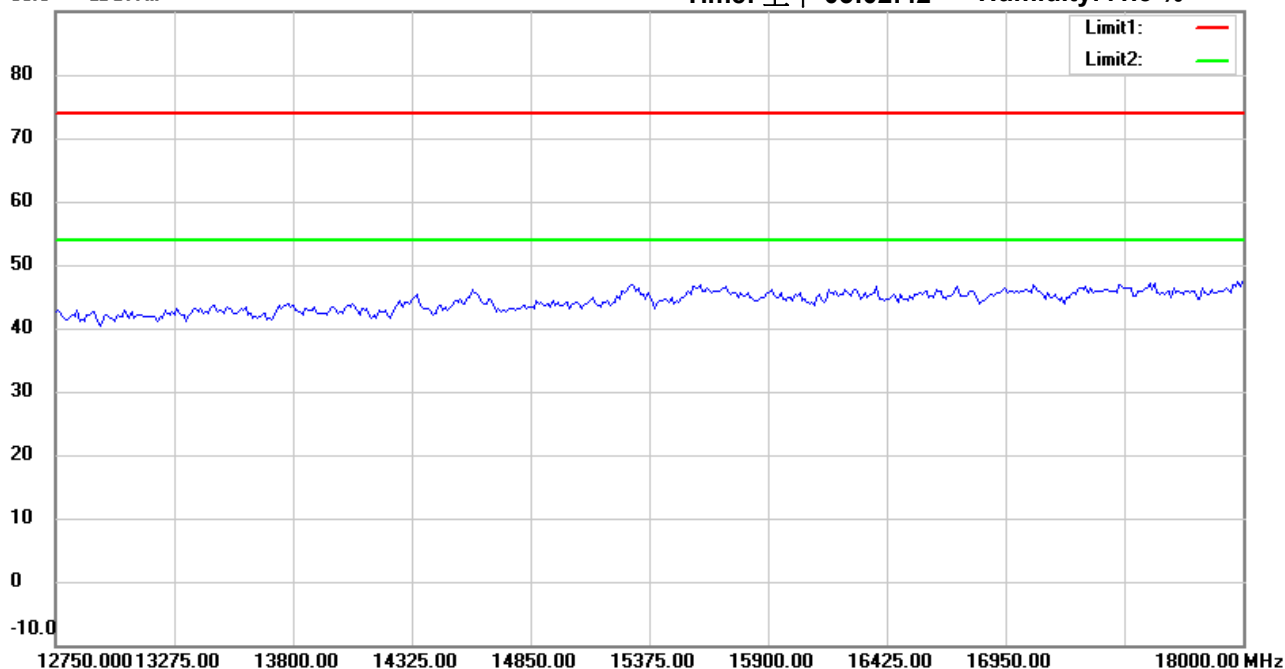
Condition : FCC\_part 15 RE-Class C\_Above 1GHz\_PK

Test Mode : TX 2480MHz

Polarization: Vertical

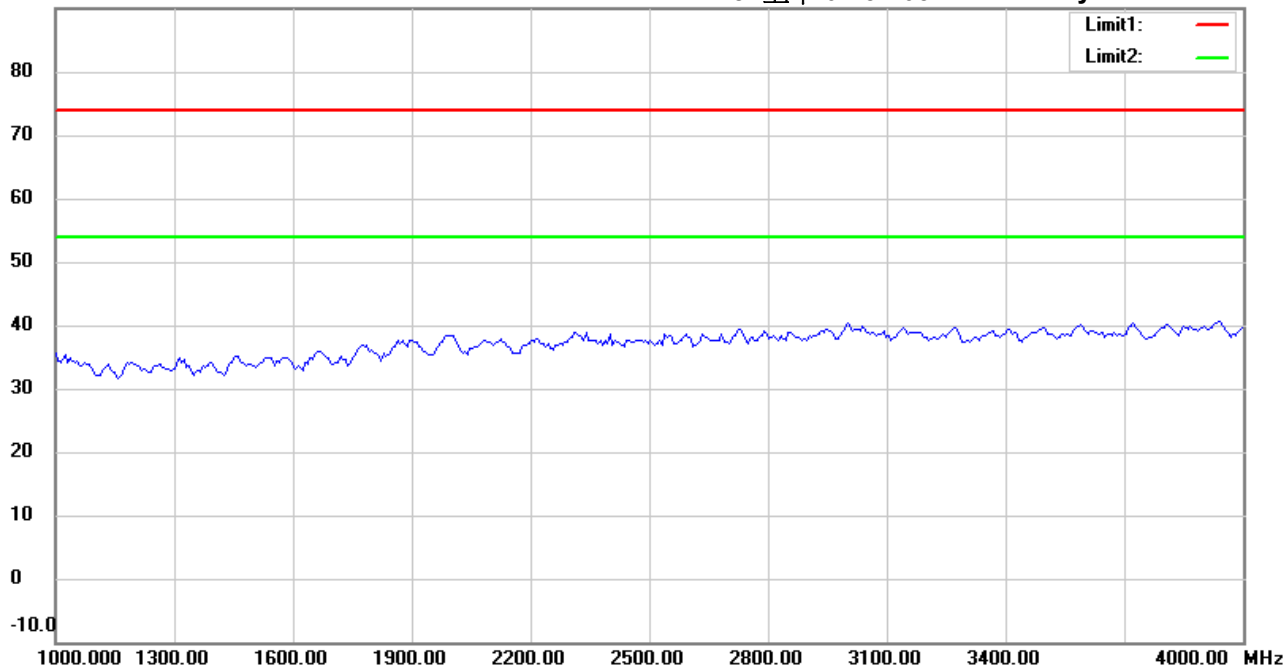
Condition : FCC\_part 15 RE-Class C\_Above 1GHz\_PK

Test Mode : TX 2402MHz

Polarization: *Vertical*

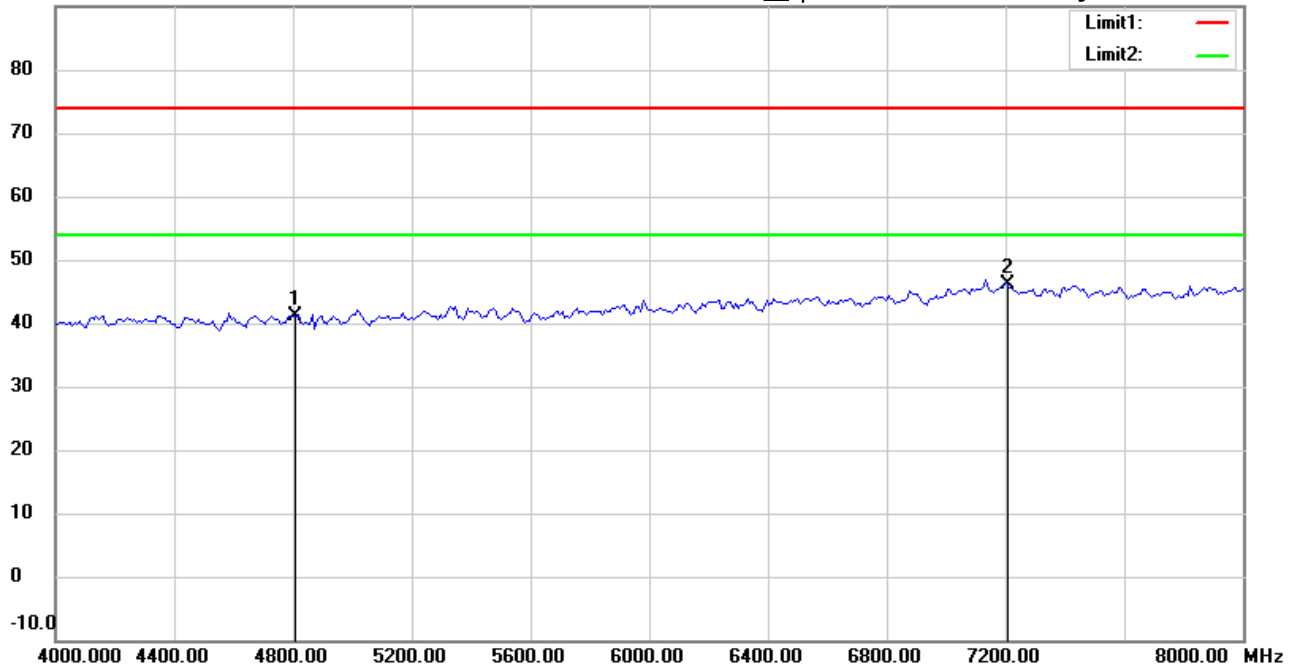
Condition : FCC\_part 15 RE-Class C\_Above 1GHz\_PK

Test Mode : TX 2402MHz

Polarization: **Horizontal**

| Mk. | Frequency (MHz) | Reading (dBuV) | Detector | Corr. factor (dB/m) | Result (dBuV/m) | Limit (dBuV/m) | Ant.Pos (cm) | Tab.Pos (deg.) | Margin (dB) | Comment |
|---|---|---|---|---|---|---|---|---|---|---|
| | 4804.000 | 42.79 | peak | -1.73 | 41.06 | 74.00 | 155 | 224 | -32.94 | |
| * | 7206.000 | 42.03 | peak | 4.08 | 46.11 | 74.00 | 152 | 103 | -27.89 | |

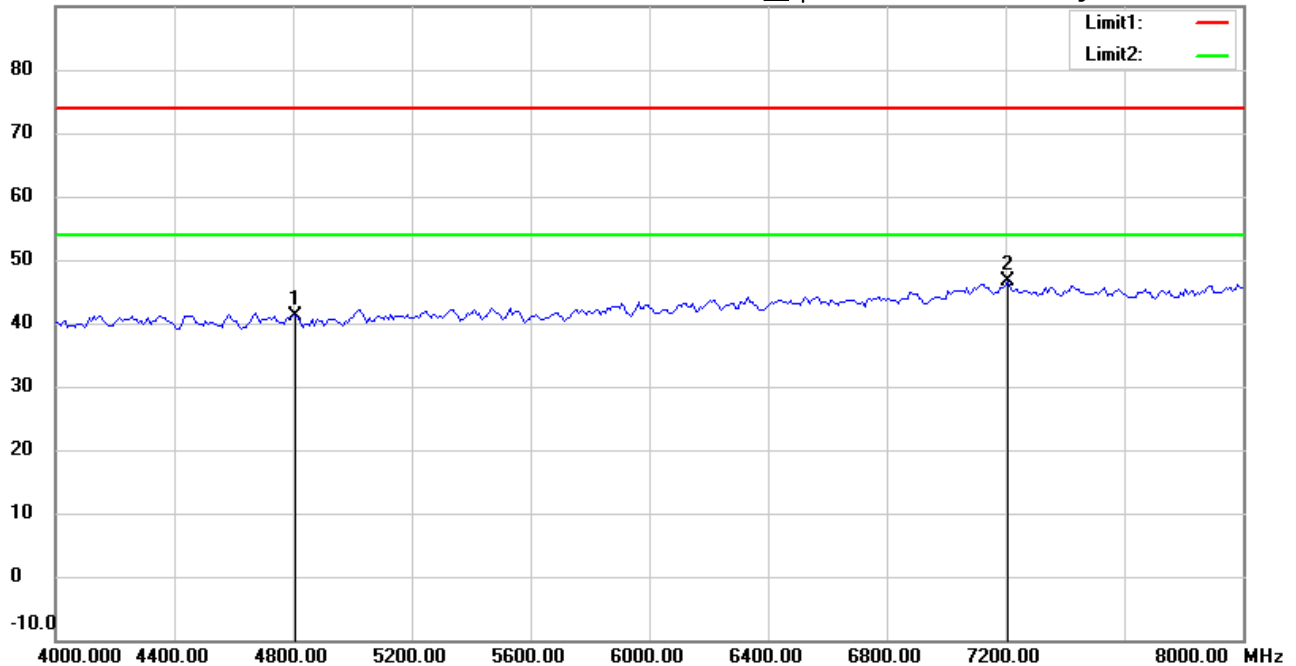
Condition : FCC\_part 15 RE-Class C\_Above 1GHz\_PK

Test Mode : TX 2402MHz

Polarization: Vertical

| Mk. | Frequency (MHz) | Reading (dBuV) | Detector | Corr. factor (dB/m) | Result (dBuV/m) | Limit (dBuV/m) | Ant.Pos (cm) | Tab.Pos (deg.) | Margin (dB) | Comment |
|---|---|---|---|---|---|---|---|---|---|---|
| | 4804.000 | 42.96 | peak | -1.73 | 41.23 | 74.00 | 153 | 285 | -32.77 | |
