# Antenna Test Report

| Project | S1 |
| Antenna Revision | A0 |

This report is to measure the performance of antenna for **S1** The antenna operating frequency at 2400-2500MHz, All test data are showed as below.

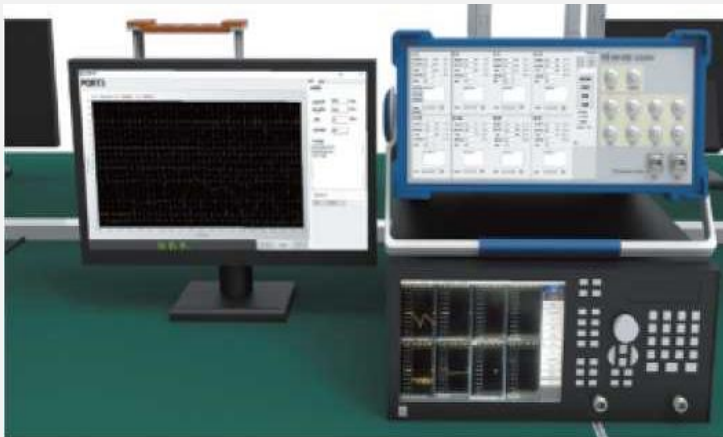
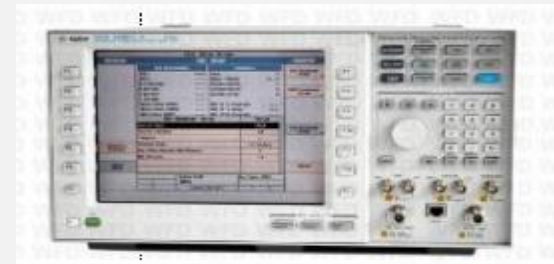
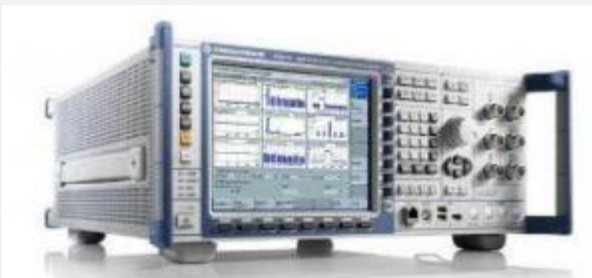
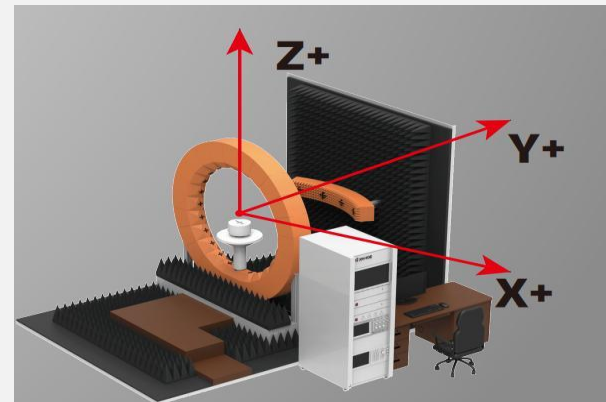
# 1.TestSystem

| Sequence Number | Test Item | equipment |
| S parameter | VSWR | Agilent 5071C & Agilent 5071B |
| OTA Test | TRP&TIS | Agilent 8960 & CMW500 STIMO |
| Gain & Efficiency | Gain & Efficiency | SATIMO<br>Agilent 5071C |

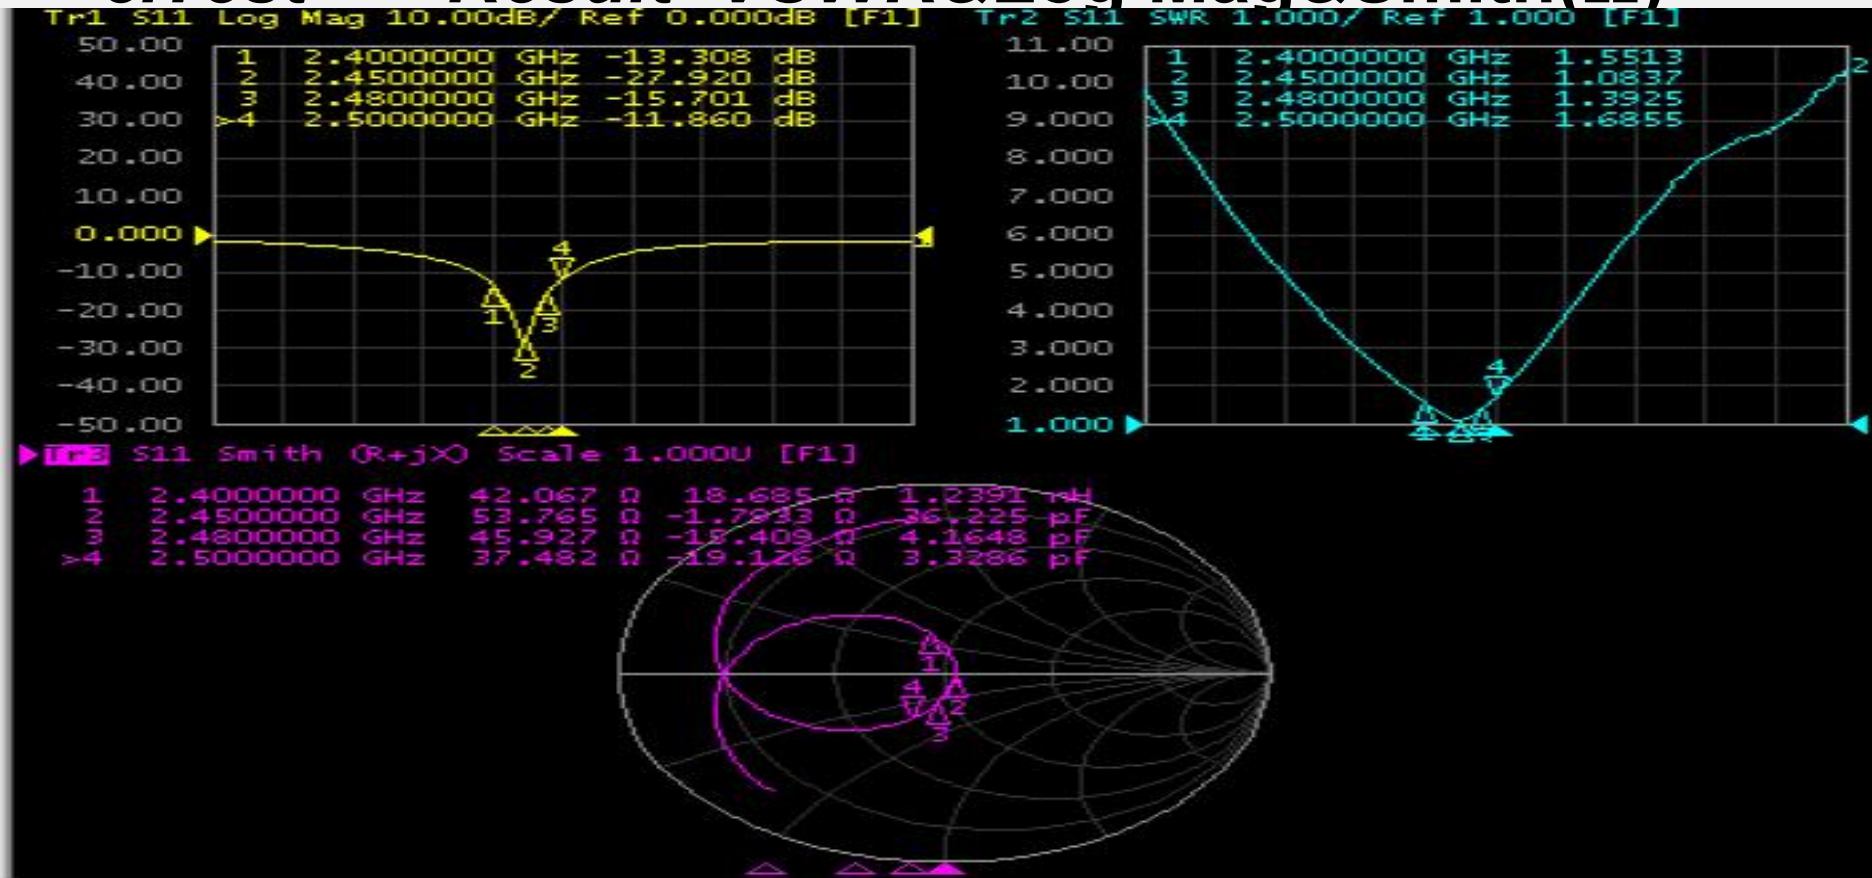
### 3.Test Result VSWR&Log Mag&Smith( $\Omega$ )

| Frequency (MHz) | 2400 | 2450 | 2480 | 2500 |
| Log Mag | -13.30 | -27.92 | -15.70 | -11.86 |
| VSWR | 1.55 | 1.08 | 1.39 | 1.68 |
| Smith( $\Omega$ ) | 42.06 | 53.76 | 45.92 | 37.48 |

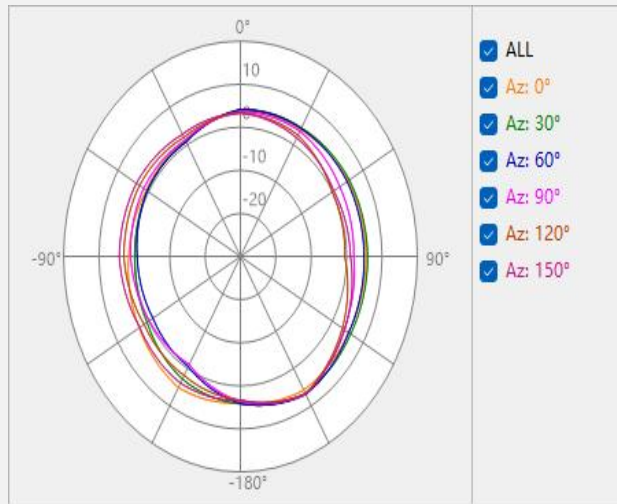
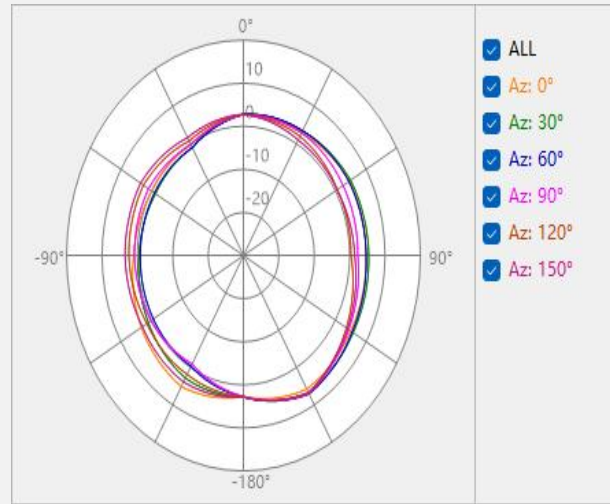
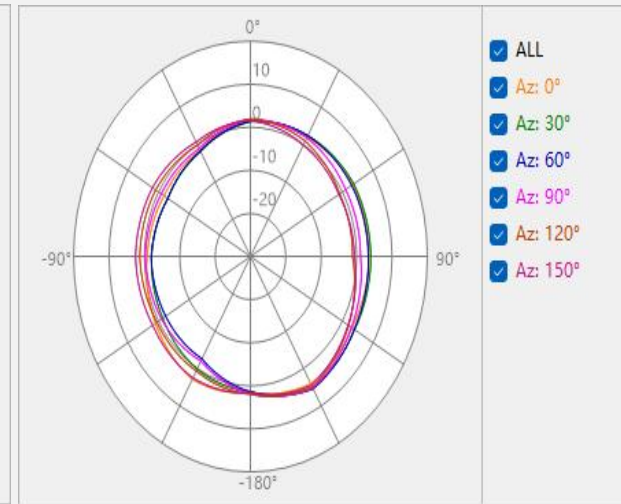
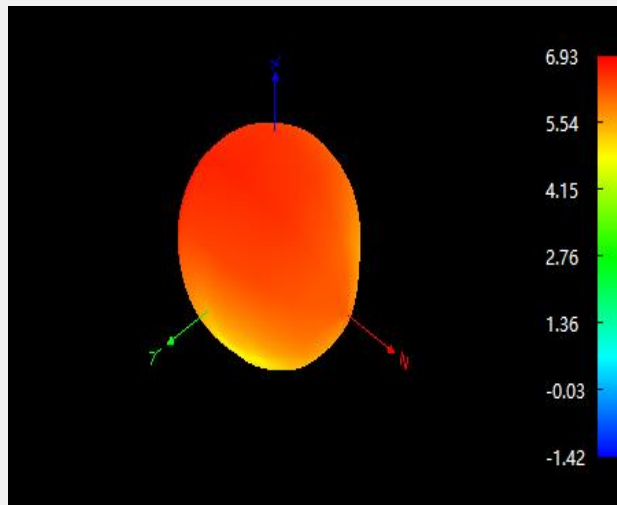
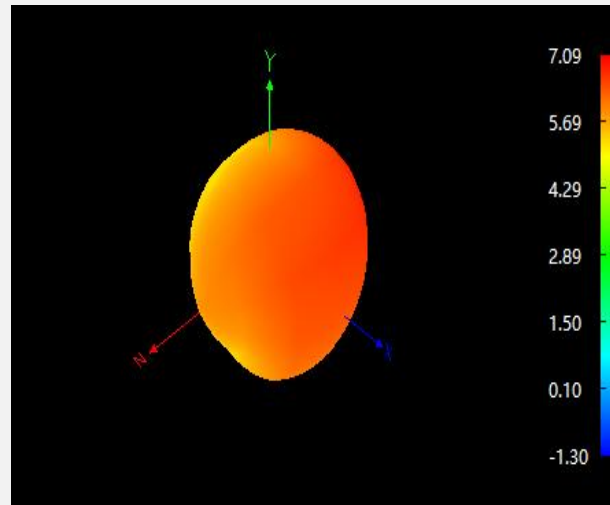
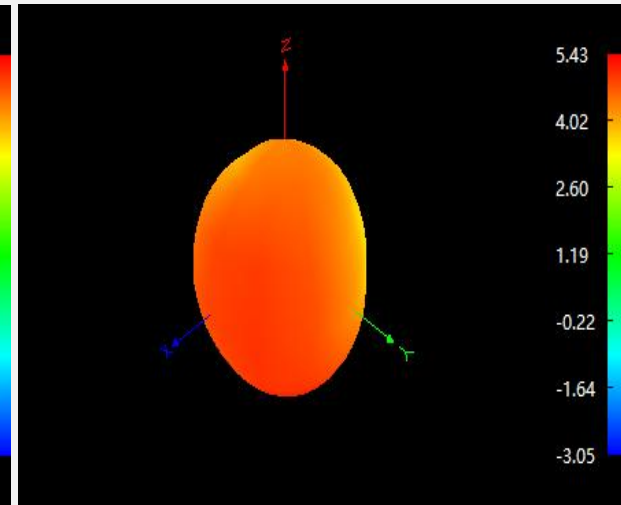
# 5.1 Test Result TRP

| Test Equipment: | R&S CMW500 | | | |
| Test Condition: | 3D chamber | | | |
| Band | | Channel | TRP(dBm) | TIS(dBm) |
| BT | | 0 | 4.01 | -90.17 |
| | | 39 | 3.76 | -90.75 |
| | | 78 | 2.24 | -90.49 |
