**ANNEX 1 - PLOTS OF MEASUREMENTS**  
**TRANSIENT FREQUENCY BEHAVIOR**

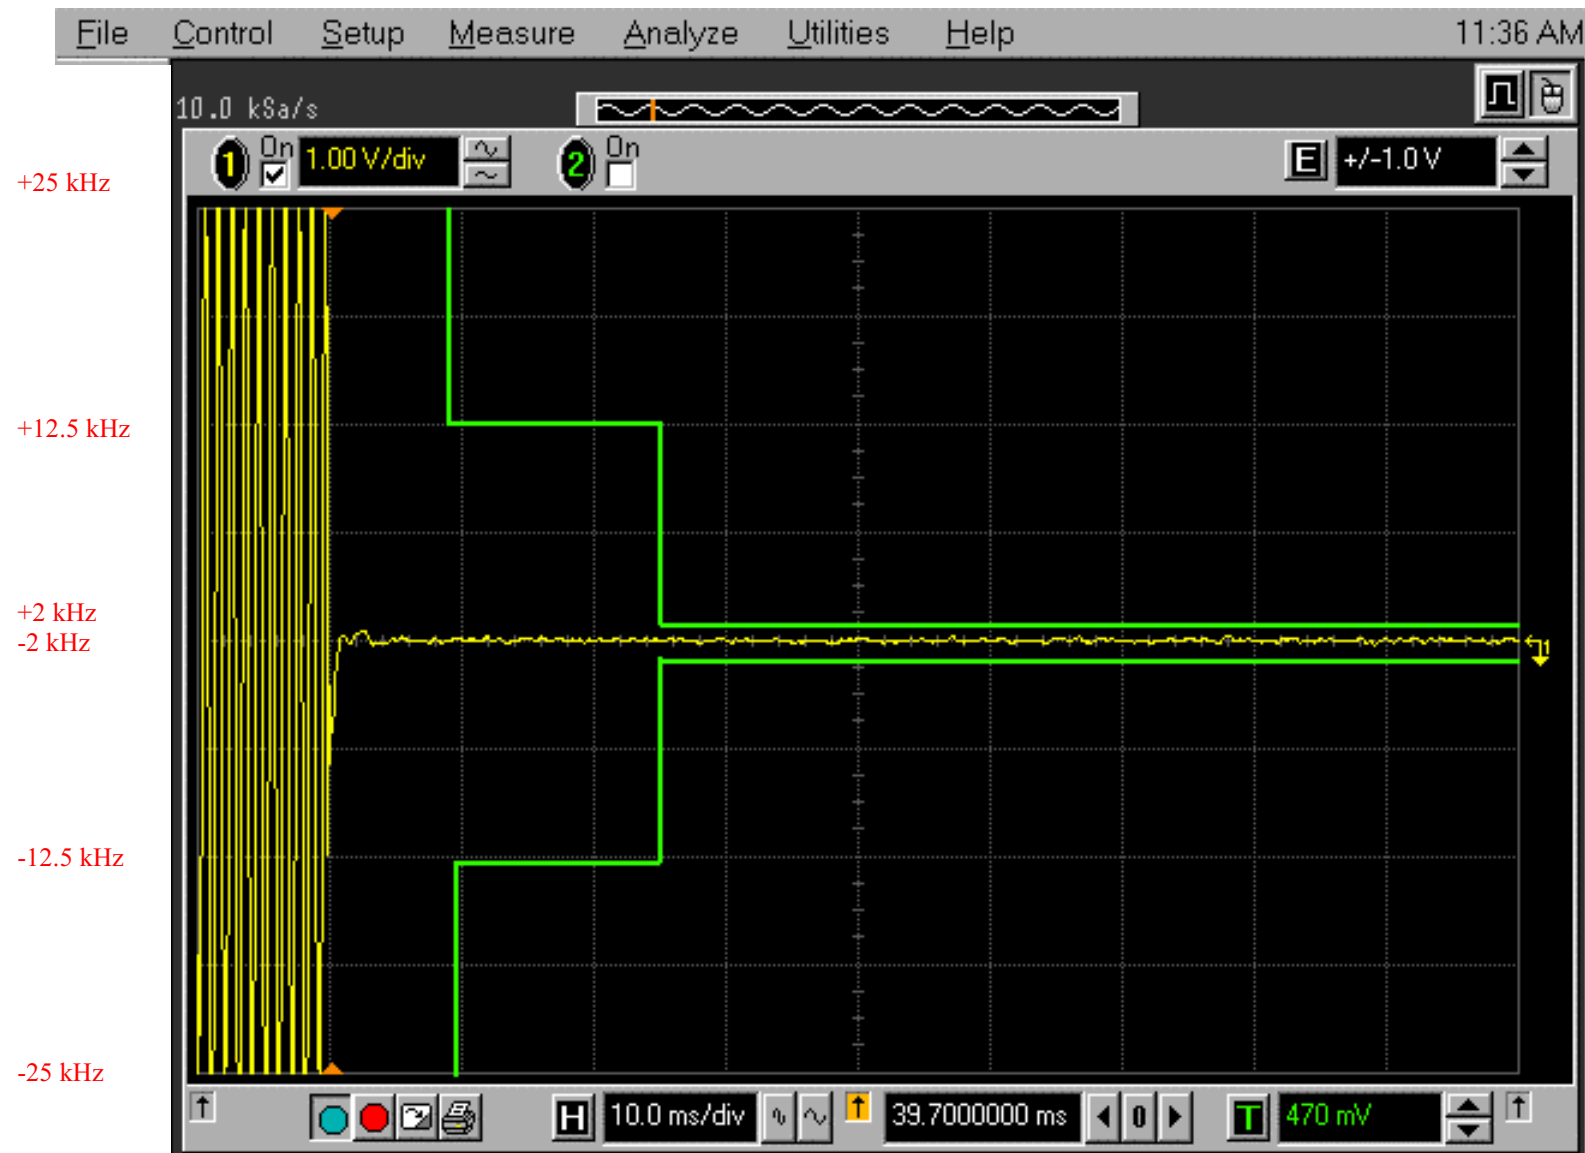
**PLOT # 34**

**25 kHz Channel Spacing, Transmitter was being turned ON, NO MODULATION**

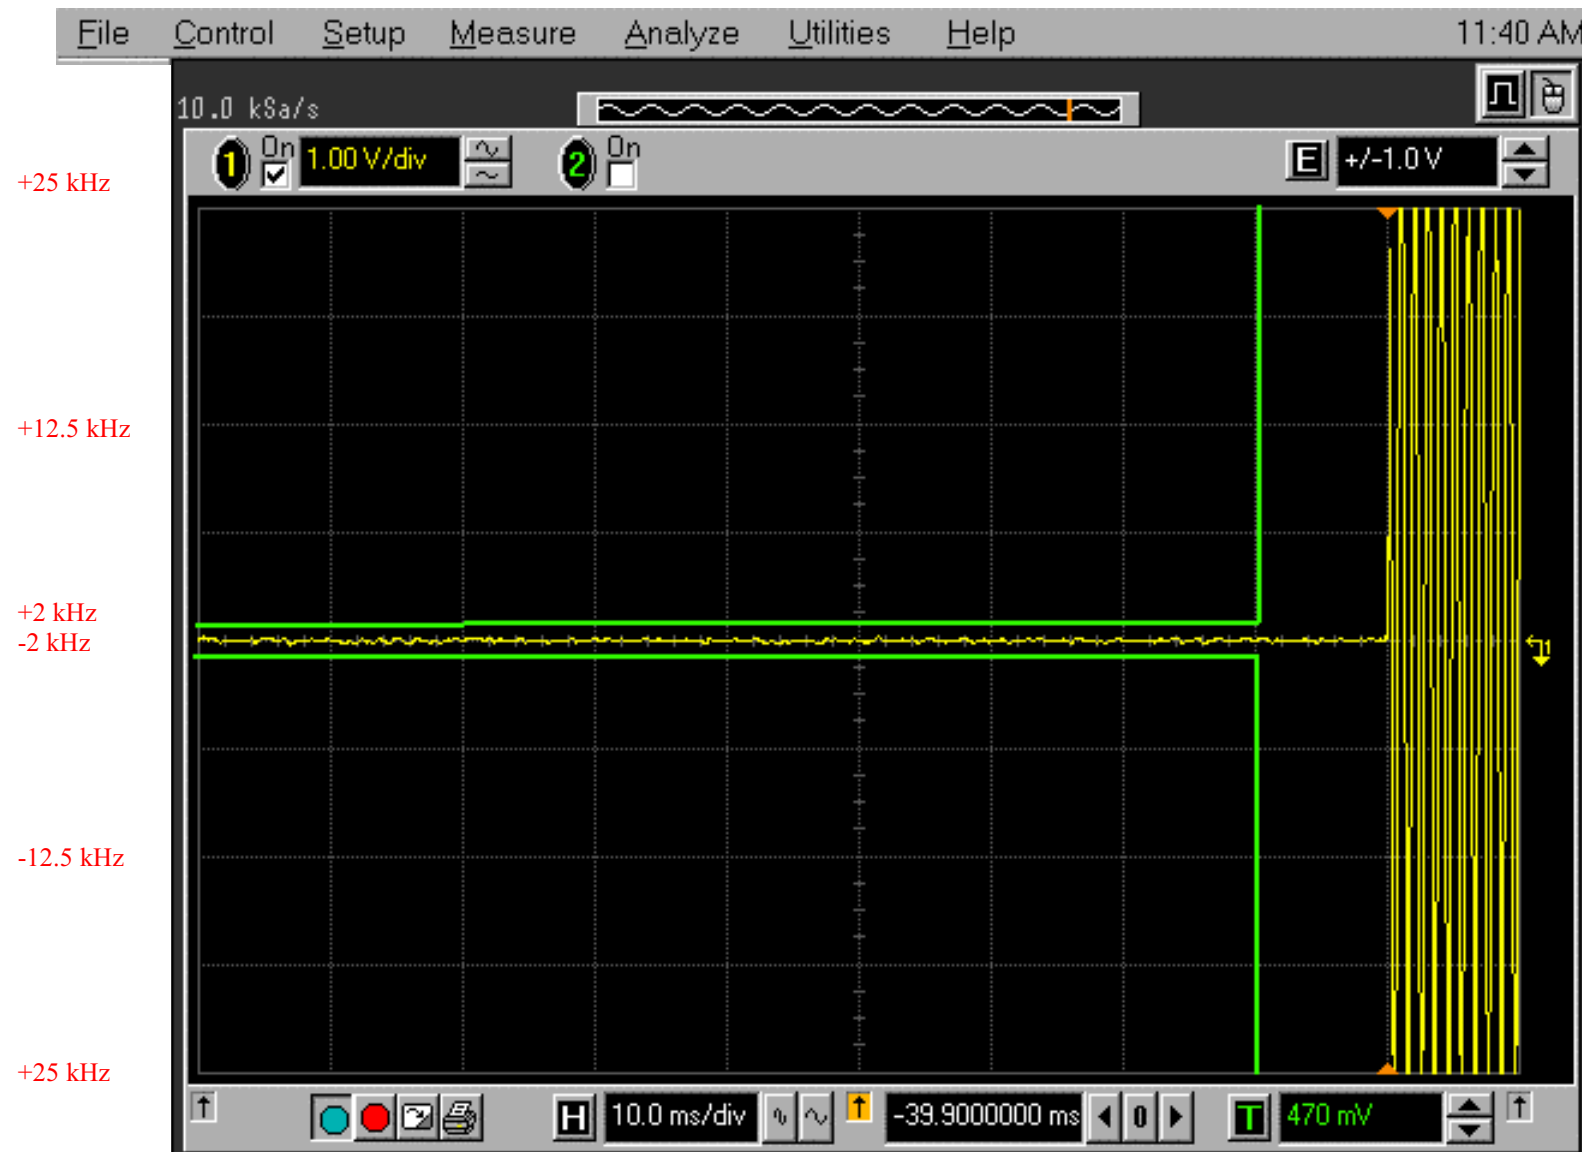
**PLOT # 35**

**25 kHz Channel Spacing, Transmitter was being turned OFF, NO MODULATION**

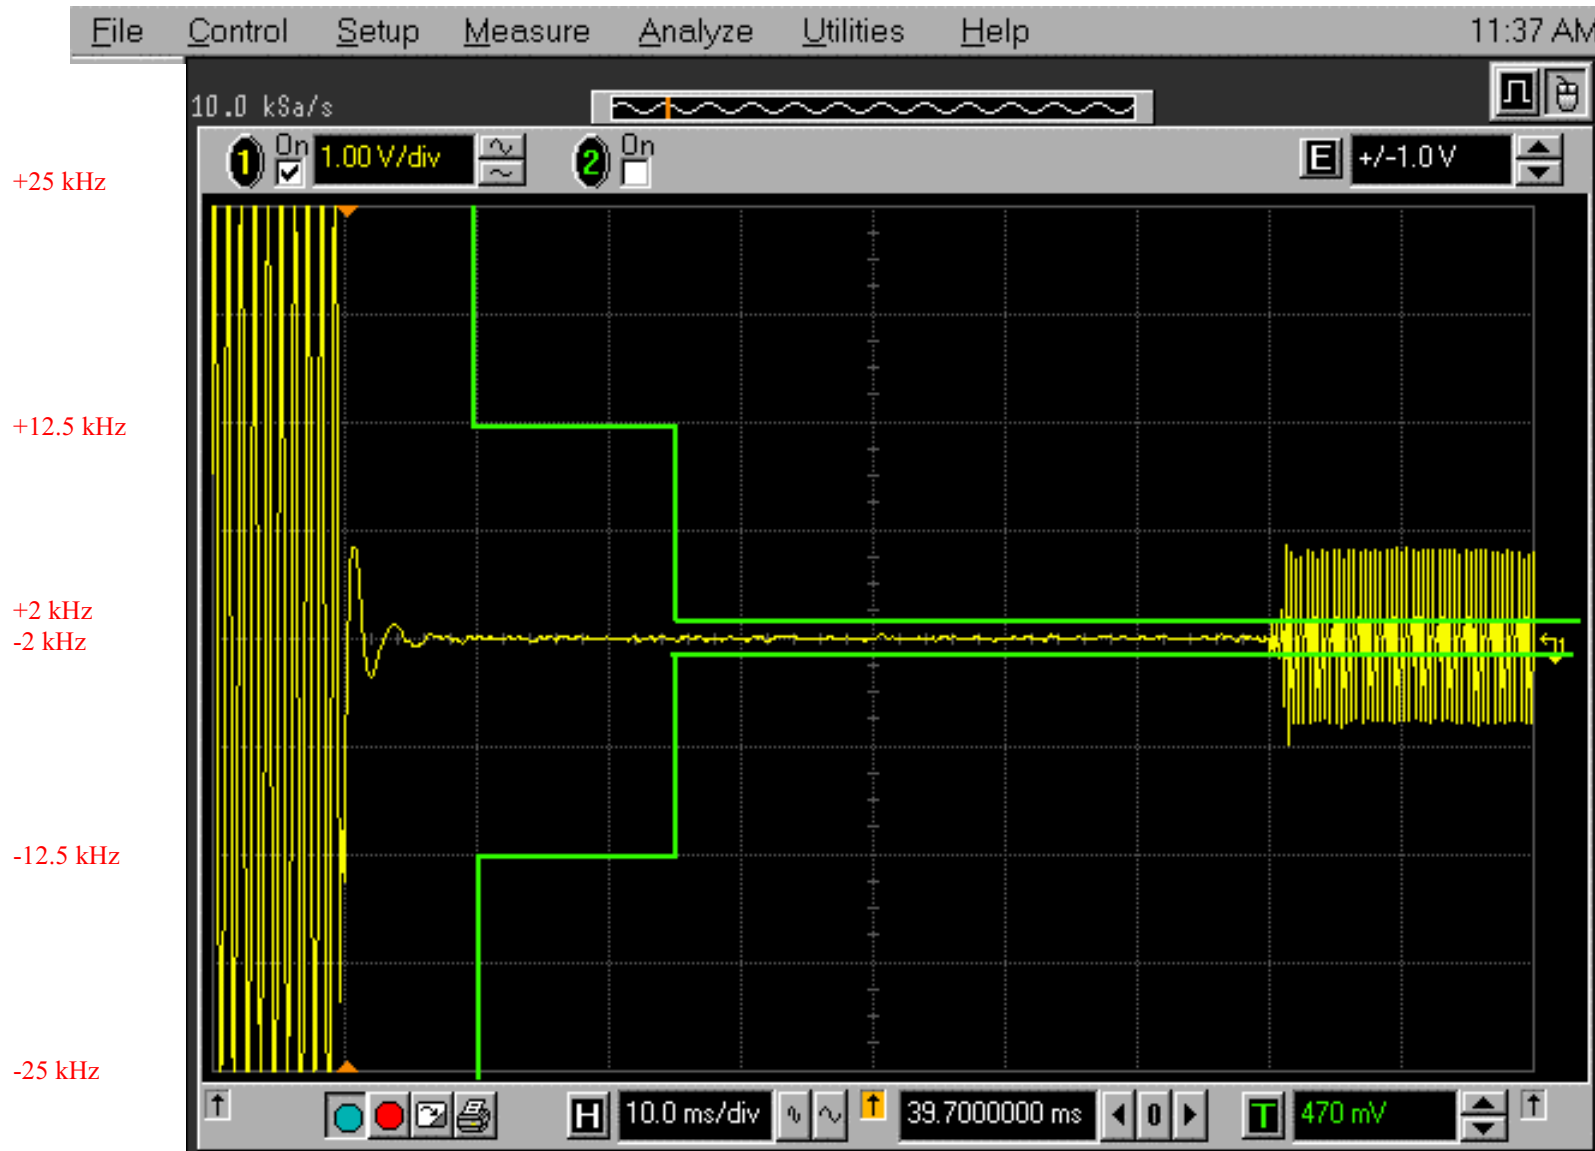
PLOT # 36

**25 kHz Channel Spacing, Transmitter was being turned ON, FM MODULATION WITH 1 kHz Sine Wave Signal**

The modulation of this transmitter is delayed by approximately 70 mS after the transmitter is turned on

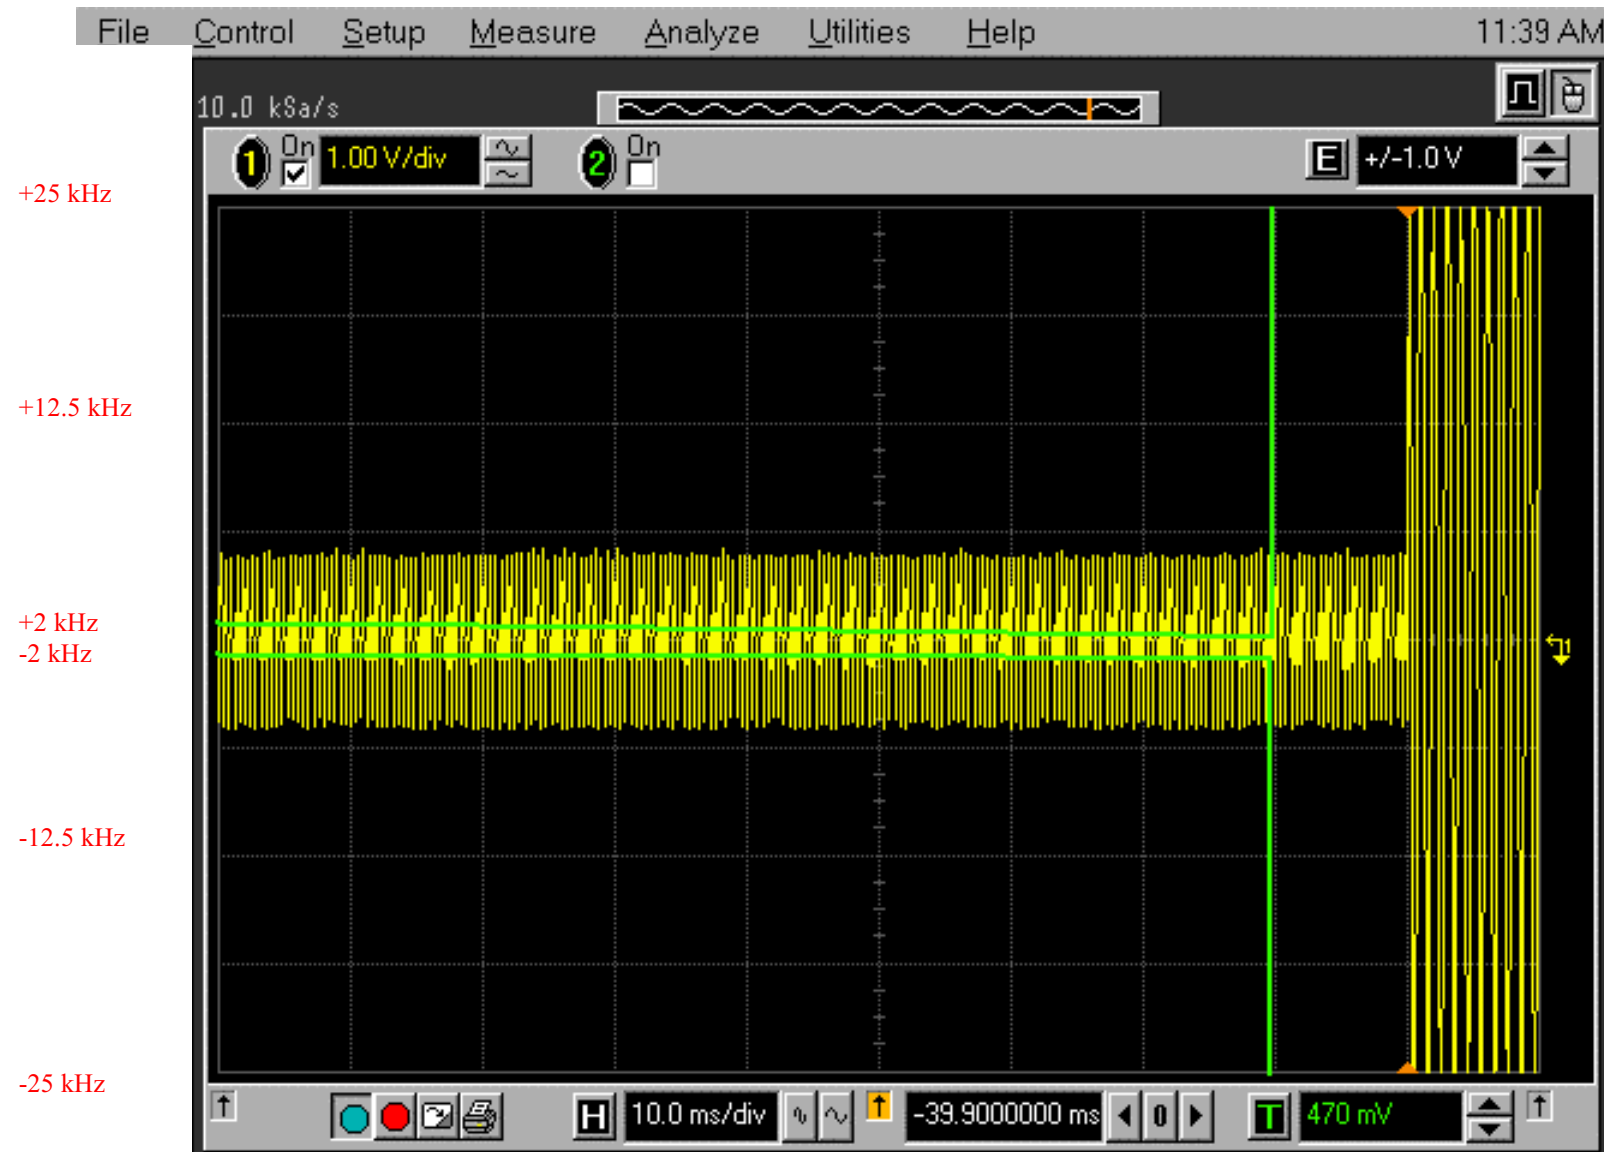
PLOT # 37

25 kHz Channel Spacing, Transmitter was being turned OFF, FM MODULATION with 1 kHz Sine Wave Signal
